The Magnetic Map of a Fireplace Base

3 November 2003

prepared for: Eric Deetz
Jamestown Rediscovery
1367 Colonial Parkway
Jamestown, VA 23081

by: Bruce Bevan
Geosight
356 Waddy Drive
Weems, VA 22576

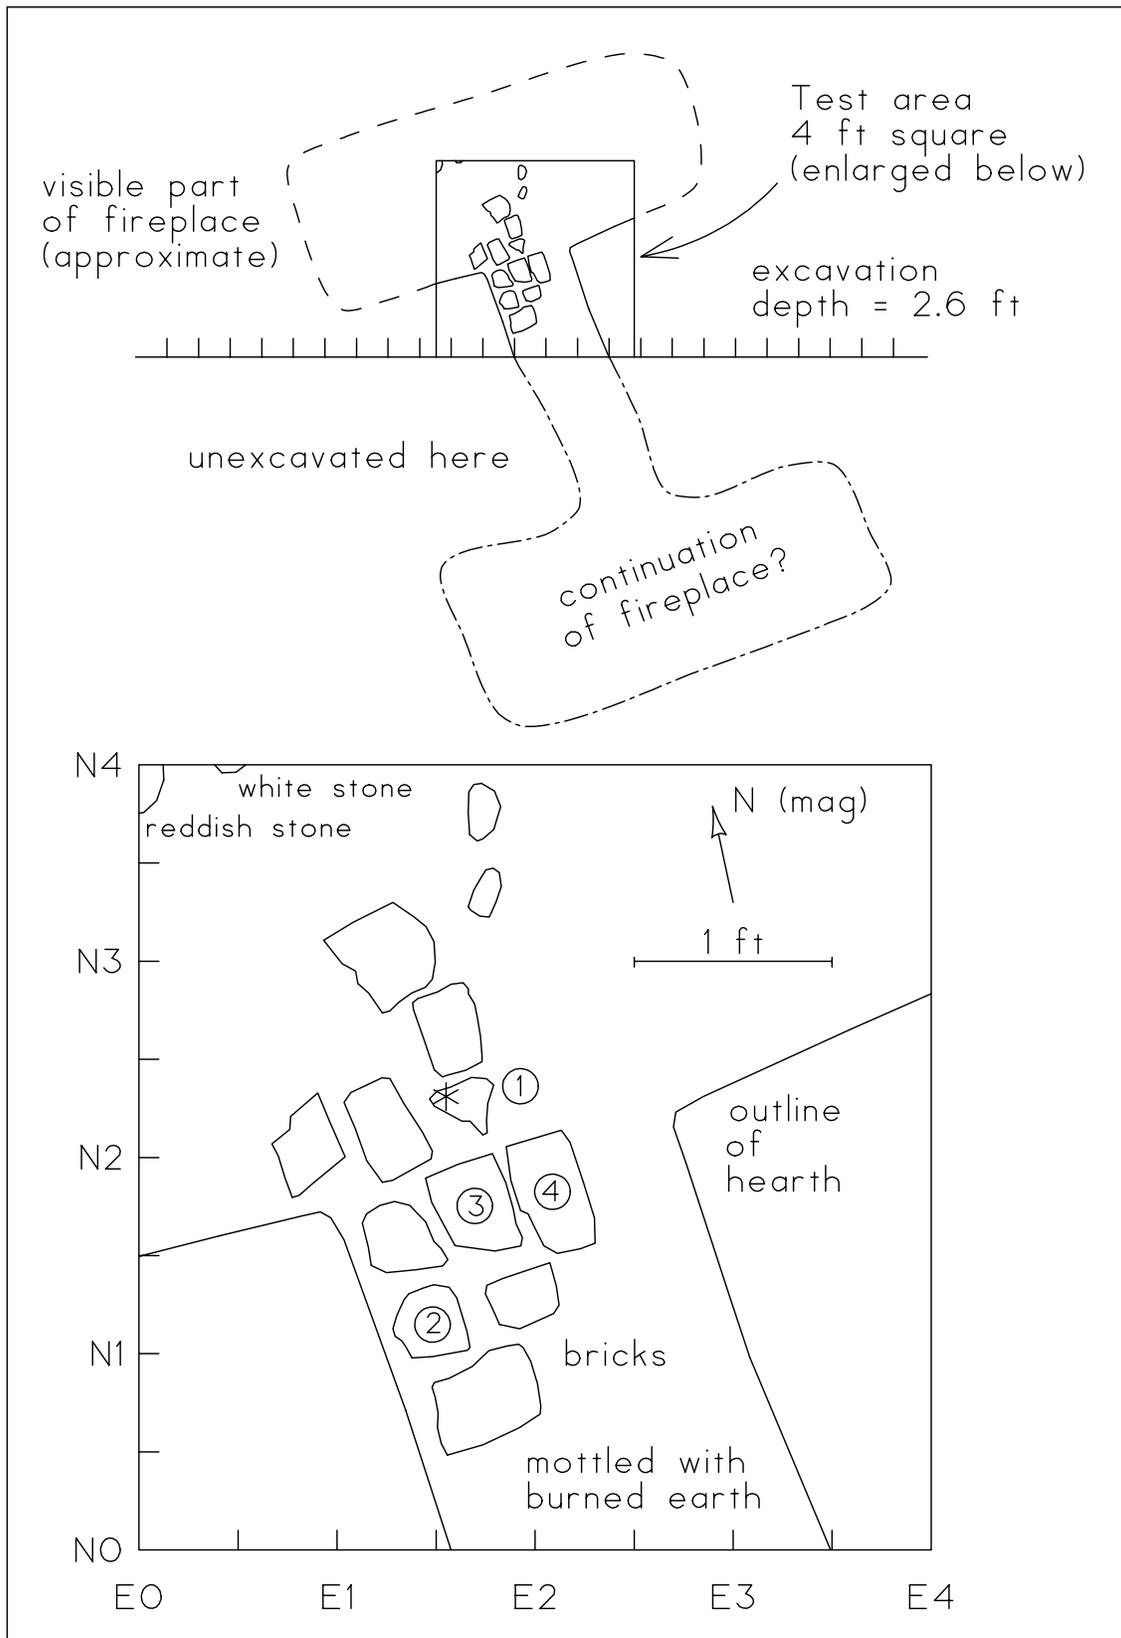
Four bricks were detected by this magnetic survey; these are marked with circled numbers in [Figure 1](#). There are no magnetic anomalies where bricks are not visible at the surface. This means that it is unlikely that there is a layer of bricks deeper in the soil. If there was a layer of bricks at a depth of 0.25 ft underground, some of them should have caused magnetic anomalies that would have been seen in this map.

In [Figure 1](#), the edge of the fireplace is marked with a line. There is no change in the magnetic readings near this line. This means that the soil along this line was not magnetized by the fires that would have been inside the fireplace. There was also no suggestion from the magnetic map than any of the visible bricks were remagnetized in the fireplace. It is possible, therefore, that the archaeological surface that is visible now was underground and cool during the operation of the fireplace. This finding is not certain, because it is possible that the base of a fireplace may have been insulated by ash, keeping it cooler than one would think. This result was suggested by magnetic measurements on fireplace bases in structure 165; no evidence of brick refiring was found within two fireplaces there.

The two stones that are found in the northwest corner of the survey square ([Figure 1](#)) were found to be not magnetic. The white stone probably does not contain iron minerals, and would not be magnetized in a fire. The red stone could contain iron; it probably is not igneous and was never in or

The soil was mottled with an orange color at the southern side of the survey area ([Figure 1](#)). The geophysical survey did not find any magnetic anomalies in this area. This suggests that the possible firing of these soil clumps was not enough to magnetize the soil to any detectable extent.

Figure 1: The area of the geophysical survey. This is feature JR1361, the base of an early fireplace. A magnetic map was measured in a square area that is 4 ft on a side. Brick fragment 1 (next to the circled number) was found to be very magnetic; while bricks 2 - 4 were moderately magnetic, the remaining bricks could not be detected with the magnetic survey.

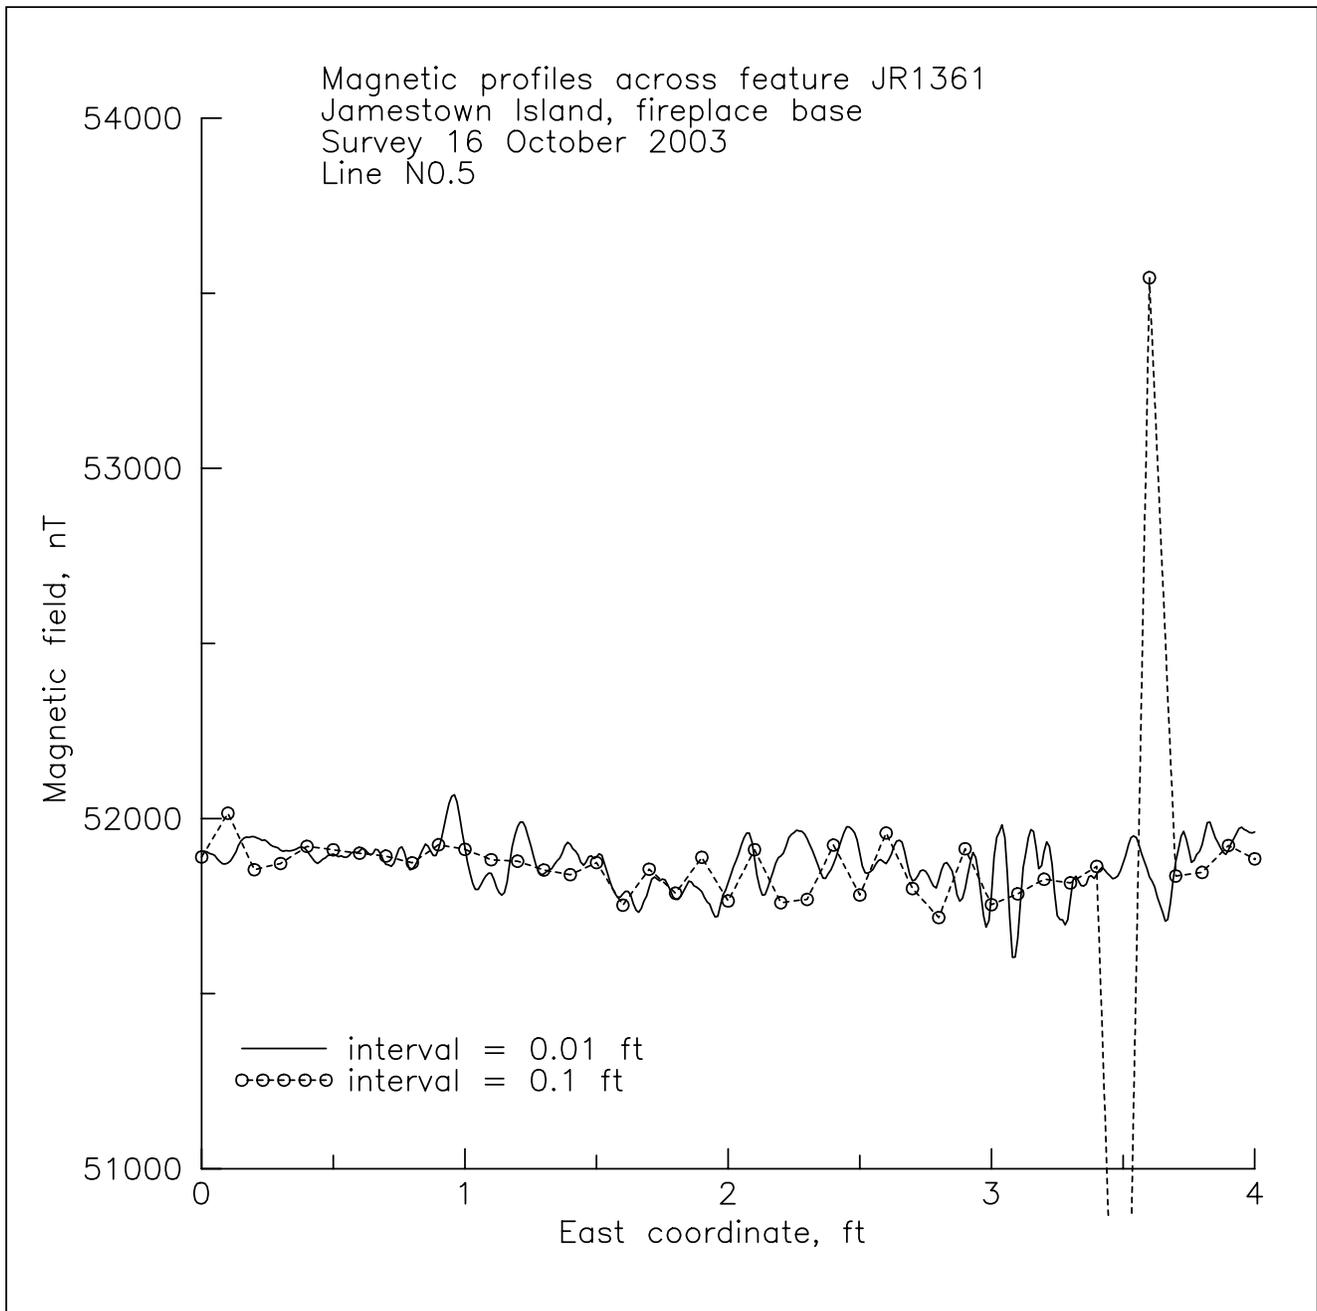
I measured the magnetic anomaly of a shovel that is similar to those of the excavators. It caused an anomaly of about 100 nT at a distance of 3 - 4 ft. There may have been two shovels in the excavation at some times. The soils were screened on the north side of the excavation, and there was little effect from the iron in the screen. However, a wheel barrow was brought there at some times to remove that soil to a disposal area, and this wheel barrow had a large amount of steel. The large double spike at E3.5 in [Figure 3](#) must almost certainly be caused by the wheel barrow.

Figure 3: A duplicated magnetic profile across the fireplace base. The smooth solid line shows the initial measurements; the spacing between these readings was 0.01 ft. The line was later repeated with a measurement spacing of 0.1 ft; the circles on the broken line show these readings. The double spike on the repeated readings at E3.5 was caused by iron moving in the nearby excavation.

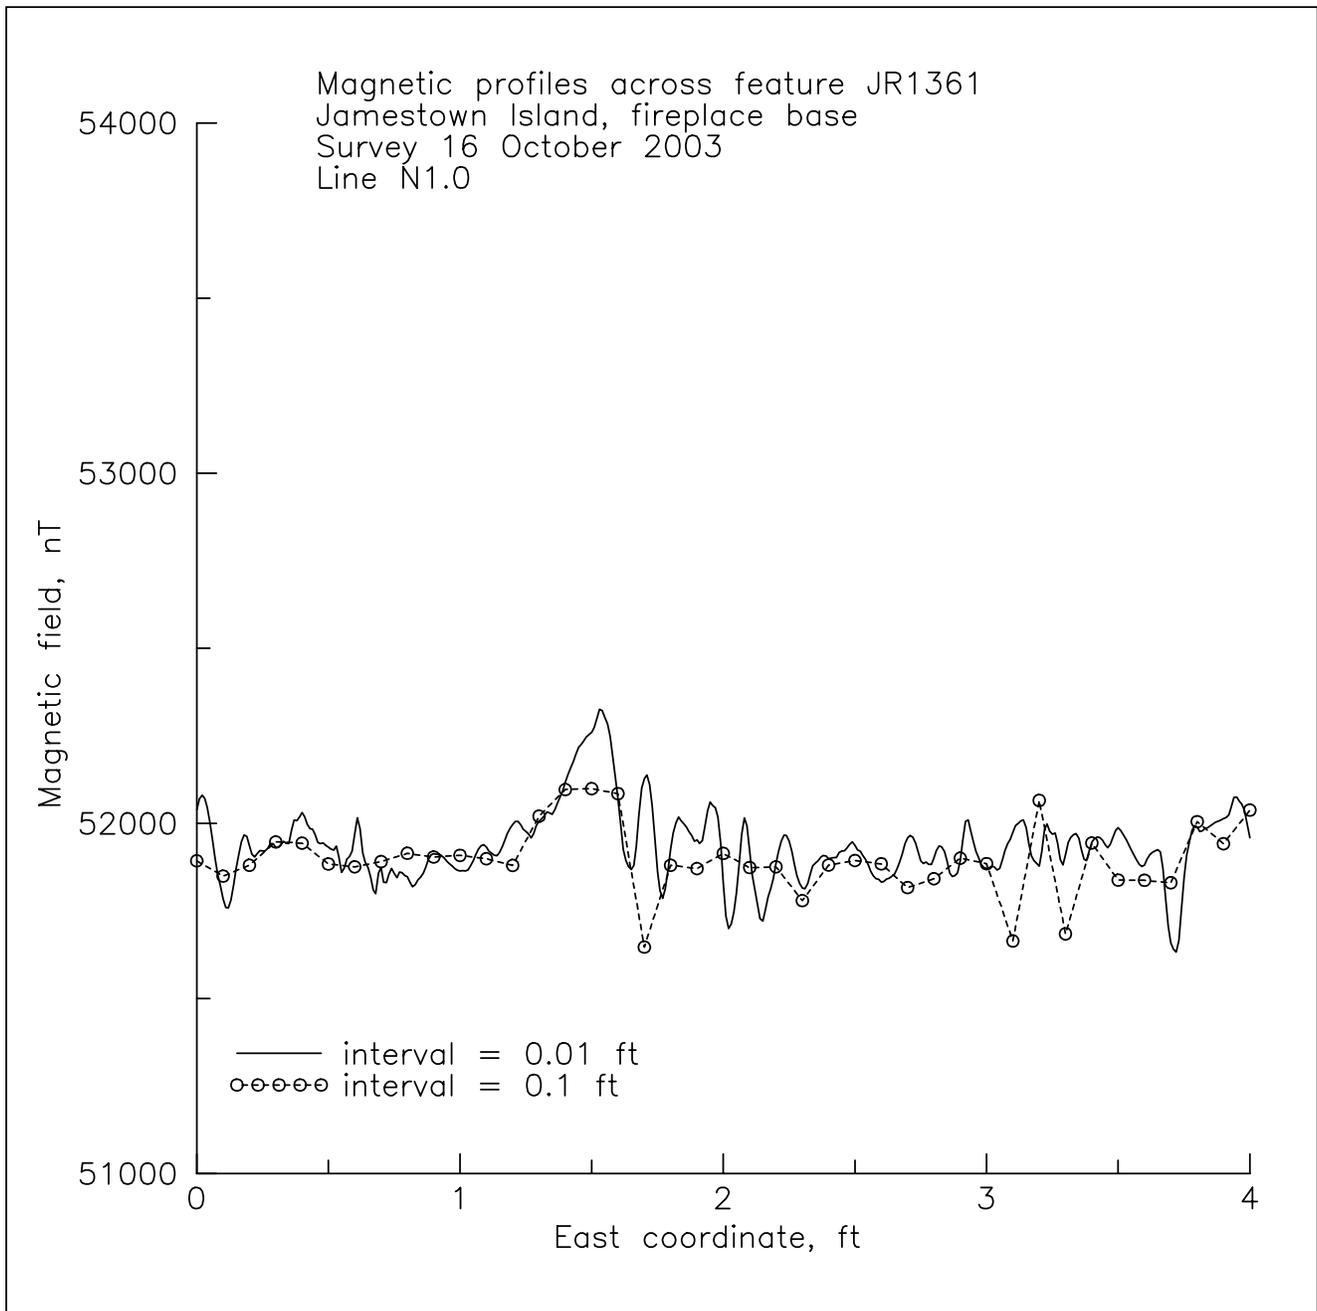
Figure 4: Another pair of magnetic profiles. These measurements were made on line N1.0 ft, which is 1 ft to the north of the edge of the excavation. The high readings near E1.5 are at brick 2 in the map of [Figure 1](#).

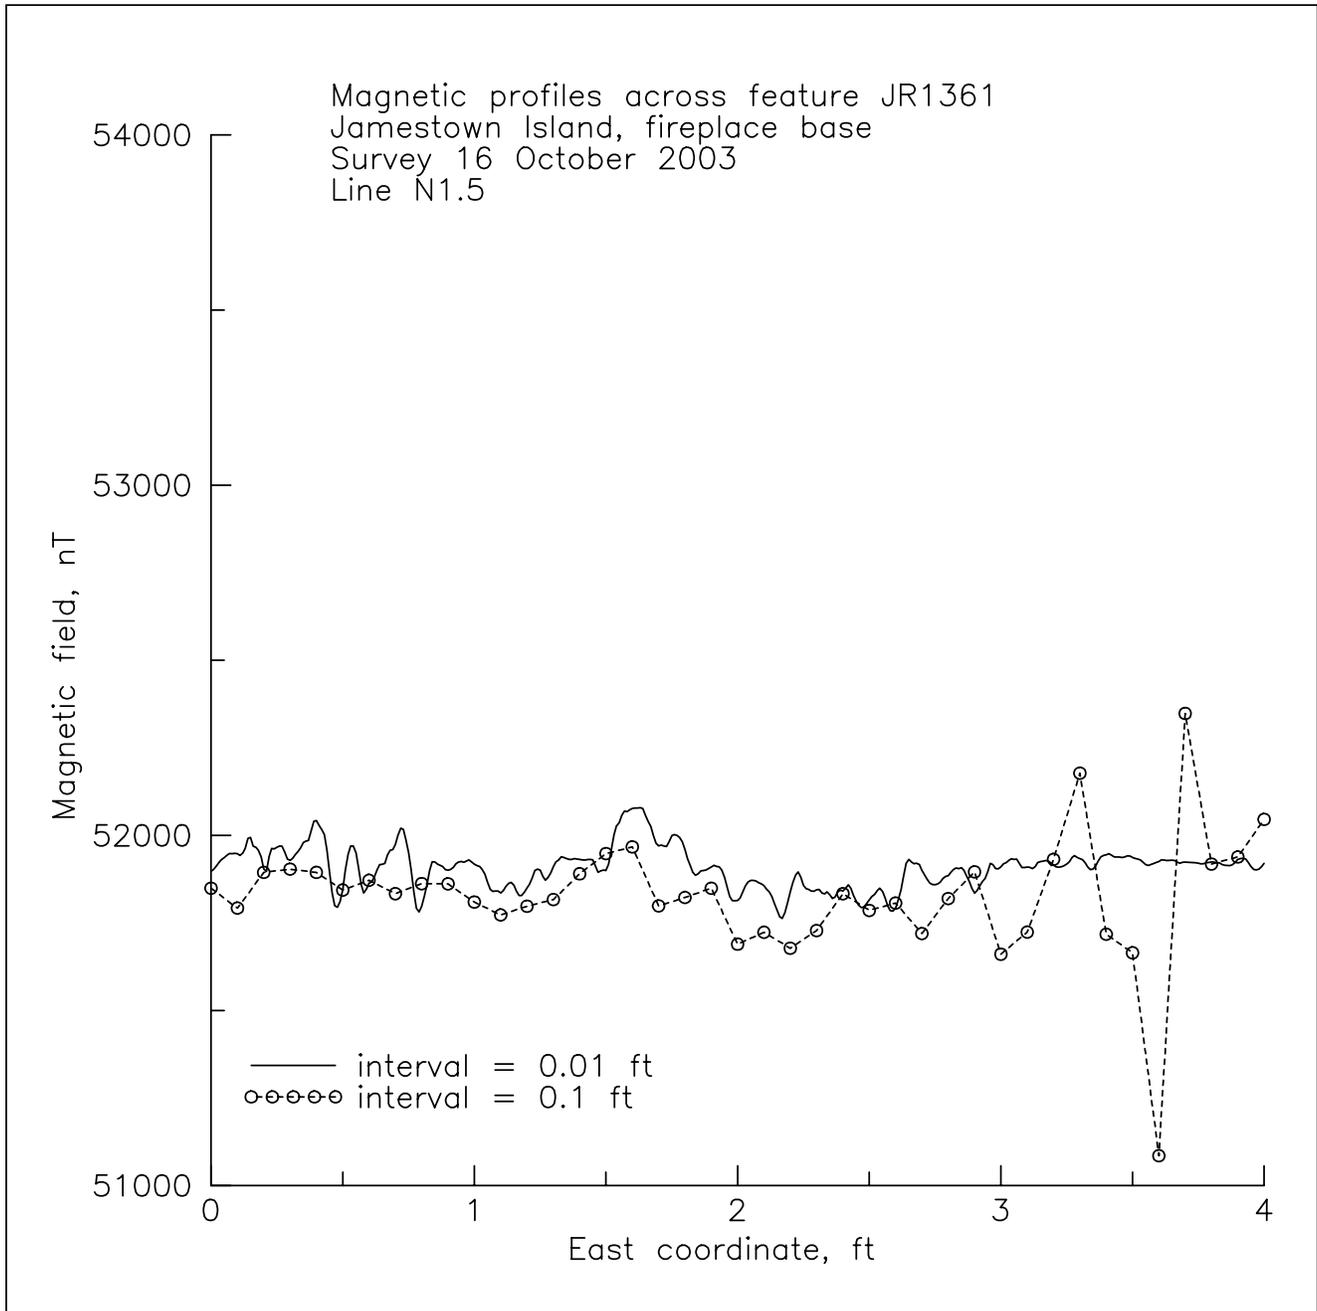
Figure 5: Magnetic profiles of line N1.5 across the fireplace. Little was detected on this line. The irregularities on the dashed line at the right end are caused by moving iron tools in the excavation that was to the east.

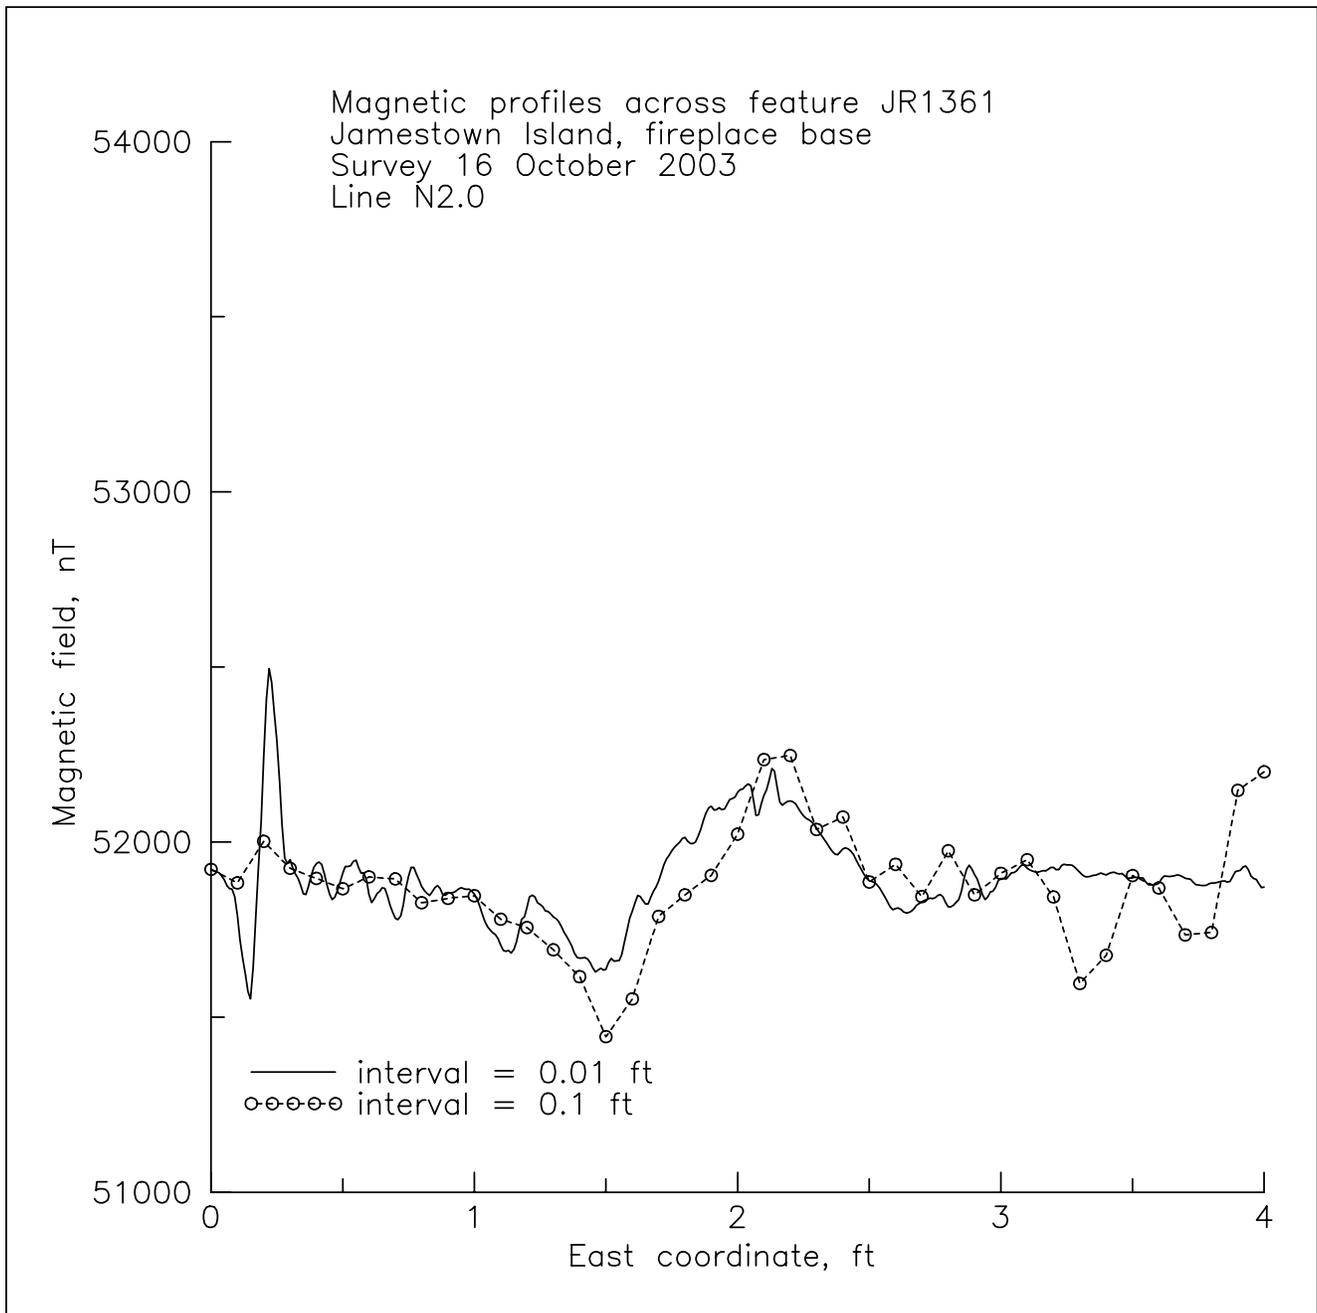
Figure 6: The magnetic effect of two bricks. On this line, brick 3 causes the low readings near E1.5, while brick 4 causes the high readings near E2. The large swing of the solid line curve near E0.2 has an unknown origin, but it is not caused by an underground feature.

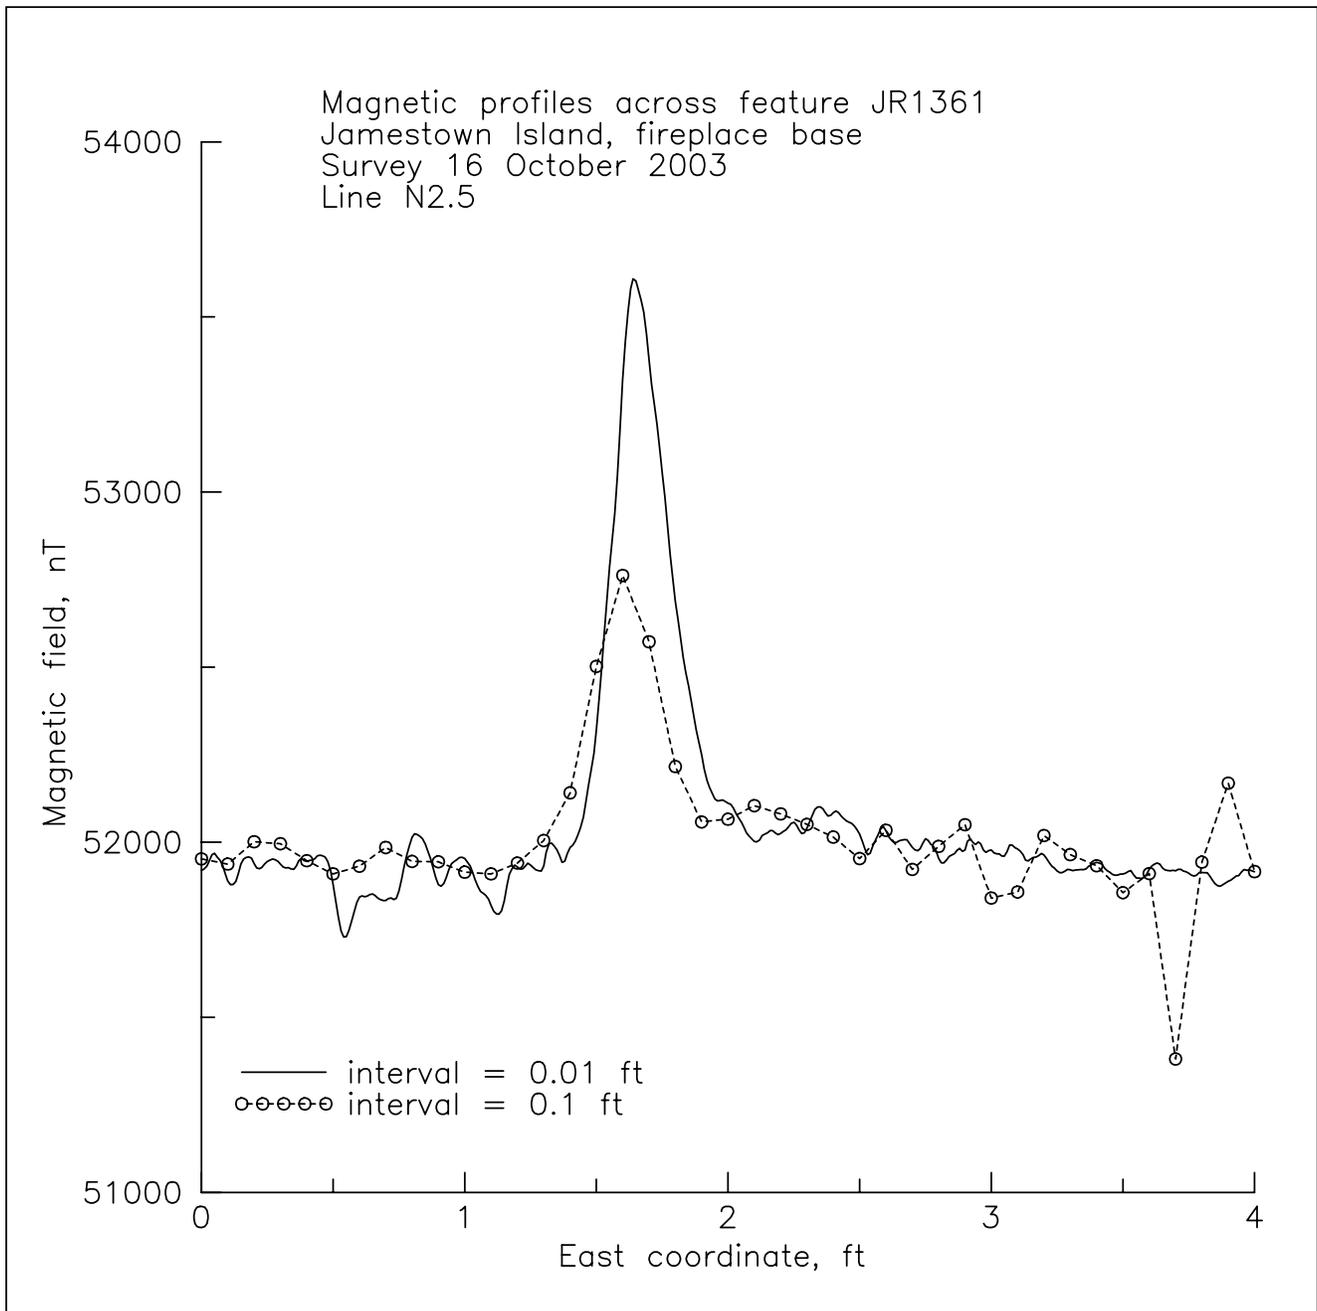
Figure 7: The most magnetic brick. The large peak near E1.7 is caused by brick fragment 1; it is much more magnetic than any of the other bricks in this fireplace base. The difference in the amplitudes of the magnetic anomaly on the two curves may be due to differences in spatial resolution; one set of readings was made at intervals of 0.1 ft while the other set was at 0.01-ft intervals.

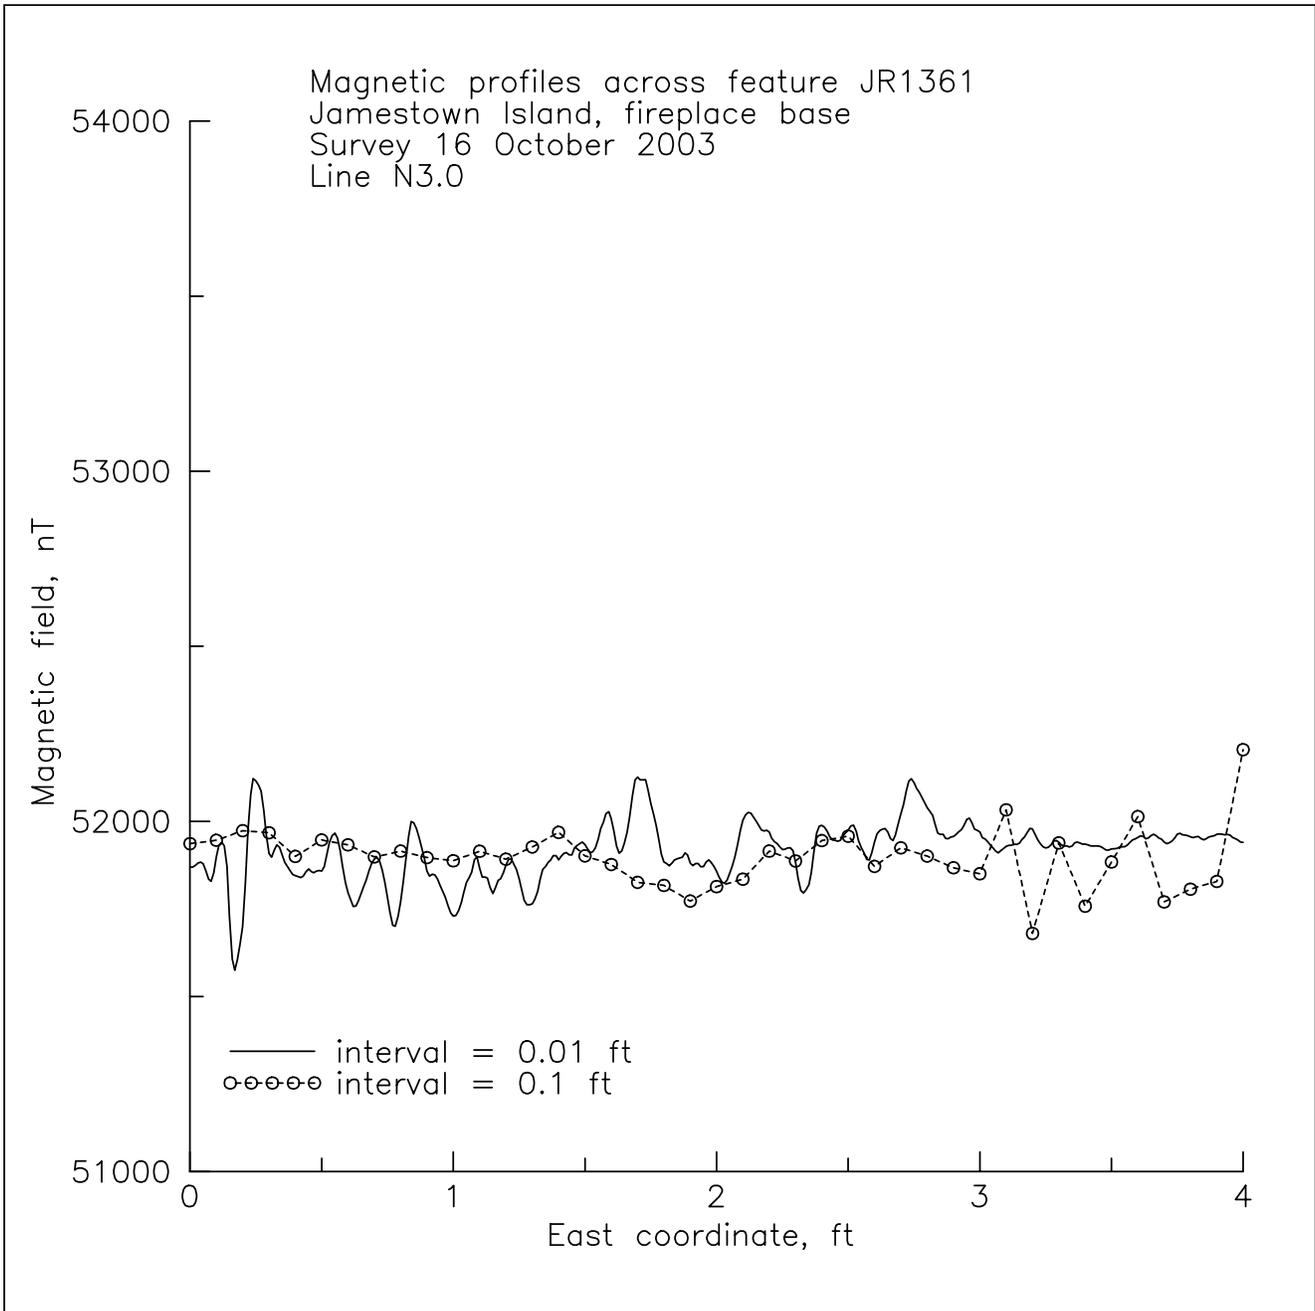
Figure 8: The final magnetic profiles. While this line crosses a brick at E1.3, that brick was not detected by the magnetic survey. This is evidently because this brick is not very magnetic; it must be about as magnetic as the surrounding soil.

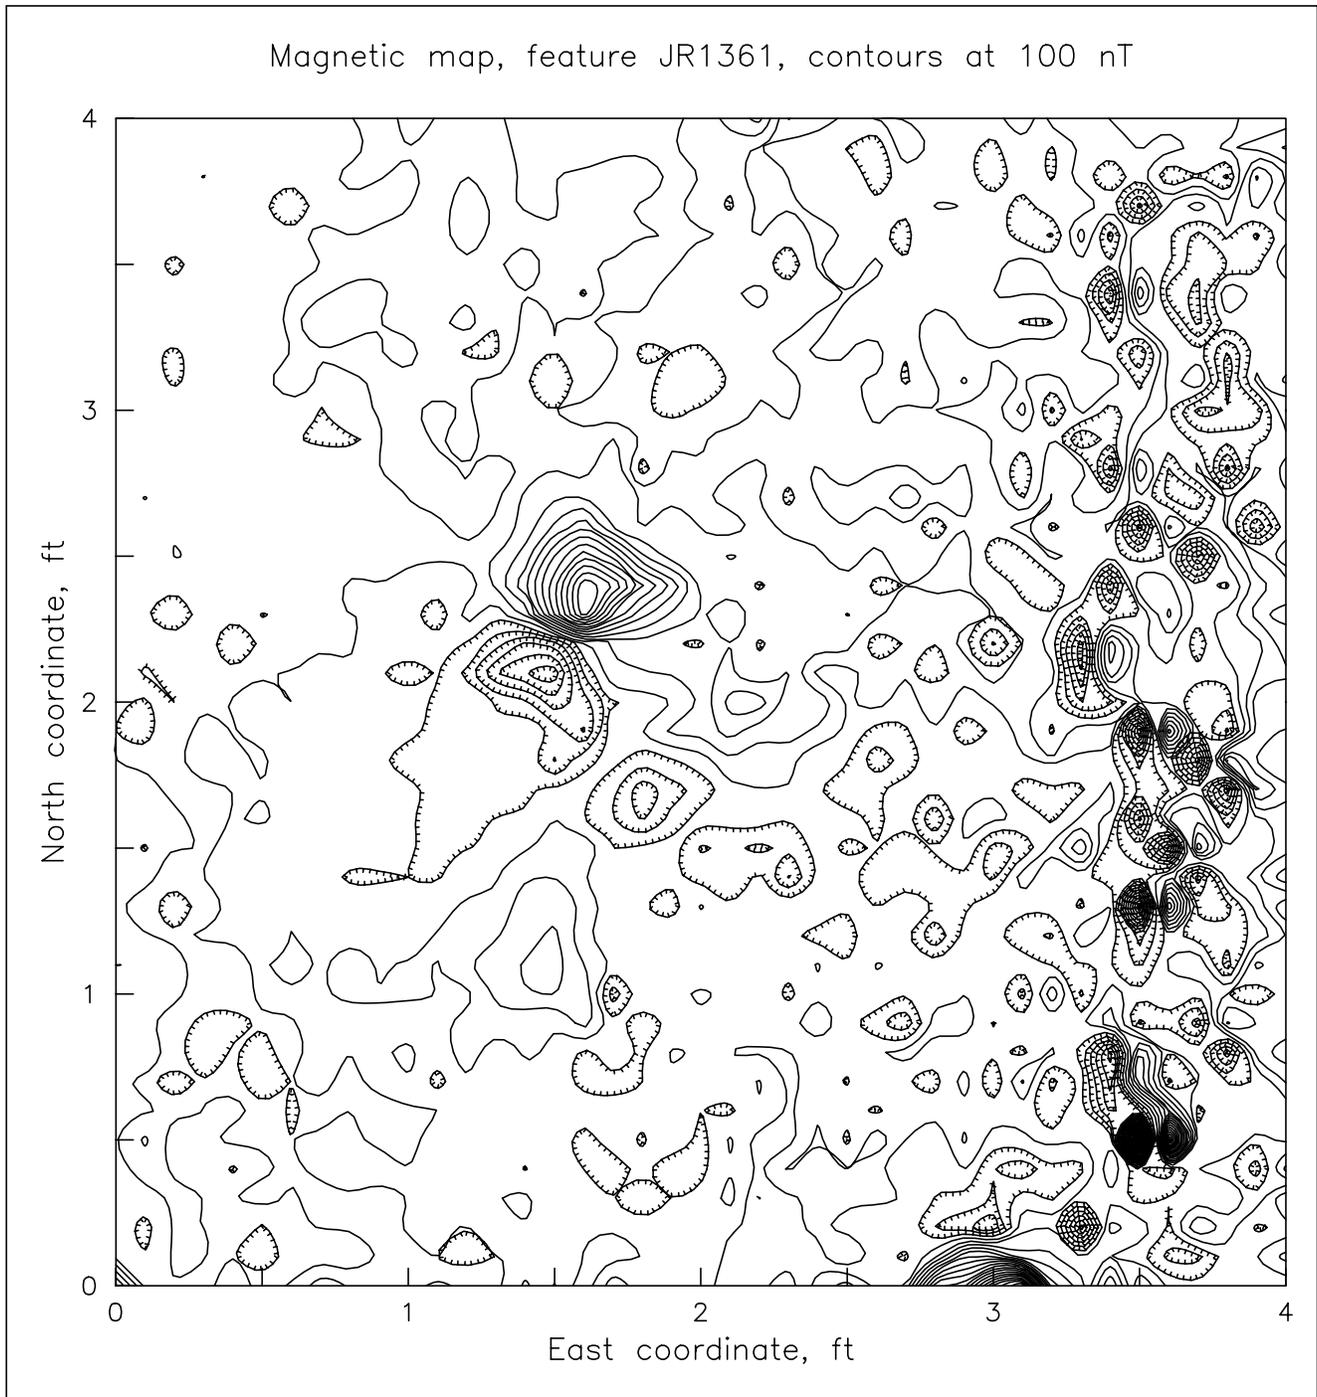
The major magnetic anomaly is the dipolar pattern centered at E1.5 N2.2 in the map. This anomaly was analyzed by assuming that it was caused by a compact magnetic object that could be approximated by a magnetic dipole. The analysis also assumed that the earth's field had the parameters: Magnitude = 52,000 nT, inclination = 65.7° (from IGRF2000), declination = -10.5° (grid angle, from a magnetic compass). The magnetic dipole that best fit the measurements had the following parameters: Moment = 6.4 mAm², inclination = 14.7°, declination = -151.6°, location = E1.55 N2.31, and depth = 0.21 ft. This location is marked with an asterisk in [Figure 1](#); it is evidently brick fragment 1 that causes this anomaly. The interpreted moment and depth are more likely overestimates than underestimates (because of the dipole approximation). Brick fragment 1 is roughly a quarter of a brick, so the entire brick would have had a total magnetic moment of about 25 mAm². This brick is about twice as magnetic as the average of two samples of brick from structure

The remaining anomalies in the magnetic map of [Figure 9](#) are not distinct enough to be worth a careful analysis. However, there are clearly three more magnetic anomalies that are so close to bricks that they must be caused by those bricks; these are numbered as 2 - 4 in [Figure 1](#).

Each of the magnetic profiles in [Figures 3](#) - [8](#) shows duplicated lines of measurement. These repeated measurements differ by a good amount at some locations. Part of the difference is due to the differing resolutions of the repeated surveys: With measurements spaced by 0.01 ft, many more small features are detected than can be found with an 0.1-ft measurement spacing. However, there are also large differences that cannot be explained by the change in resolution. These large differences, which are almost entirely found on the eastern side of the survey area, are caused by the iron tools that were moving in the excavation to the east. These moving iron objects cause the fine-textured patterns that are seen on the right-hand side of the magnetic map in [Figure 9](#).

Figure 9: The magnetic map. The magnetic sensor was at a height of 0.053 ft (0.63 inch) above the brick surface and the measurement spacing was 0.1 ft. The interval between the contour lines is 100 nT. Enclosed low values have contours with tick marks along them. The band of complex anomalies on the right is caused by moving iron tools that were nearby.

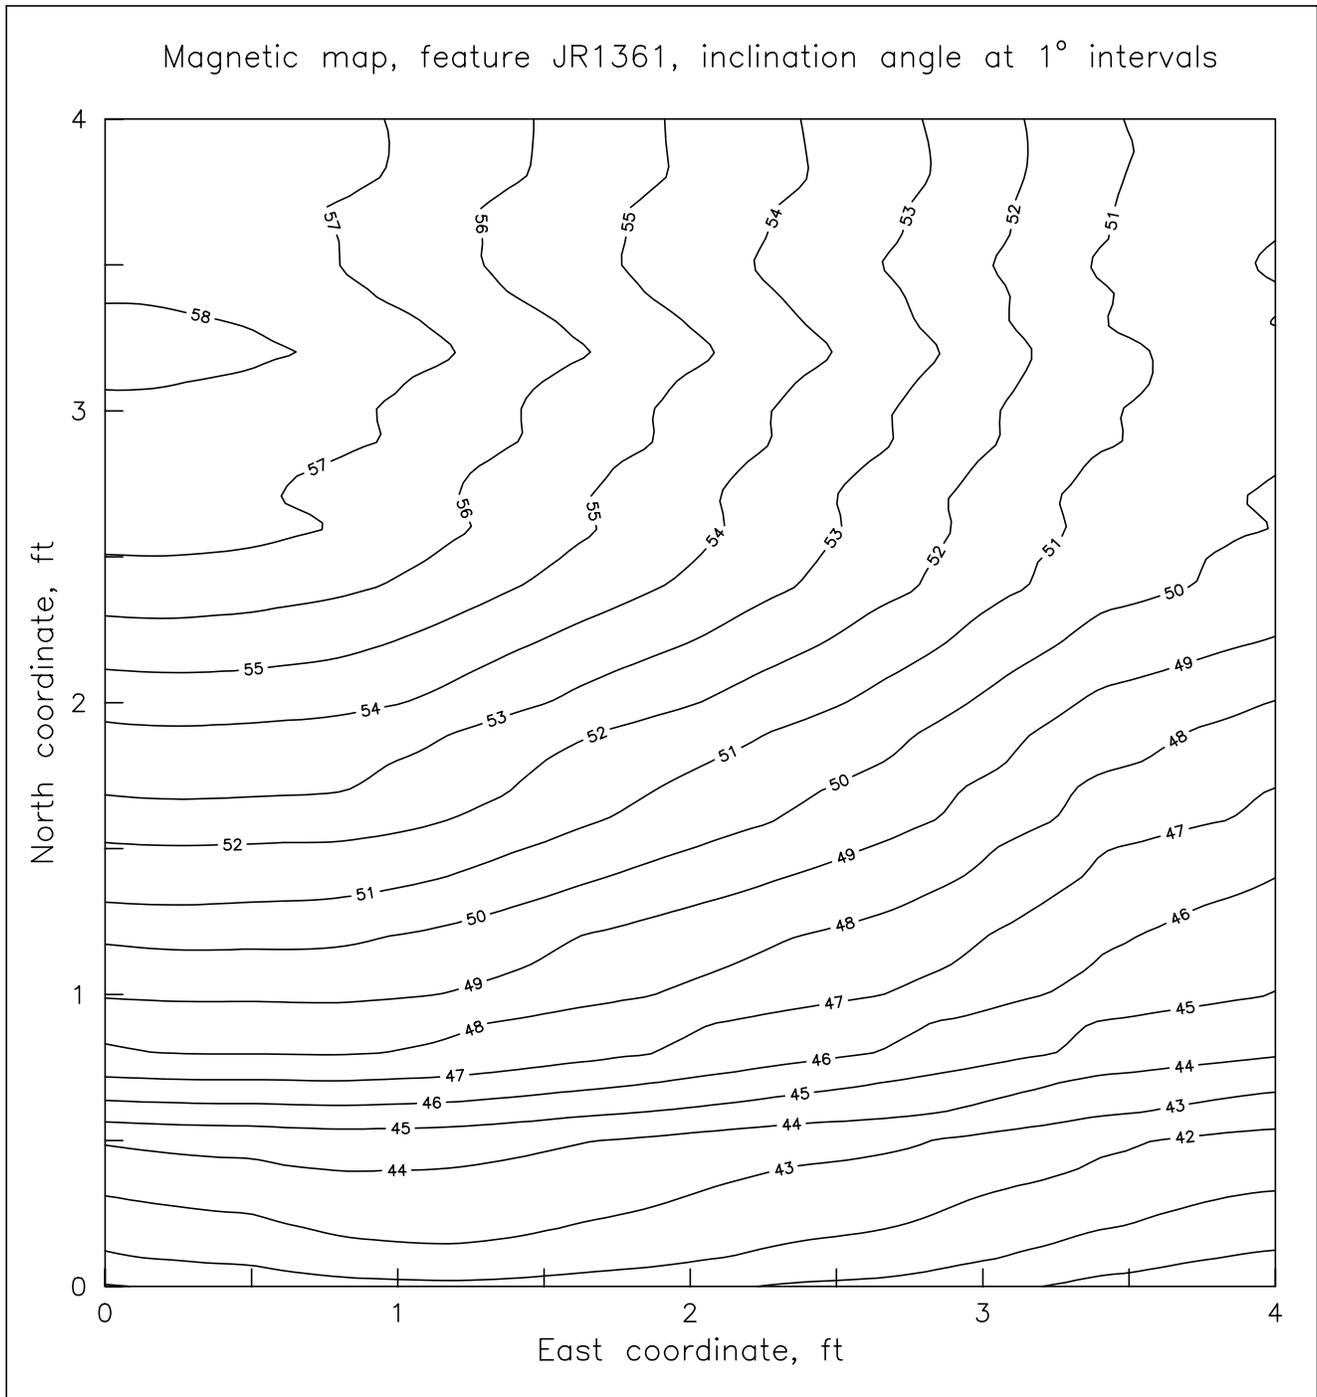
Figure 10: The inclination or dip of the magnetic field in the 4-ft square. The numbers show the angle, in degrees, below the horizontal. Without magnetic features, the dip of the earth's field should be about 66° at Jamestown. The angle is much less at the southern side of the square; this is likely due to the effect of the magnetic soil in the unexcavated ledge to the south.

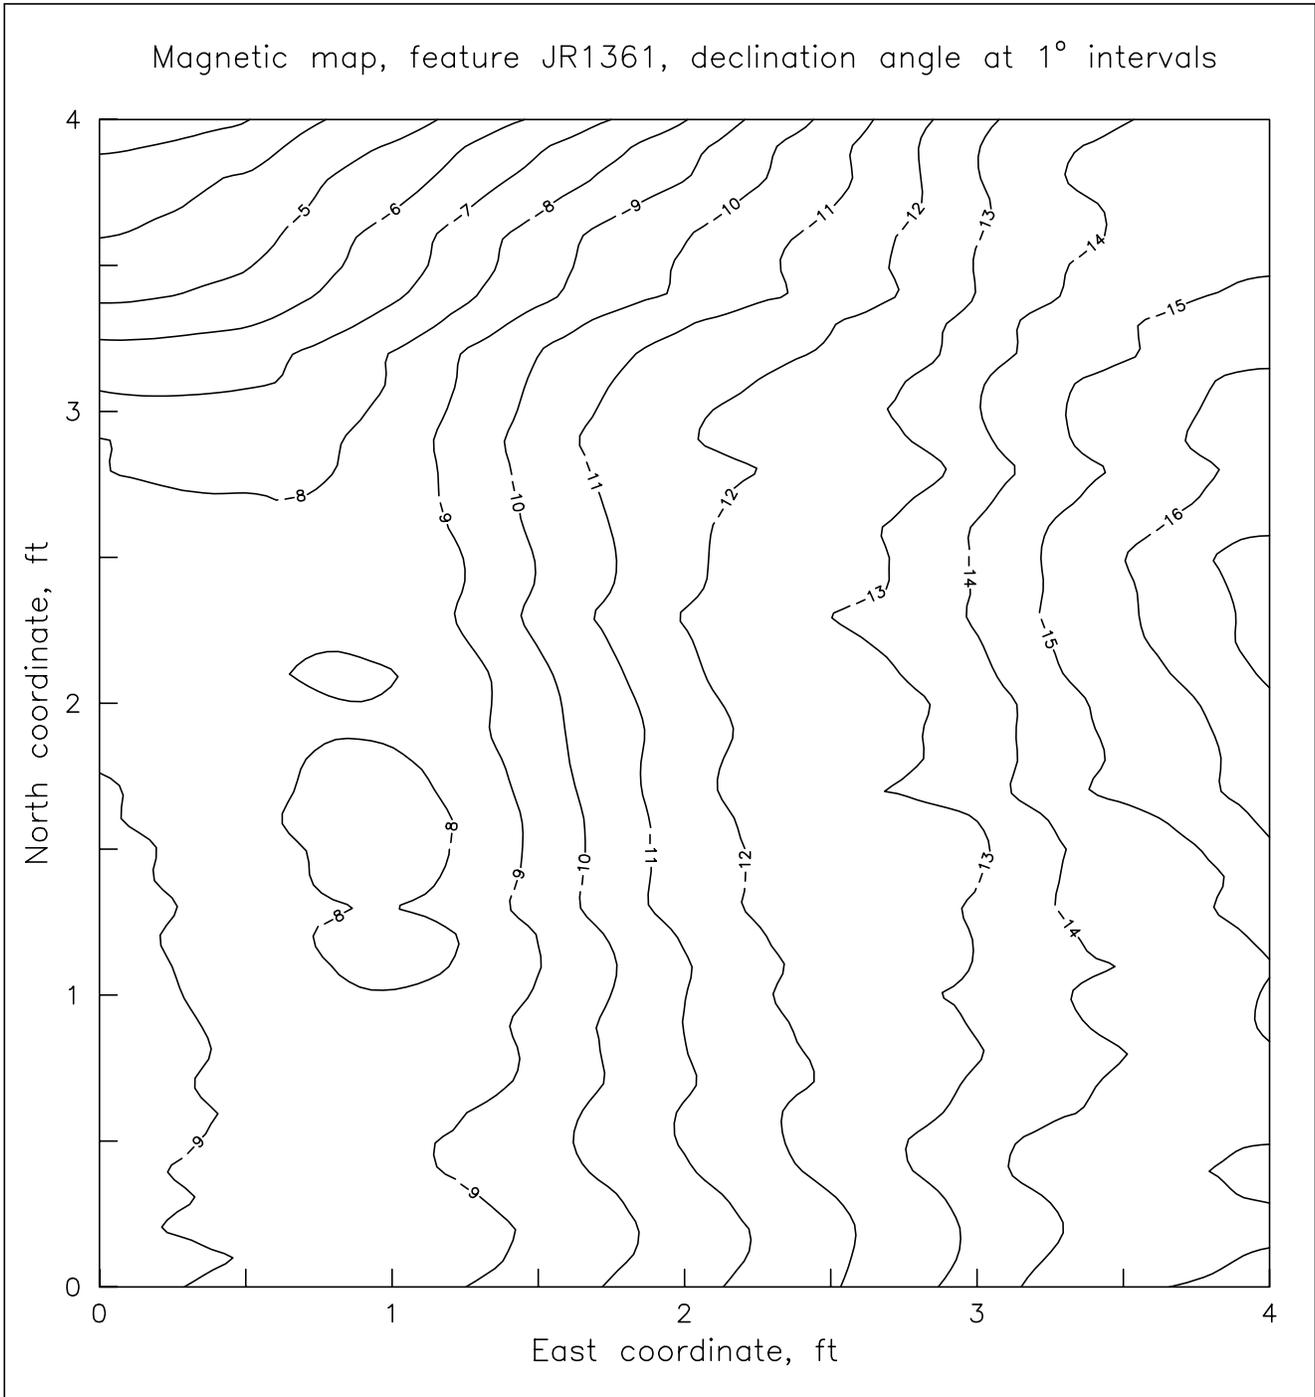
Figure 11: The grid declination of the magnetic field in the square. It varies over a range of about 12° in this area. The cause of this pattern has not been studied. The negative numbers mean that the local direction of magnetic north is to the west of grid north.

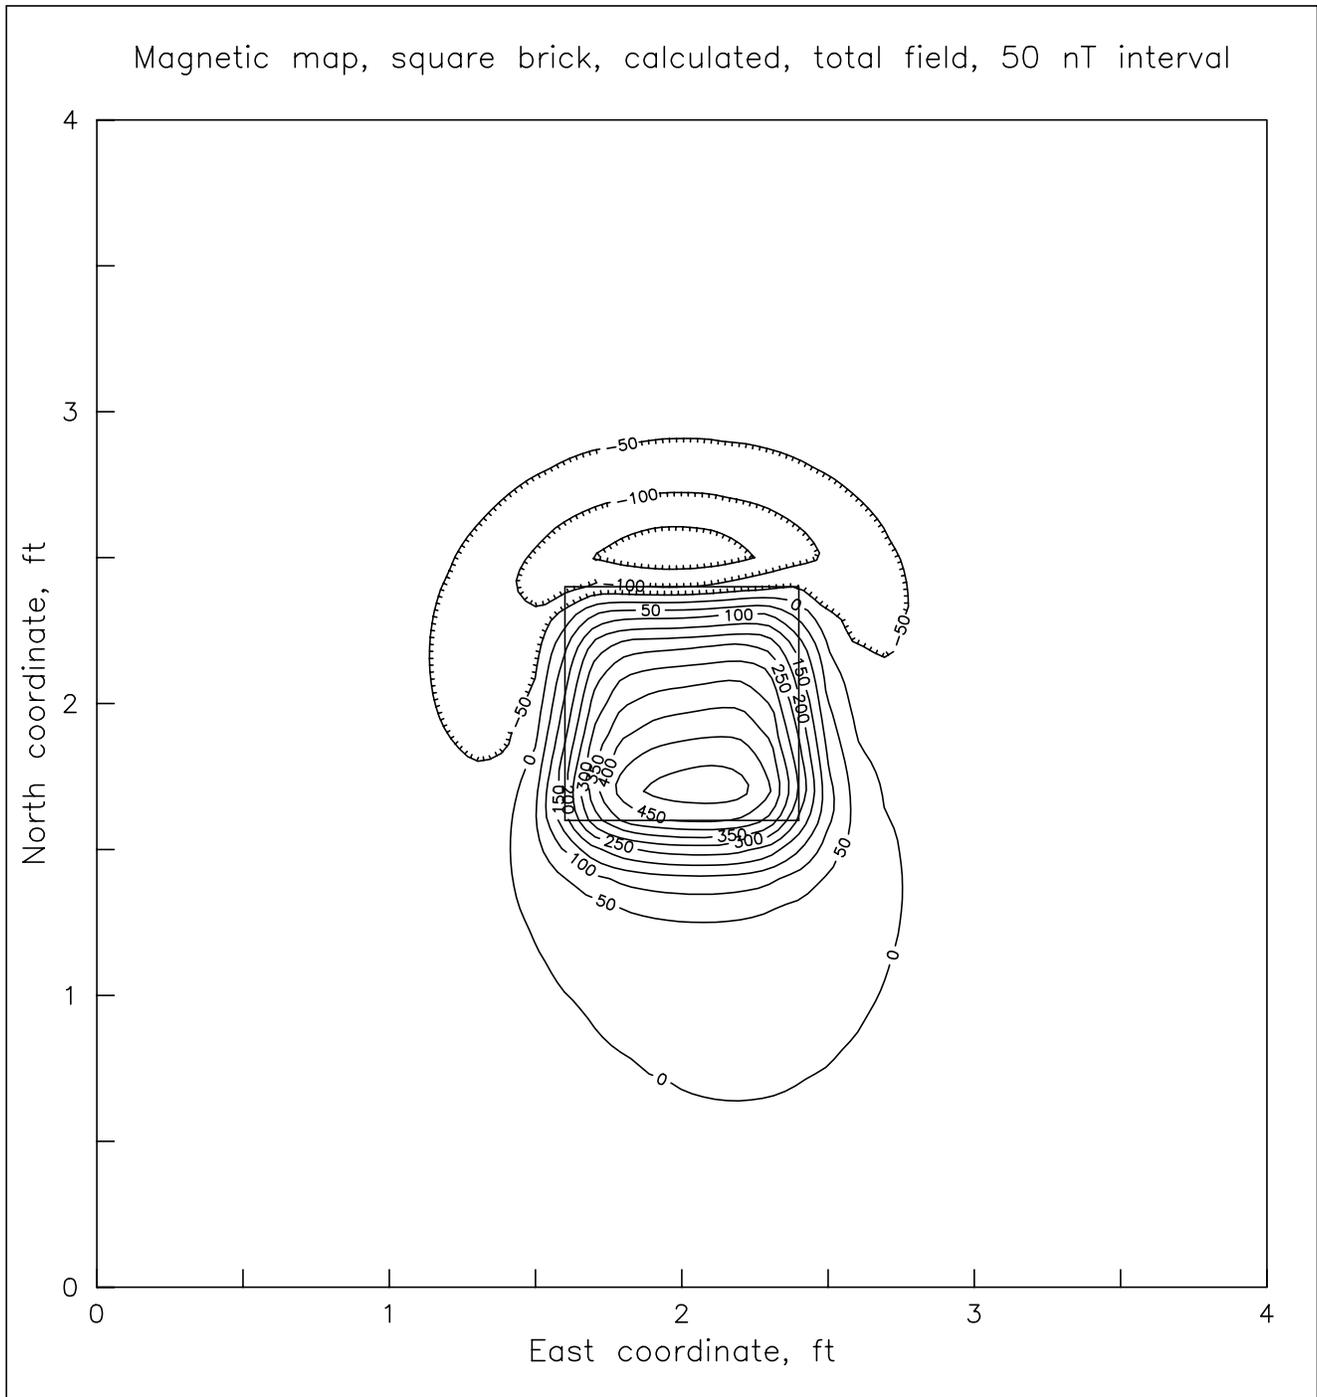
The calculated total field map is plotted in [Figure 12](#). This anomaly is weaker (with a peak of 531 nT) than that of brick fragment 1 in [Figure 5](#). The calculated anomaly has its magnetic low to the north, while the measured anomaly of brick 1 has its low to the south. This just reveals the fact that brick 1 has a strong remanent magnetization, and that it is not oriented as it was when it was fired in a kiln. Brick 1 could not have been remagnetized by the heat in the fireplace.

Figure 12: The calculated magnetic map of an approximated brick. The brick is outlined with a square, and is 0.8 ft on a side. This brick has been assumed to have been fired in place, and this causes the magnetic low to be north of the brick. In the measurements of [Figure 9](#), brick 1 has its low to the south; this means that it was not fired in place and was not remagnetized in the fireplace.
