The Magnetic Map of a Fireplace Base

3 November 2003

prepared for: Eric Deetz
Jamestown Rediscovery
1367 Colonial Parkway
Jamestown, VA 23081

by: Bruce Bevan
Geosight
356 Waddy Drive
Weems, VA 22576

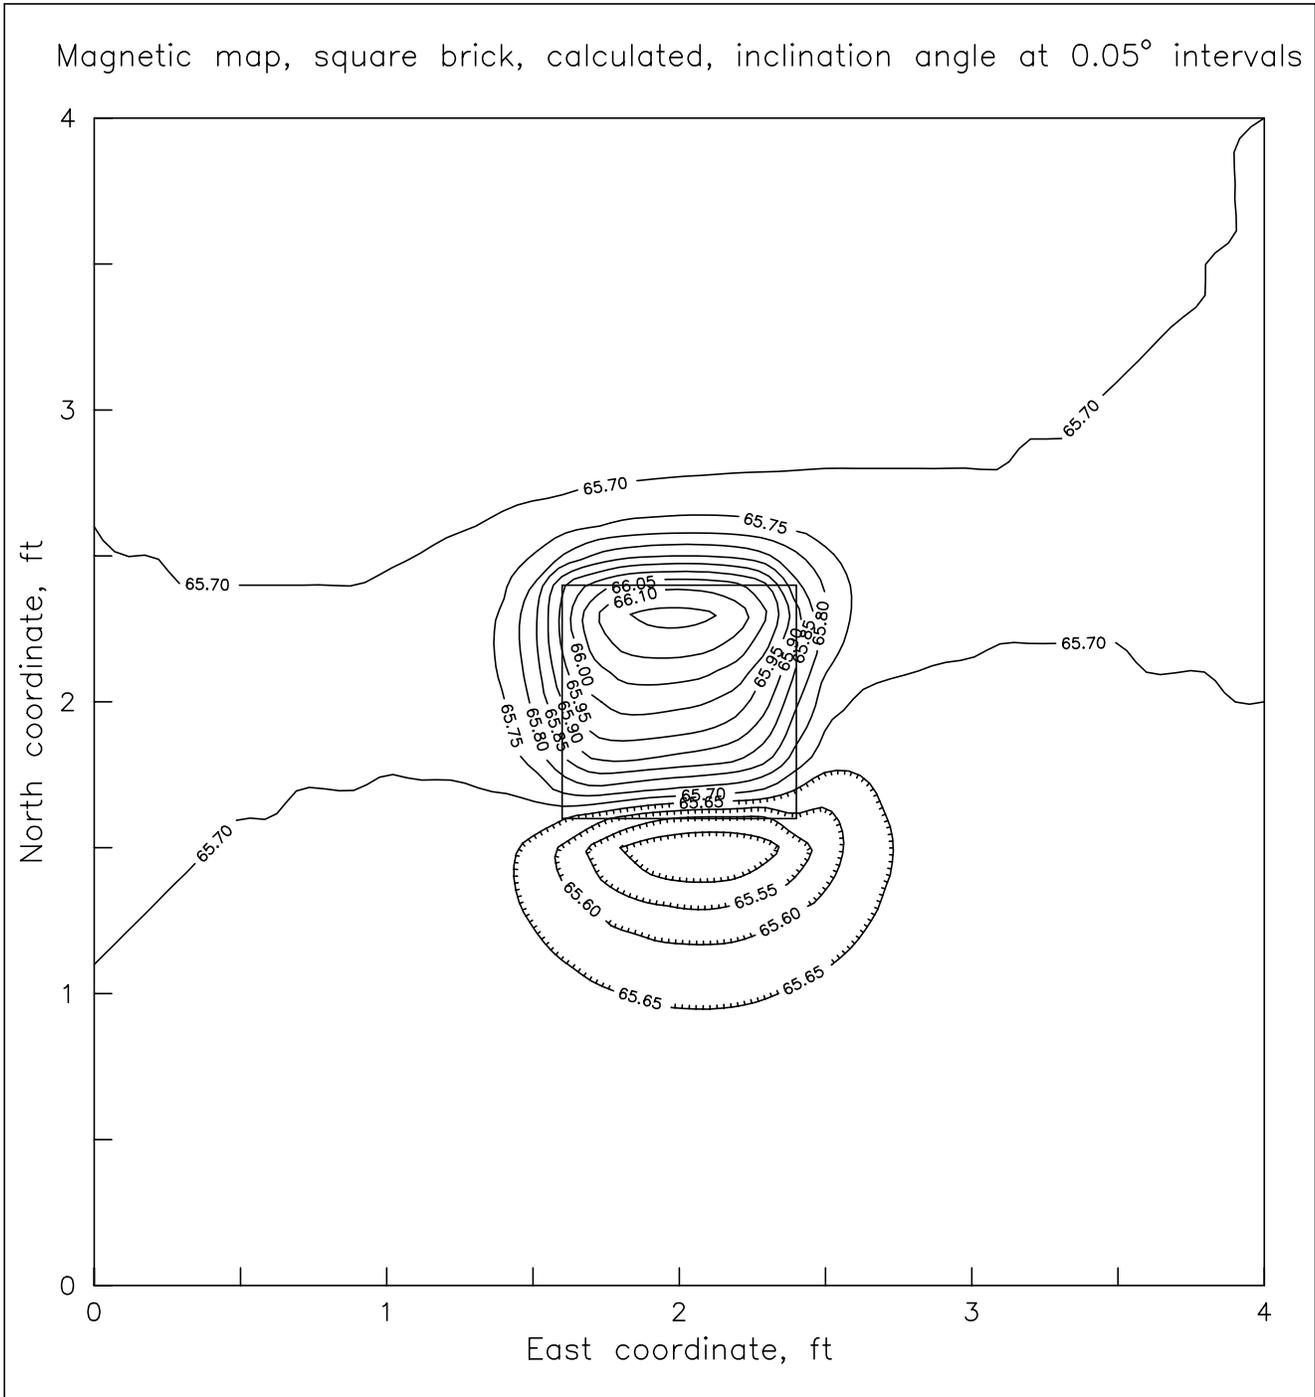
Figure 13: Calculations of the inclination angle of the magnetic field that would be measured over a brick. Again, a square locates the brick. The magnetic field dips to a steeper angle over this brick. This is to be expected if there is no self-demagnetization within the brick.

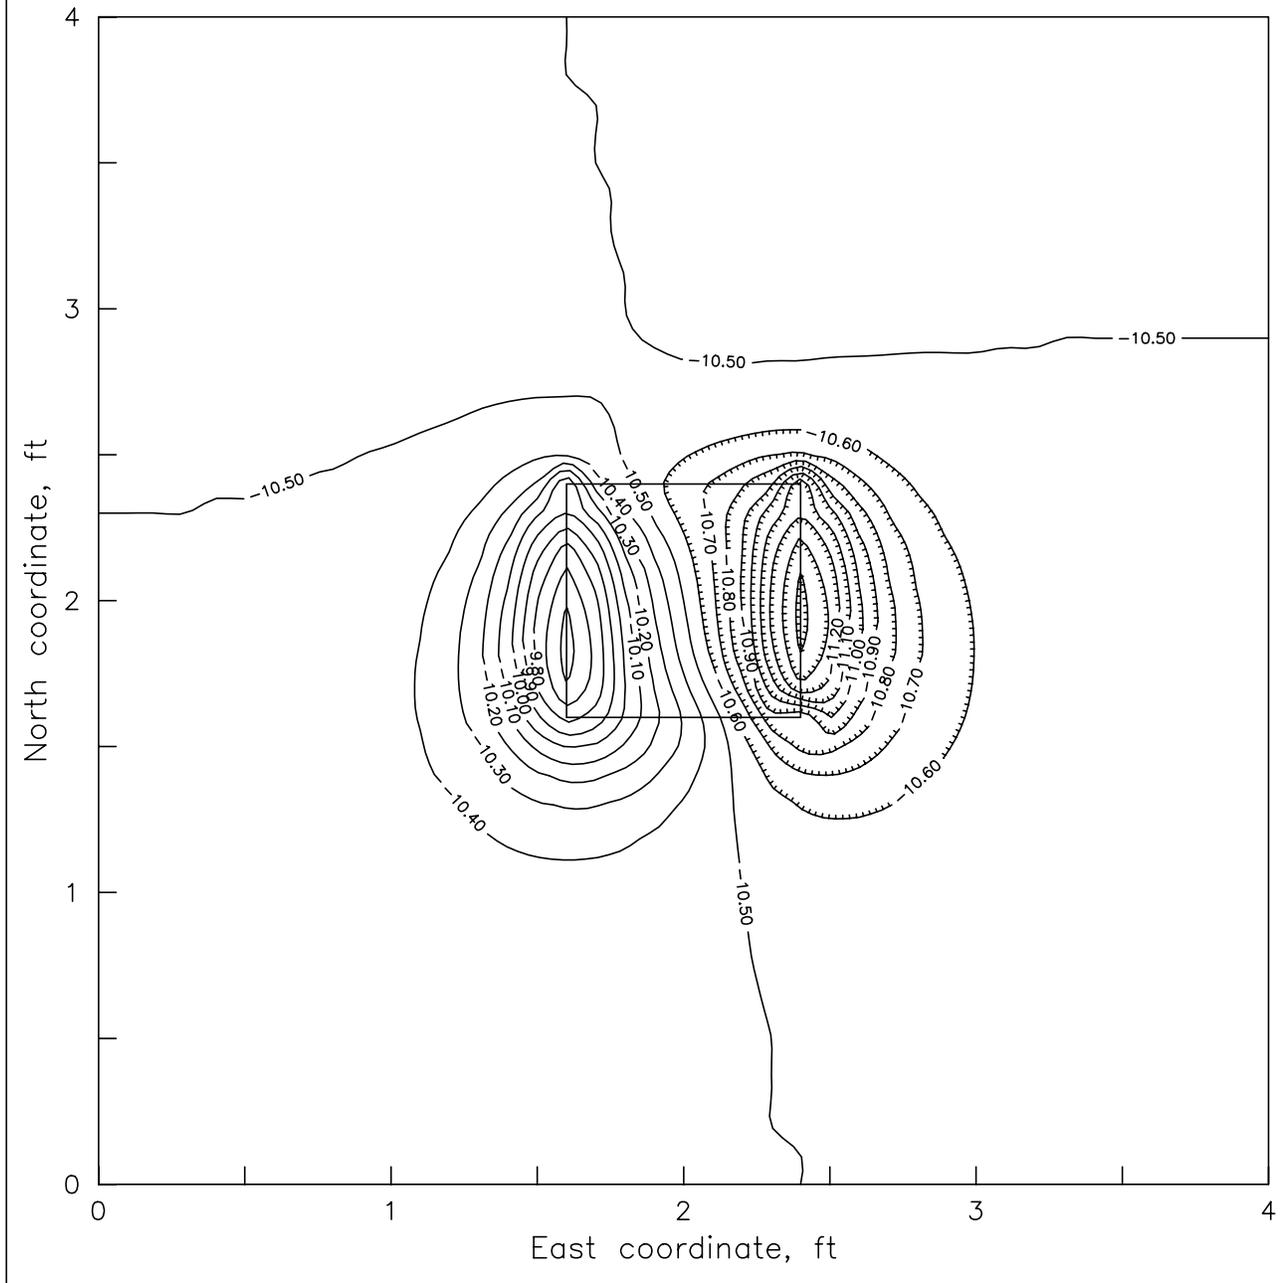
Figure 14: The grid declination angle of the magnetic field over the brick. This pattern means that a magnetic compass that was set on the brick would have its direction of north angled toward the north-south midline of the brick. This angular pattern has indeed been measured over magnetic objects.

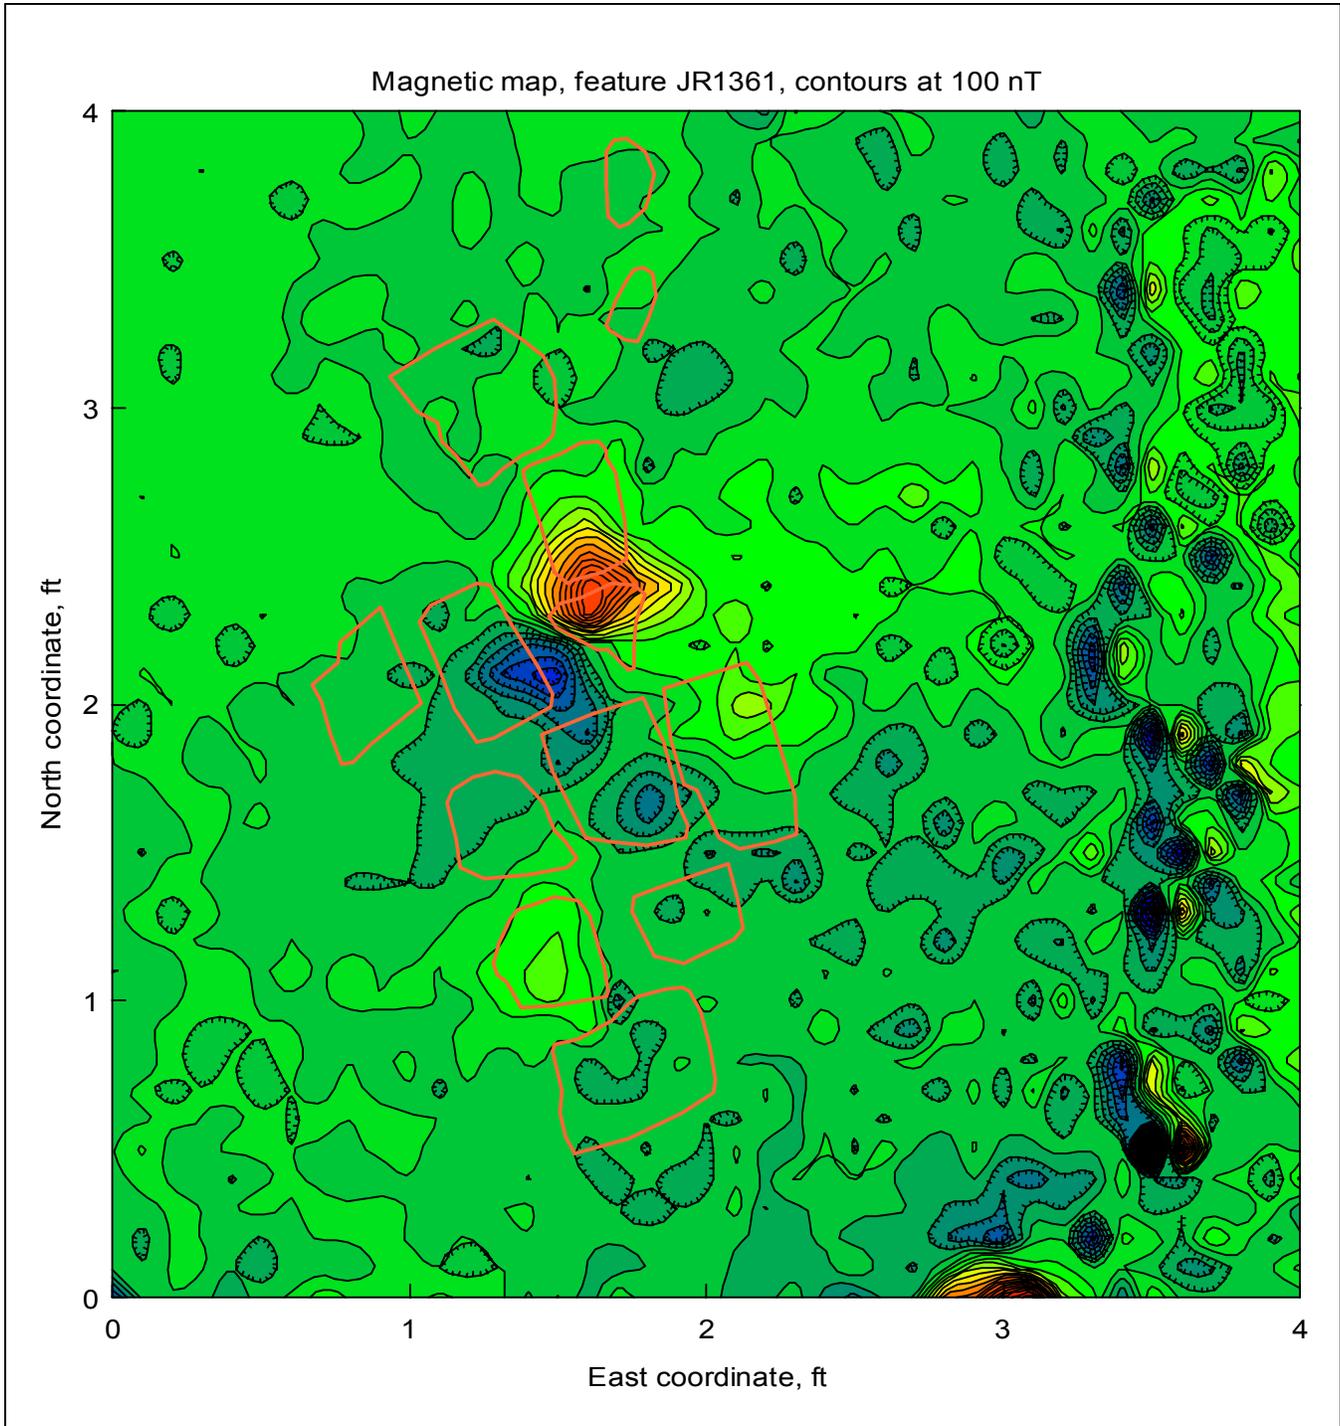
The magnetic map that was measured over the fireplace base is plotted in [Figure 15](#). The most distinctive pattern is to the left of the center of the map; the adjacent pair of areas with high and low readings is caused by a fragment of a brick (perhaps a quarter of a whole brick).

Most of the bricks (outlined in red in [Figure 15](#)) were not detected by the magnetic survey. This is because the soil itself is rather magnetic; it is as magnetic as some of the brick. Weakly magnetic bricks are invisible in the soil here.

In [Figure 15](#), there is a band of small magnetic anomalies on the eastern (right hand) side of the map. These patterns are caused by the moving iron tools of the excavators who were to the east. These irregularities do not affect the important central part of the magnetic map. [Figure 15](#) shows a magnetic anomaly at E3 N0; this is at the excavation face on the south side of the survey area. There is clearly a magnetic object, such as a brick fragment, at that location; however, I did not locate a brick in my map there. An initial test was done in the square with a simple audio-indicating magnetic locator. This suggested that bricks whose color was dark orange were more magnetic than light-orange bricks. This difference in color and magnetism may be due to different clays or simply to a different location in the firing kiln. The colors of the bricks in [Figure 1](#) were not recorded.

Figure 15: The magnetic map. Cool colors (such as blue) show low values while warm colors (red) are high. The adjacent pair of high and low values near E1.5 N2.2 are caused by a brick fragment that is very magnetic. This triangular fragment is indicated in [Figure 1](#) to the left of the circled 1. The bricks are outlined with red lines; while a few of these were moderately magnetic, most were not detected.
