# 2007–2010 Interim Report

on the Preservation Virginia Excavations at Jamestown, Virginia

March 2012

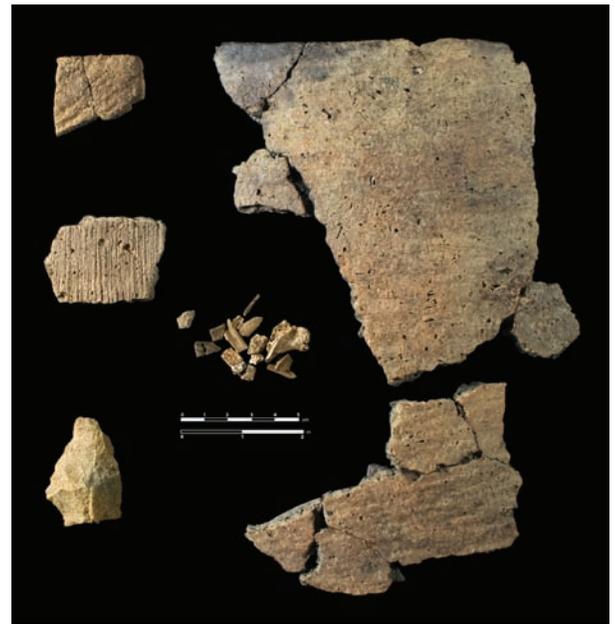
Figure 2. Notable artifacts recovered in JR2382: Varina ware type (upper left), Mockley (left, center), Townsend (right), quartzite preform (lower left), and calcined bone (center)

The initial 5 cm of the strata (JR2382A) contained a sizable number (n=26) of prehistoric sherds of various typologies and temporal periods. Two mendable sherds were Varina ware, which is a Middle Woodland ceramic composed of a dense paste tempered with coarse sand or gravel and is generally thought to date from B.C. 500–A.D. 200.<sup>4</sup> The mended sherds show cord-marking on the surface and appear to incorporate the

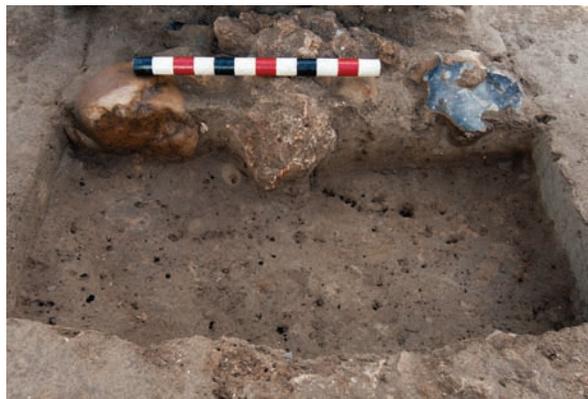
Figure 4. Test JR2590 into the foundation of Structure 176 (facing west)

A 2' by 1' test, JR2590A, into the southern foundation of Structure 176 in the fall of 2008 exposed cobblestones and mortar that likely supported a timber sill for a framed structure. A Caribbean andesite and an English flint cobble were present in the foundation trench, which was found to be 3" deep with a level bottom. Other features associated with Structure 176 were discussed in the 2000–2006 Interim Report.<sup>1</sup>

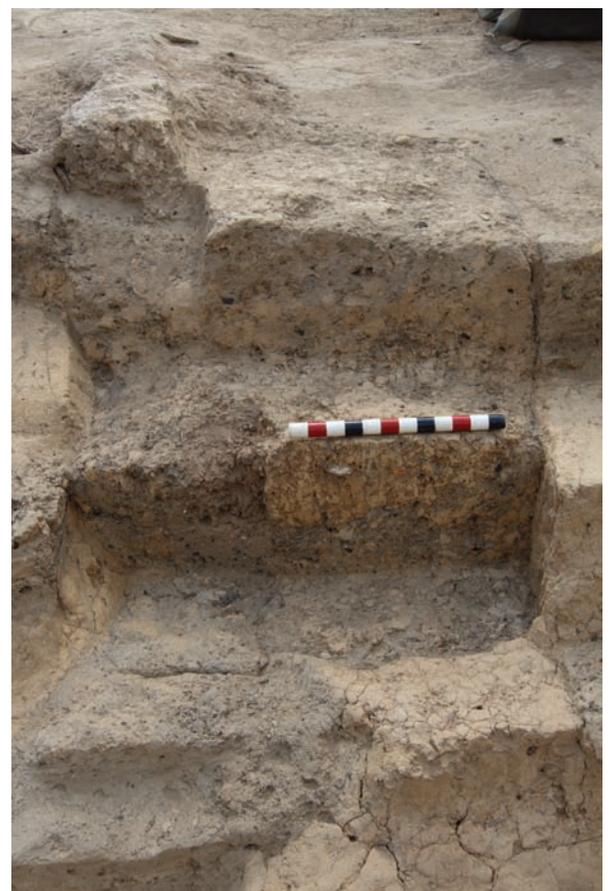
Figure 6. Partially excavated posthole JR2484 and Structure 183 steps

Features from Structure 176 that disturbed Structure 183 included an E/W line of postholes. These features include one post (JR2484), a line of plaster (JR2334) that extended between and through the postholes, and a possible section of foundation, which had settled into the cellar. A line of brickbat and cobble rubble, JR2369, may have been the remnants of Structure 176's foundation. Finally, the earliest feature to impact Structure 183 was Pit 16. It was approximately 6' in diameter and appeared to have been used to mix mortar. The contexts of this feature included JR2359A–F, and the pit is believed to have been a late James Fort-period feature ca. 1617–24, possibly related to the nearby construction of the probable governor's residence, Structure 176. Excavations of Structure 183's cellar, JR2361, began after the more recent features were removed. The first layers to be excavated were layers of backfill deposited after the cellar was no

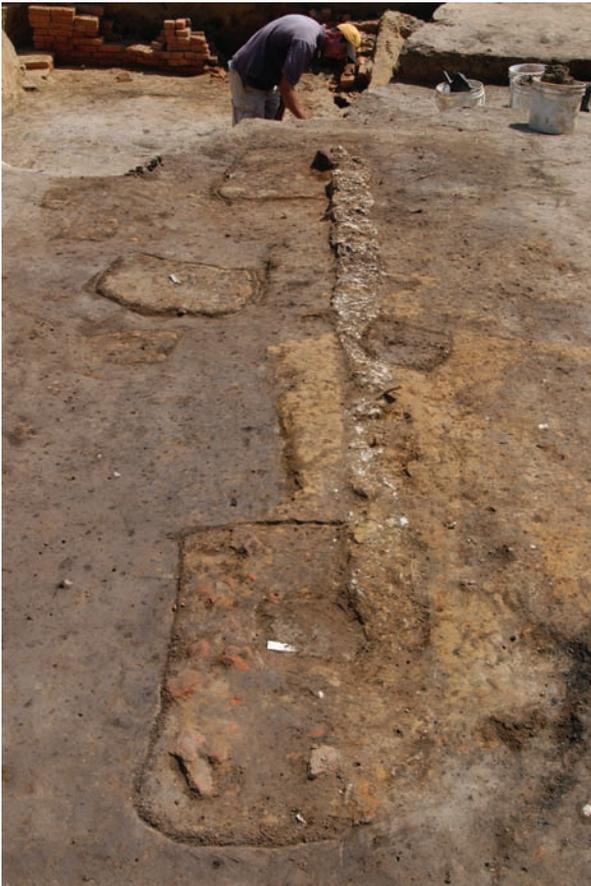
Figure 8. Plaster remnant of decayed wall

A 4' section of the plaster line, JR2334, above Structure 183's fill was removed. The plaster was 1½" thick, and likely was from the destruction of a wall that had been supported by the two posts. The plaster line may have formed as plaster fell from the decaying wall and settled into a trench that secured lath and/

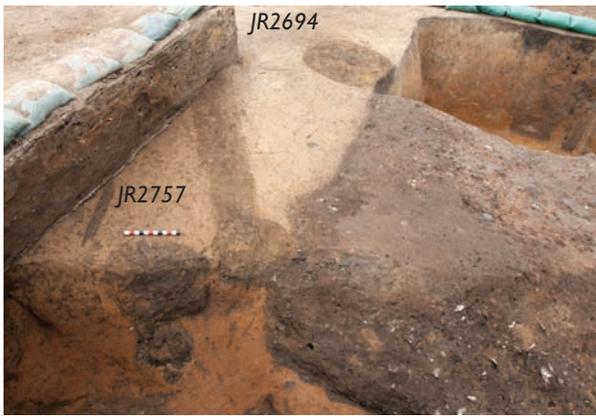
Figure 10. Postholes JR2694 & JR2757, Structure 185 cellar (right)

Found 8' to the east of JR2061, a previously suspected storehouse post for the northern end of Structure 179, was another unmistakable storehouse post, JR2694. Like all of the postholes found on the western wall of the storehouse, JR2694 was large, measuring 3' in diameter with a 10" diameter mold. Although the posthole was not excavated, the fill composition looked identical to all other posts associated with the structure. The fill on the eastern end of JR2694 had been partially disturbed by the cellar of Structure 185, but the mold remained unaffected. Structure 185 was a contemporaneous structure, and it likely was an

addition to Structure 179. The location of this cellar due east of posthole JR2694 meant that there were no more postholes associated with Structure 179 on this E/W line, which verified that JR2694 represented the northeast corner post to Structure 179. It also made it apparent that JR2061 had been a center post on the northern end of Structure 179, spaced 8' from JR2694.

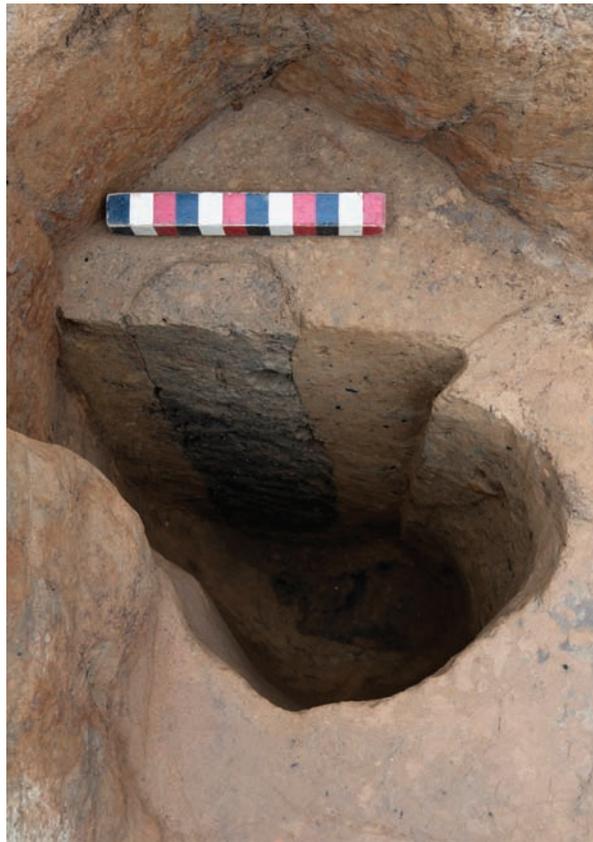
Figure 22. Bisected posthole JR2514 (facing north)

visible. The majority were major structural postholes to support the post-in-ground structure covering the cellar. Structural postholes were found in the corners of, and on an E/W axis through, the center of the cellar, as well as interspersed at midway points along

the cellar's perimeter. The postholes were from 2'6" to over 3' deep, and when the postmolds were clearly defined, they showed that the posts were circular and measured between 6" and 8" in diameter. Several of these structural posts had been disturbed by later repairs, which indicated that the cellar was in use for an extended period of time. The southwestern and northwestern corners had two posts each, one original and one repair. The southeastern corner post, JR2502, also had been replaced, but the limits to the repair post could not be established. The likely original north-

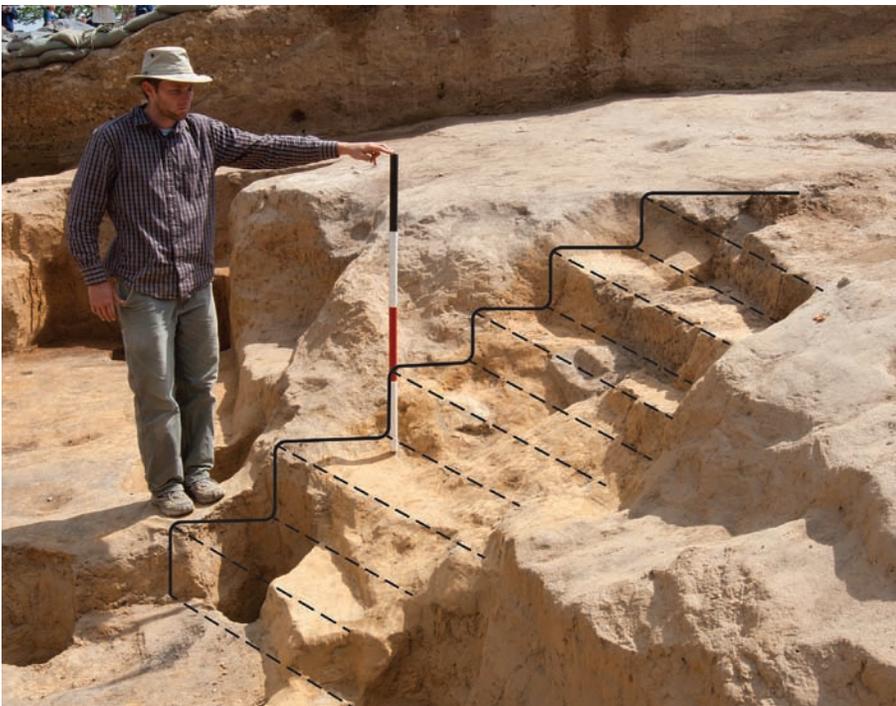
Figure 21. Cellar steps (facing southwest)

Evidence of only one cellar entrance was found: six steps carved into the subsoil along the western end of the cellar. The steps led only into the room north of the partition. While it was difficult to get any definitive measurements of the eroded steps, the best preserved examples indicated that the entryway was about 4' wide.

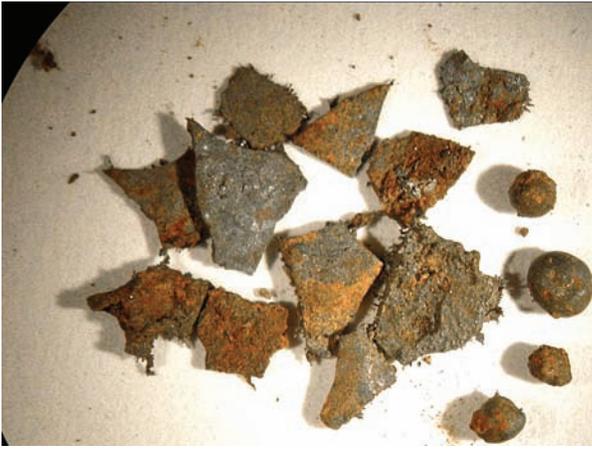
Figure 24. Hammerscale and spherical iron droplets, byproducts of blacksmithing

The north chamber's original floor, JR2361AE, was a compact sandy layer with some clay and measured from 2" to 3" thick with a bottom elevation of 8'2". The layer contained numerous hammerscale and spherical iron droplets, byproducts of blacksmithing.<sup>15</sup> This waste is typically made from the sparks created by repeated strikes while working hot metal with a hammer. The presence of nail rod also indicated blacksmithing along with a more curious find: residue from working iron found on the interior of a Native American pot. The iron tuyere (the bellow's nozzle, which concentrates and directs air from the bellows) found in JR2361D also indicated smithing operations that involved working iron rather than producing it, and, although found in the upper layers of debris, may have been used in the cellar's smithing operations before it was abandoned and backfilled. Ceramic or copper tuyeres are used for iron production that employs temperatures high enough to melt iron.<sup>16</sup>

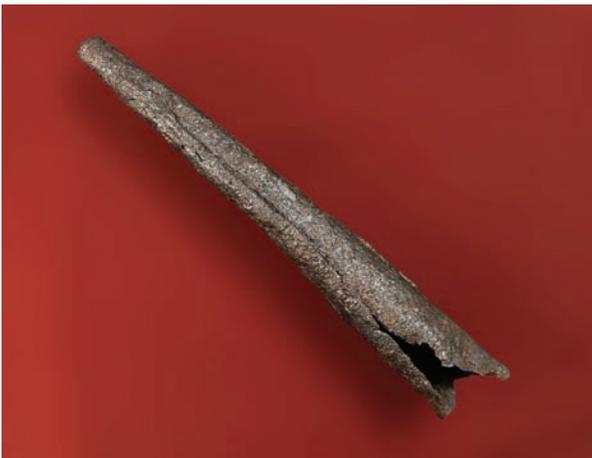
Figure 25. Iron tuyere (length 20 mm, diameter 25.5–58 mm)

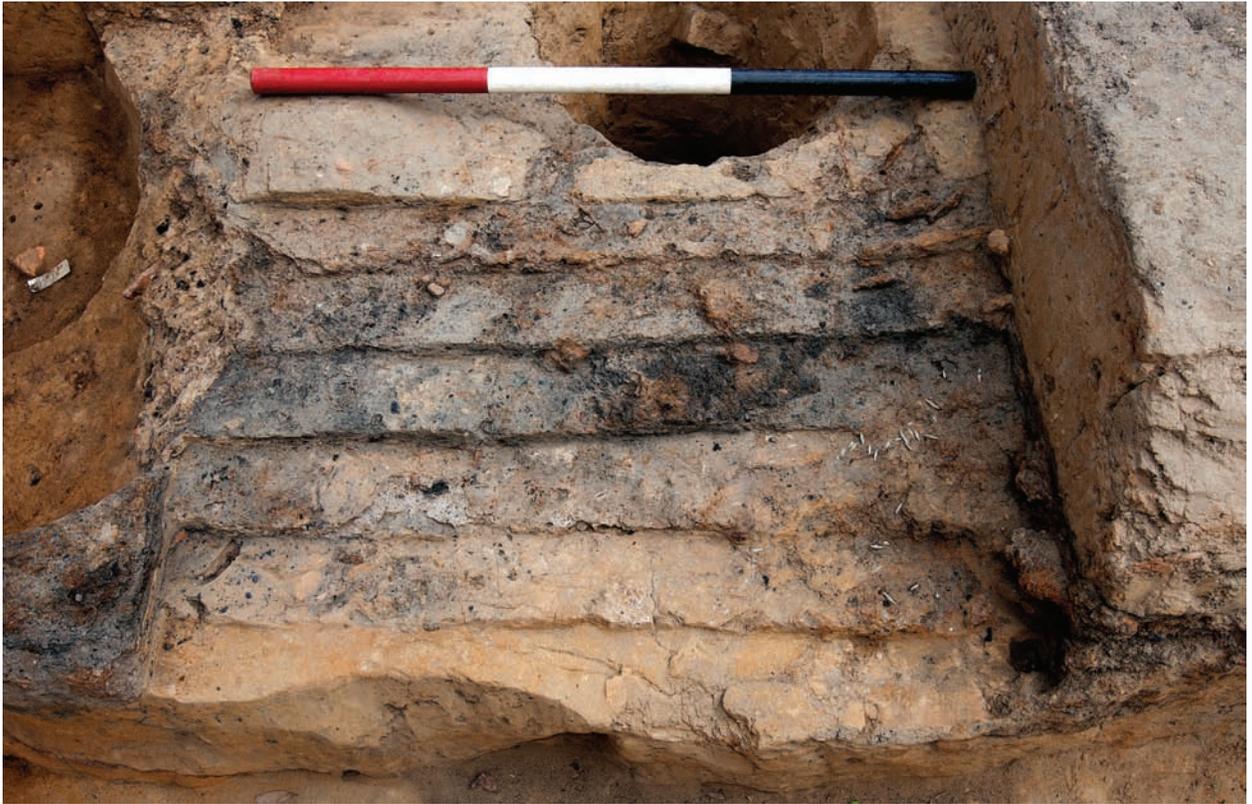
Figure 26. Metalworking floor tests (facing south)

A 3'3" by 2'8" section of debris in the northern room was excavated in 4" by 3'3" test strips to attempt to define any separate layers of metallurgical activity. When a possible layer change was identified, a new test strip was begun with a new layer designation. The resulting excavation resembled a small set of steps. Six subtle layer changes were identified: JR2361AE, AR, AS, AT, AW, and AX. All of these layers contained the smithing waste, but in varying degrees of density. While the test did show some changes in the consistency of the smithing waste, it did not yield any clear divisions. It was concluded from the test and subsequent soil profile that the smithing debris was one overall layer. The debris was likely built up over an extended period of time, but because it was the same type of waste, the true divisions could not be deduced. All remaining metallurgical waste in the northern room was recovered as JR2361AE. The unscreened fill from

In addition to blacksmithing during the first phase of cellar use, it also appeared that the colonists were assaying ores and manufacturing lead shot there. The iron-rich cellar floor, JR2361AE, also contained numerous Hessian crucible fragments that may have been used during metallurgical trials. Many of these fragments mended, suggesting that the crucibles broke while being used in the cellar. Several heavy concentrations of lead droplets also were found on the floor in this layer. These droplets could have been produced during the process of making small lead shot by pouring molten lead through a sieve.

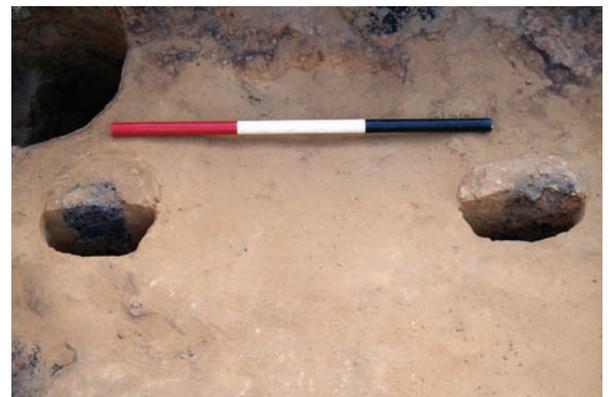
Figure 27. Bisected postholes JR2513 & JR2526 (facing east)

either the flue or furnace base. These holes (JR2513, JR2526) on the eastern side of the northern room were used during the first phase of cellar occupation. The postholes were nearly identical in size and appearance, suggesting they were contemporaneous. JR2513 was 11" wide and 1' deep, with a postmold 5" in diameter, and JR2526 was 1' wide and 1'2" deep, with a postmold 5" in diameter.<sup>20</sup> The holes were separated by 3'5" and were about 3' from the eastern cellar wall. The fill in the postmolds contained hammerscale and iron droplets, similar to the blacksmithing layer JR2361AE. The iron in the postmolds suggested that JR2361AE was the only occupation layer in the cellar when the posts from JR2513 and JR2526 were removed, which allowed for the smithing debris to fill the voids left

by the posts. This scenario suggests that JR2513 and JR2526 were in use during the blacksmithing and metallurgical phase of the cellar.

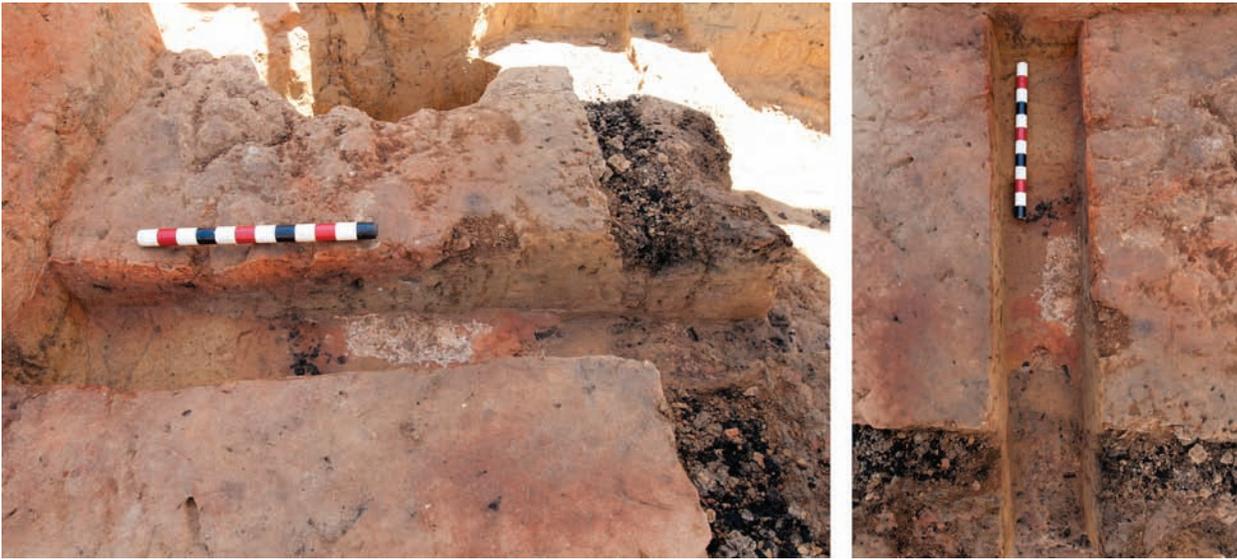
Figure 28. Burned floor visible at the bottom of Test JR2591

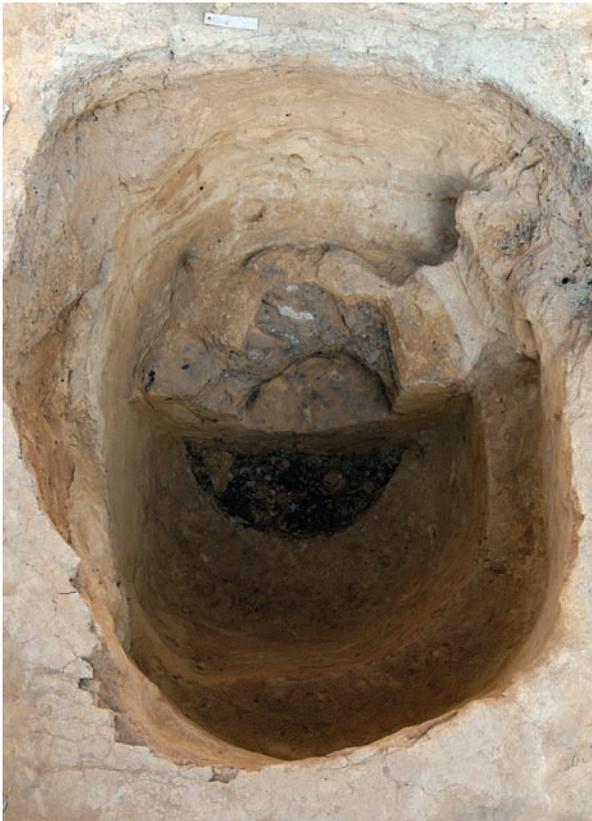
Figure 29. Barrel stain in feature JR2509 (facing north)

There were also two larger holes, JR2509 and JR2525, along the wall in the northern end of the cellar that were sump pits for drainage. A barrel-lined sump pit, JR2509, was found near the northwestern corner of the cellar. It was 2'5" deep and contained the remains of a barrel at the bottom. A dark circular stain from the rotted wood survived forming a perfect circle with a diameter of 1'6". Fourteen small iron nails were found in association with the circular stain. Another barrel-lined sump pit, JR2525, was found close to the northeastern corner of the cellar. However, the stain in the bottom of this hole did not form a perfect circle, but rather an amorphous shape. The hole was 2' deep, and the shape at the bottom was roughly 1'2" across when measured from N/S. No nails were present in association with this sump pit. There was no way of knowing during which phase of cellar use these barrel sump pits were constructed because they had no stratigraphic relationships with other cellar features.

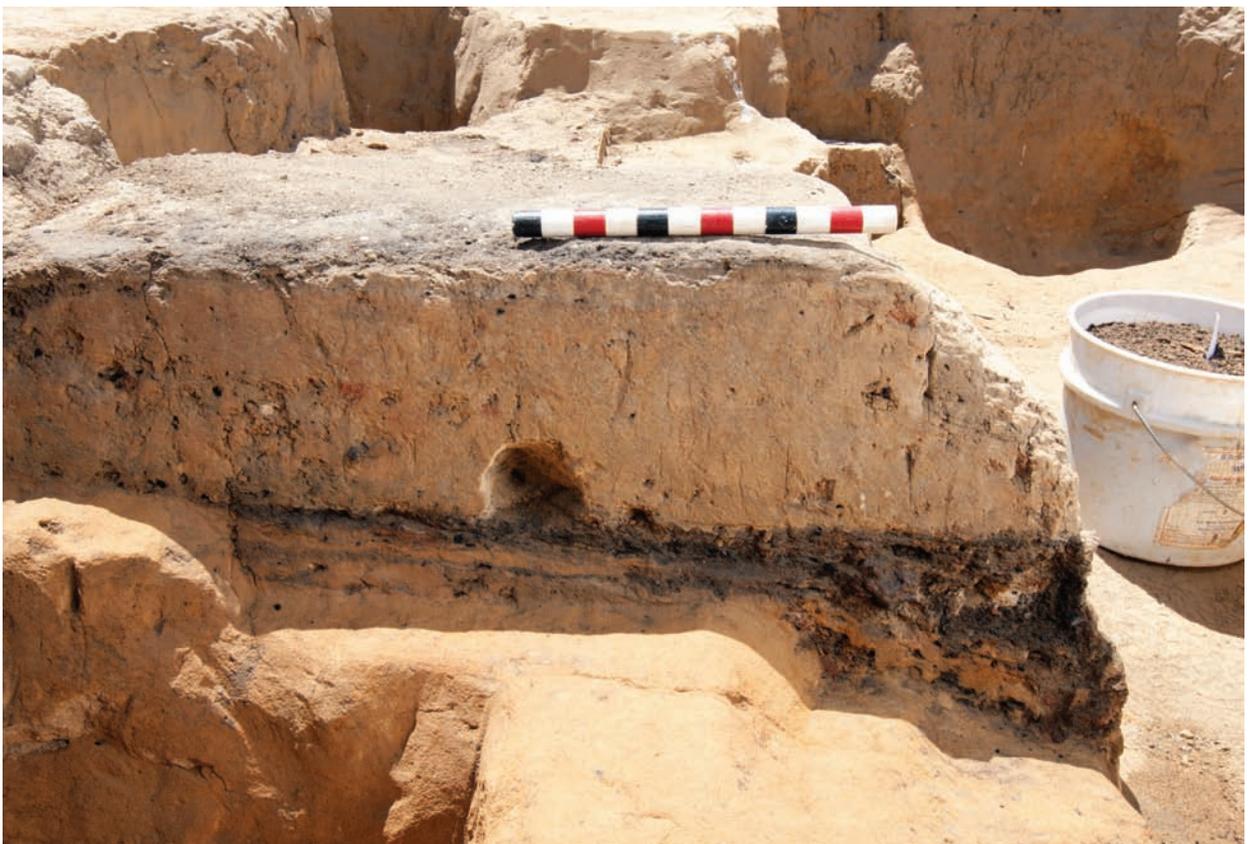
Figure 30. Raised clay floor, JR2361T, above darker metalworking layers (facing south)

Once the industrial phase of the cellar had concluded, it underwent several major changes. The floor was raised in both chambers with mixed clay, which sealed the preexisting working surface. The orange clay layer, JR2361T, measured 6" to 8" thick and, from the lack of inclusions, appeared to be redeposited subsoil. The clay probably stretched across the entire northern room at one point but, as mentioned above, 1' of the floor in this room had been dug away during the final phase of cellar usage. In the southern chamber the raised clay floor, JR2361BG, formed a contiguous layer with JR2361T, indicating that the floors in both rooms were raised simultaneously with the orange clay. The elevations of the raised floors in the two rooms were nearly the same: JR2361T was 9' and JR2361BG was 9'1". A copper-alloy pendant depicting a man's head in profile was found in the prepared clay floor layer JR2361BG. The pendant is believed to have been produced by the English in the likeness of the paramount chief Powhatan to serve as a badge of safe passage into James Fort for his Indian emissaries.<sup>21</sup>

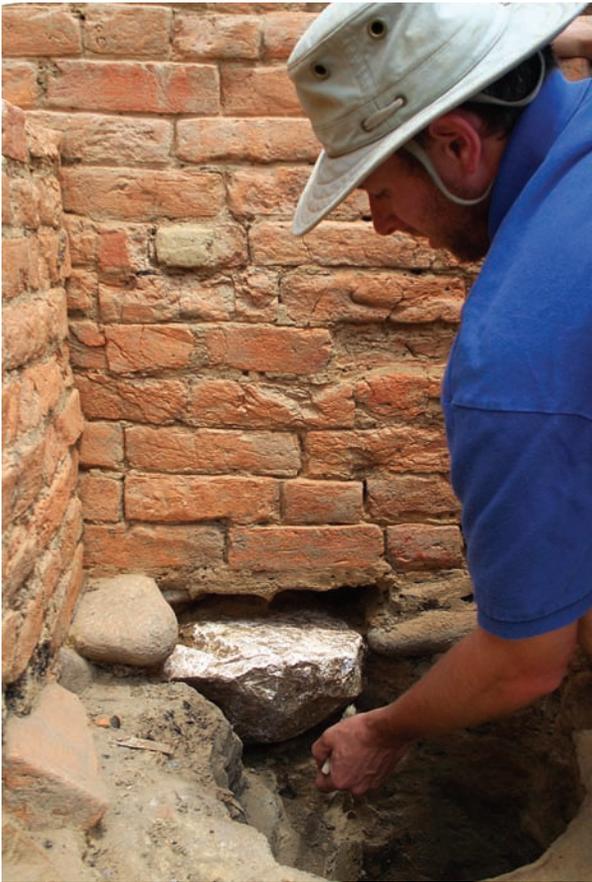
Figure 35. Limestone cobble under the northern end of the brick

this sequence of events was revealed by the survival of a small section of the original floor level that was left intact in the northeast corner of the footing when the floor was lowered. Situated in the corner of the brickwork where the southern cheek joined with the back of the façade, the intact floor level consisted of subsoil and builder's trench fill (JR2361BD). From this sequence of deposits it could be concluded that when the brick footing was built the cobblestones were set in a trench and were not visible because they were sealed by the builder's trench fill and the masonry above.

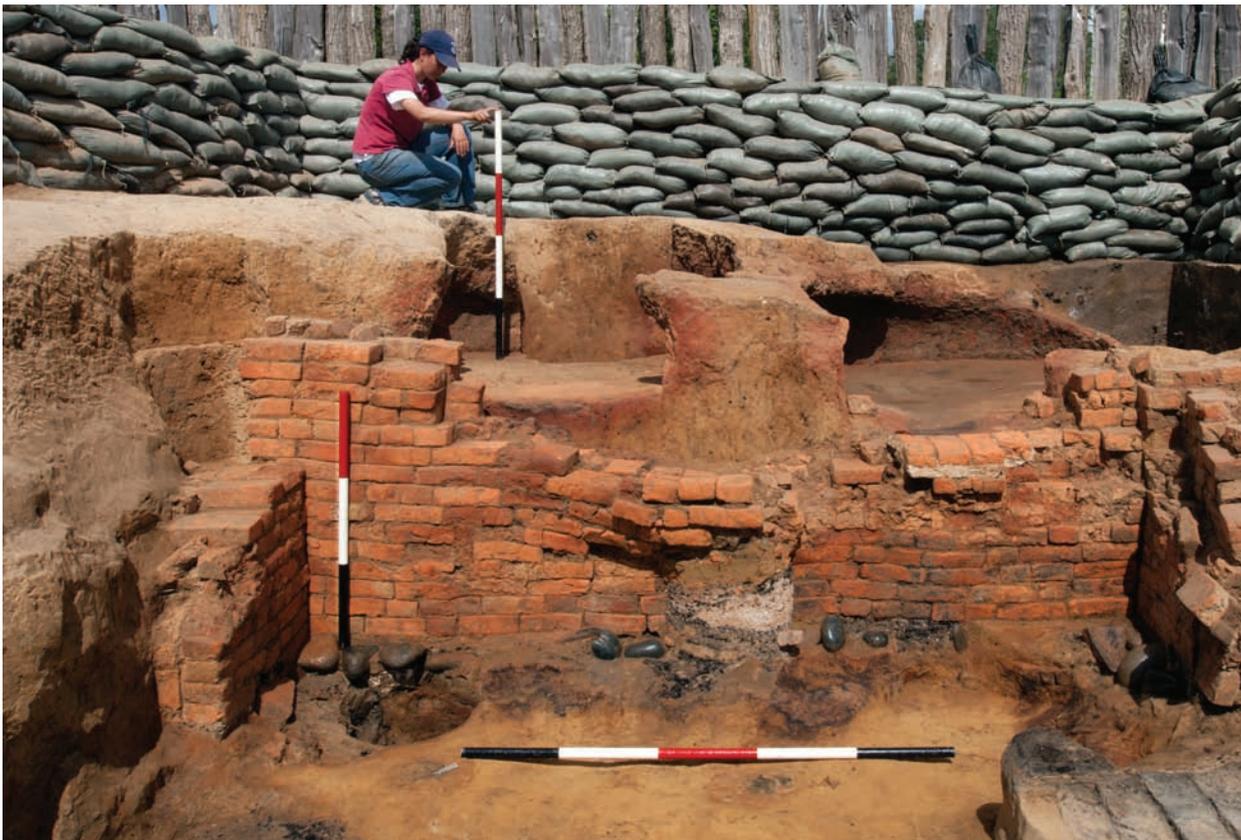
Figure 36. Overview of brick façade (facing east)

The brickwork for the flue footing, JR2361BA, rested directly on the cobblestones and likely served as the base for a chimney that transitioned from brick

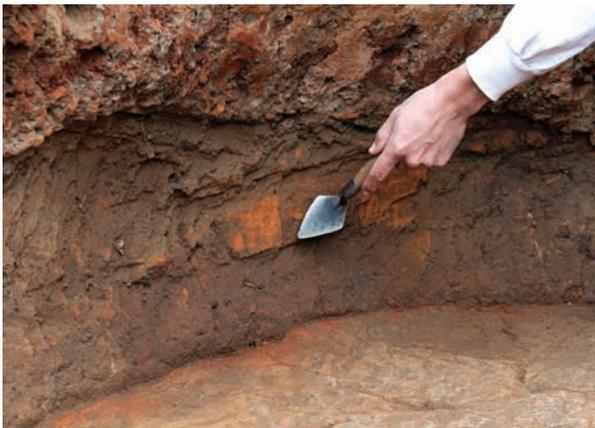
Figure 39. Pick or adze marks from the construction of oven JR2518

The surviving walls of the oven and the oven floor also exhibited these marks that were consistently about 4" wide, possibly the width of the pick or adze used to form them.

In plan, the floor of the oven was more or less ovoid, measuring 5'3" from N/S and 5'6" from E/W. The E/W measurement had to be projected because the true eastern end of the oven had been lost to disturbance JR2517. The entrance to the oven remained largely intact and measured about 3' wide. With most of the roof collapsed, it was impossible to determine exactly how tall the ceiling was; however, it was almost certainly over 1' tall, the clearance necessary for the builder to mine out the cavity.

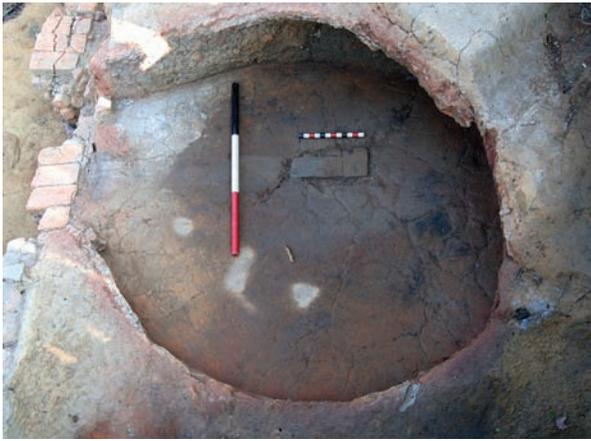
Figure 40. Brick patch on oven floor (JR2519)

across the oven floor, possibly a tool such as a small shovel used to remove the hot coals. No such groove was found on the floor of the northern oven. Yet other indications that the southern oven was used for an extended period was a hole in the oven floor that had been patched with a brick and brickbats, as well as a mortared brick pad at the oven's opening, JR2361Z. This feature had been incorporated into the brick footing and was held together with the only shell-tempered mortar used in the brickwork. The pad, made of six mortared bricks, likely was built as a replacement for the original bricks that had fallen into disrepair from the repeated use of the oven. A sample of the shell-tempered mortar was curated.

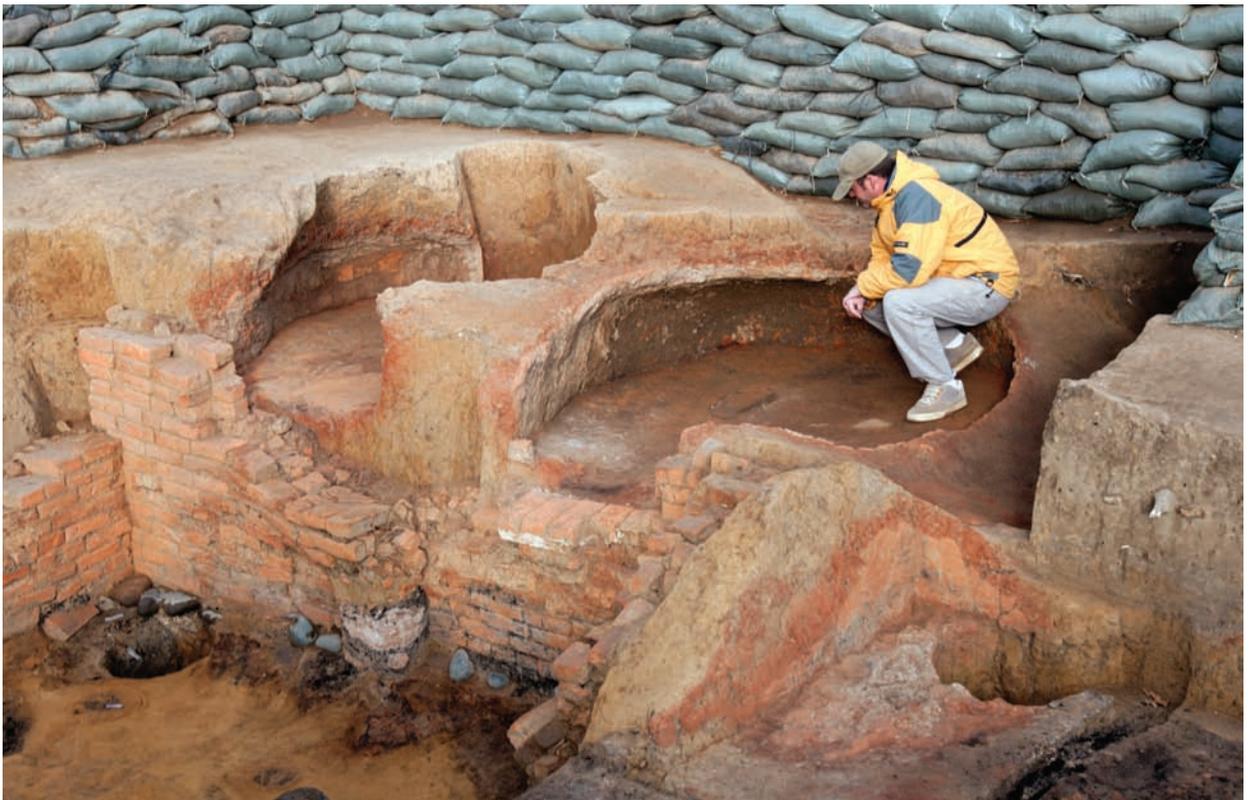
Figure 41. Relationship of the brick façade and bread ovens (facing east)

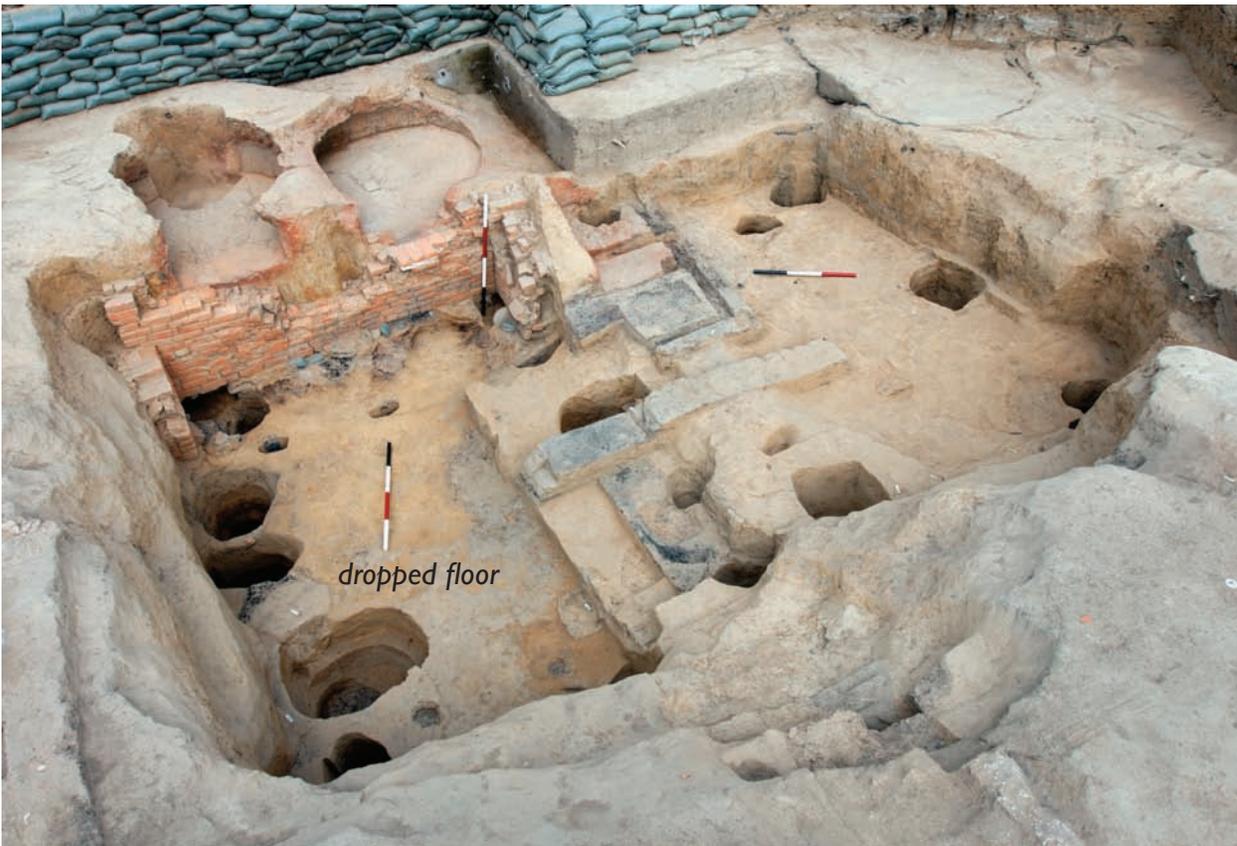
Figure 42. Lowered floor in northern room (facing southeast)

The lowering of the majority of the floor in the northern room during the third and final phase of cellar usage likely was done to allow the bakers to stand and work the ovens in a more comfortable position. This theory is supported by the presence of an even deeper depression, JR2585, of about 4" in front of the southern oven, JR2519. What had been a height of about 1'9" from the original floor level to the entrance of oven JR2519 became 2'9" after the floor was dropped, a much more manageable space in which to work. The other likely reason for the lowering of the floor was to create more space for ash disposal.

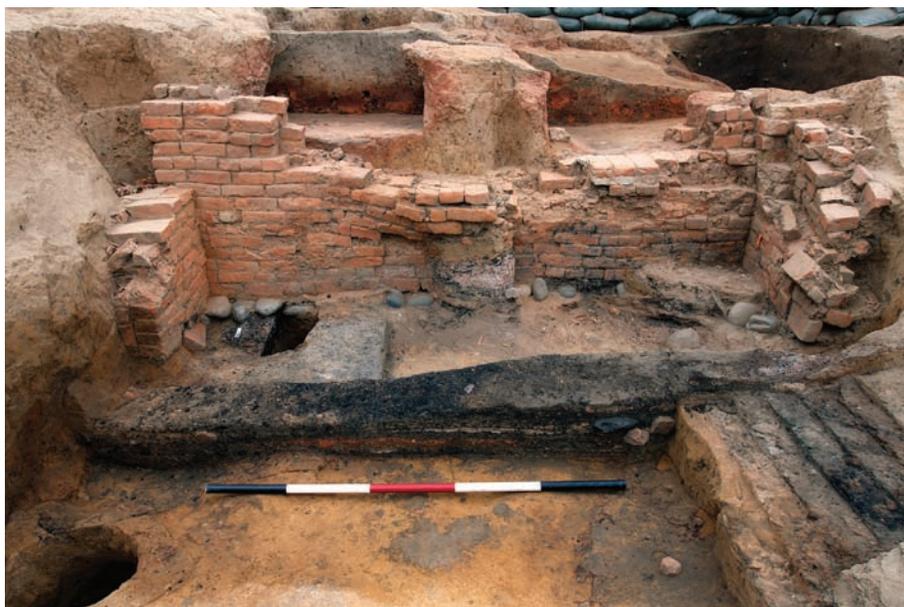
Figure 43. Profile of ash layers from bread ovens (facing east)

Yet another layer of heavy ash was found below gravel layer JR2361AG. While it seemed to be one continuous layer, the ash was separated into two contexts. These were JR2361AJ, the ash within the bounds of the chimney base, and JR2361V, a thin lens across the rest of the floor in the northern room. These ash deposits likely resulted from cleaning the bread ovens, but they had been sealed by the gravel paving episode on the floor and therefore represented ash from earlier episodes of bread-oven firings. A thin compact layer

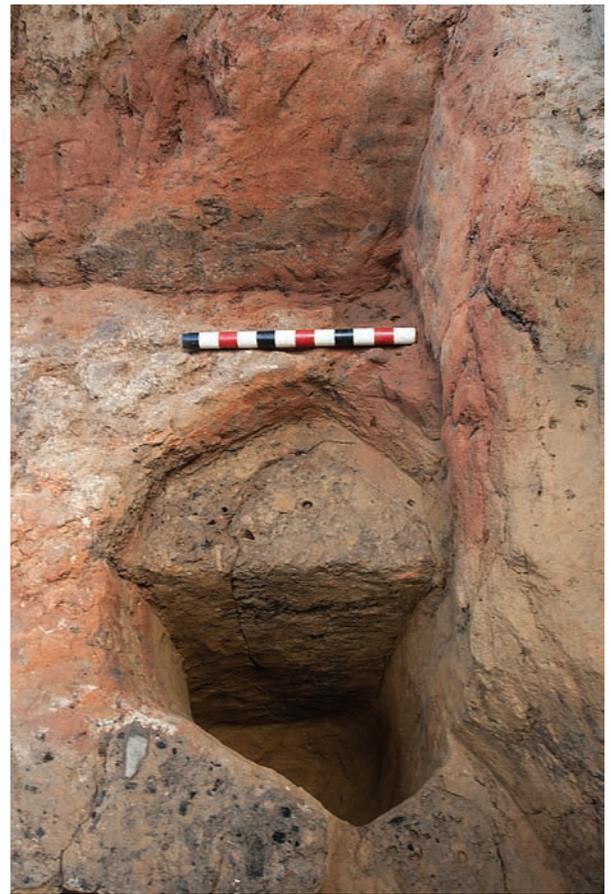
Figure 44. Posthole JR2503 disturbing burned clay floor in north-east corner of southern room (facing north)

bread ovens outlasted the timber sill feature. The ash layer mentioned above, JR2361W, is one line of evidence for this scenario, but a large posthole from the third phase of the cellar (JR2503, located in the northeastern corner of the southern room) cut through the burned clay associated with the timber sill feature. This posthole was structural in nature with a sizable postmold of 9" in diameter and a depth of 2'3". Its location proved that the timber sill feature was no longer in use when the posthole was dug. This post also provided structural support for the superstructure of the building above, in an area where no other post-holes were located.

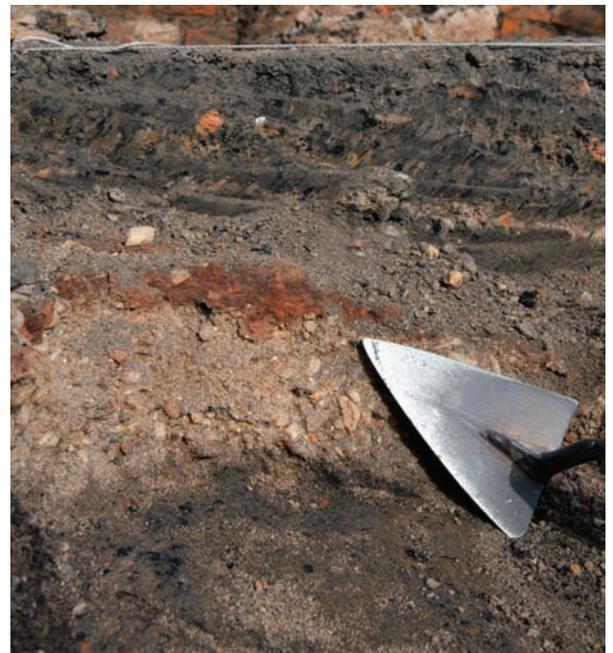
Figure 45. Floor paving layers in north chamber (JR2361AG & JR2361AF)

A floor surface of pea-gravel, JR2361AG, and a lens of burned clay, JR2361AF, were found below the ash layers stretching across the dropped floor of the northern room. The gravel consisted predominantly of small river-worn quartz pebbles. This layer was thicker closer to the brick footing, and it varied from about ½" to 1" in depth. The gravel may have been strategically placed in this lowest floor level of the cellar as a dry paving to combat wet conditions. Above the gravel in the eastern end of the northern room a 1"-thick burned-clay area (JR2361AF) was found. This layer may have been made up of small sections of burned clay from the interiors of the ovens. Pieces of the clay ovens may have broken off periodically and were discarded on the cellar floor.

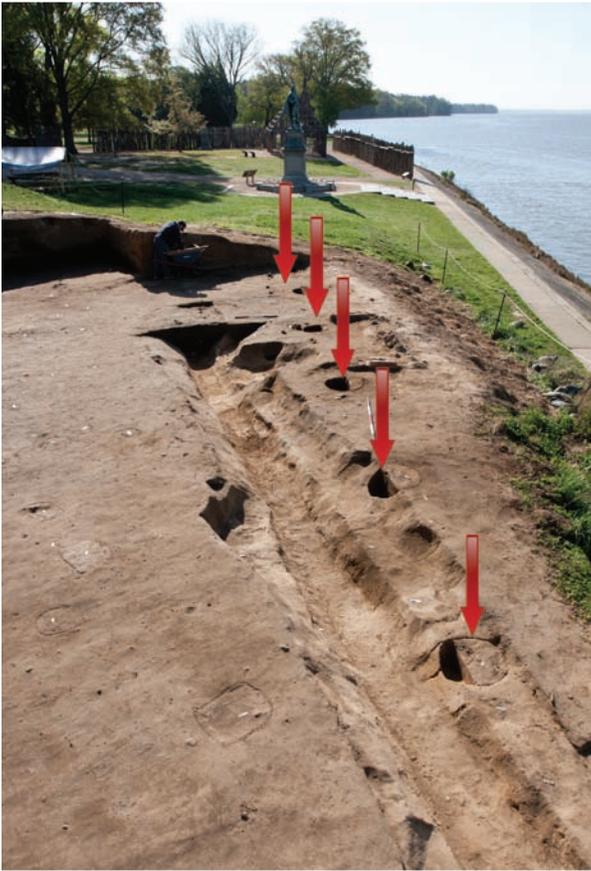
Figure 48. Overall view of Structure 184 (facing east)

The postholes were all circular with diameters from 1'8" to 2'. The visible postmolds were also circular, measuring 7" to 8" in diameter. JR2478 was the only posthole without a clearly defined postmold. The bottom elevations of the seven postholes were nearly the same, ranging from 12'1½" to 12'5¼" above sea level. The 10' spacing between the postholes was unlike the random spacing of the fort's mud-and-stud buildings and suggests that Structure 184 was timber framed. Joinery required even spacing, unlike the mud-and-stud buildings built in other sections of the fort.

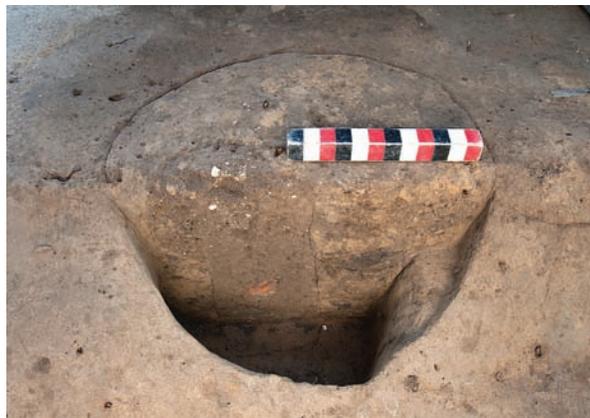
Figure 49. Bisected posthole JR2439 (facing north)

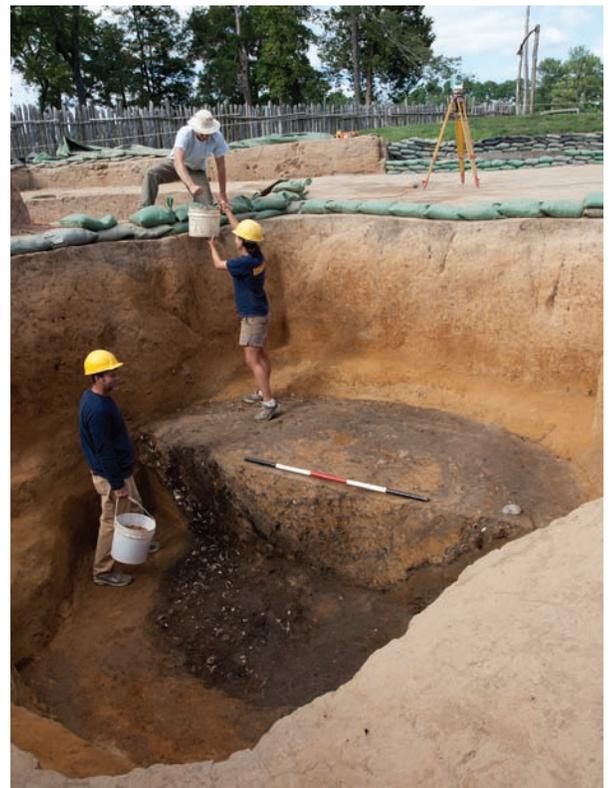
Figure 51. Archaeologists removing buckets of dirt from the upper rectangular chamber of the cellar (facing northwest)

upper cellar chamber, reached an average depth of 5' below modern grade. However, it can be assumed that the upper chamber was at least 6' deep because the top 1' of soil had been disturbed by plowing. At this depth small shelves at all four corners had been carved into the clay subsoil, which suggested a base to this portion of the cellar. Also found at this level were two step-ins or shelves carved into the subsoil on the northern and southern ends of the feature. The base dimensions of the rectangular shape were as follows: the east wall 14'2", the west wall 13'10", the north wall 10'2", and the south wall 11'6". While not a perfect rectangle, the cellar's upper chamber dimensions were prepared in a manner that indicated it was dug to hold structural elements.

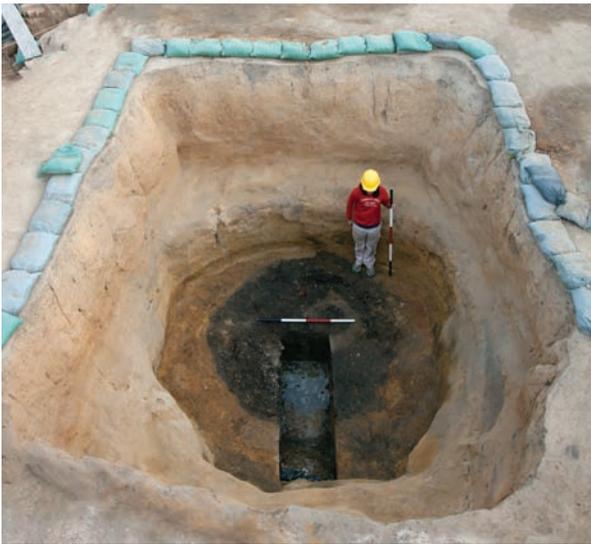
Figure 52. Excavated upper chamber, lower circular chamber undergoing excavation (facing north)

The feature extended to a depth of 14' below the undisturbed subsoil level and dramatically changed in shape as it became deeper. What started as a large rectangle became a large circular shape, which dropped to a single wooden cask or barrel for the well lining. The rectangular-shaped portion of the feature, the

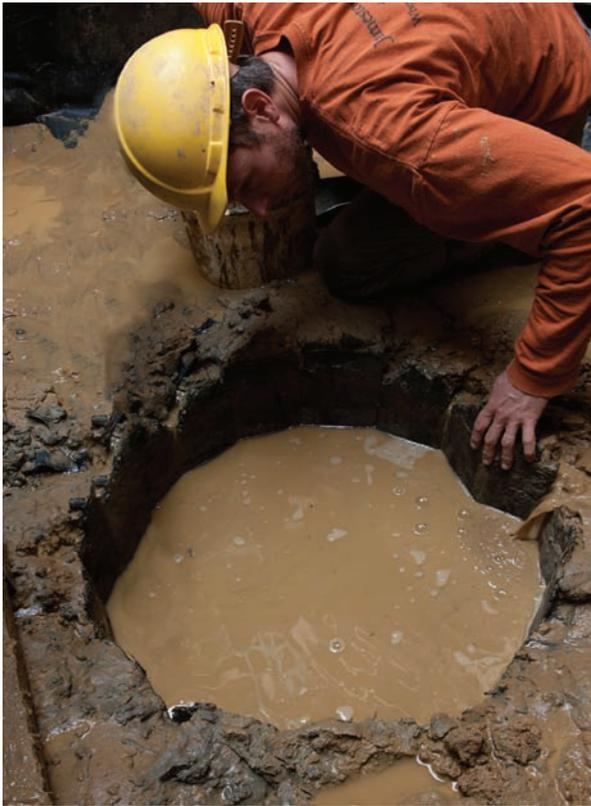
Figure 54. Well-lining cask staves, JR2718AA, in situ

Pumps were used to manage water levels as each stave was removed from the mud. A 3 mm (.12") wide croze line was found inside of each stave, 2 1/2" from the bottom. The croze line is a small linear groove into which the head planks are inserted to seal the cask. The head planks had been removed to hollow out the cask in preparation for its use as the well lining. Two adjacent staves had four 1/3"-diameter holes augured through them to secure a wooden batten to reinforce the cask's head with pegs or iron nails.<sup>27</sup> A possible bung hole measuring 16.14 mm (.64") in diameter was found on one of the staves 2 1/2" from the bottom. In addition, the staves contain ten small pegged holes. These were either sampling holes to test for spoilage, or were indications of pilfering. Also of note are two staves with carving on the exterior. One mark is a circle with a possible number within it, and the other is a circle with a line through it and a line beneath.

Wrapped around the bottom exterior of the cask were three wooden hoops used to hold the staves in alignment. The hoops vary in size: two 1" wide and one 1 3/4" wide. While species analysis is still pending, the hoops are likely hickory, oak, or ash. Several hoop sections were recovered with thin vine or reed strapping used to secure the form of the hoop. A majority of the wooden hoop fragments were recovered.

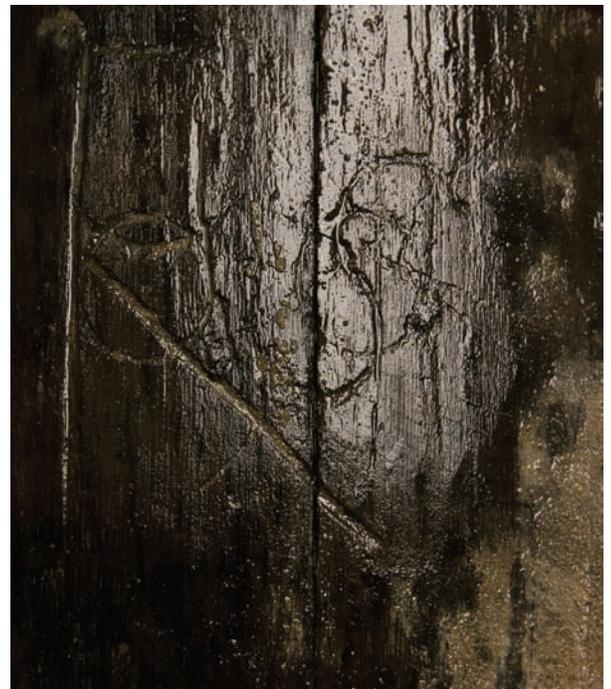
Figure 55. Cask marks

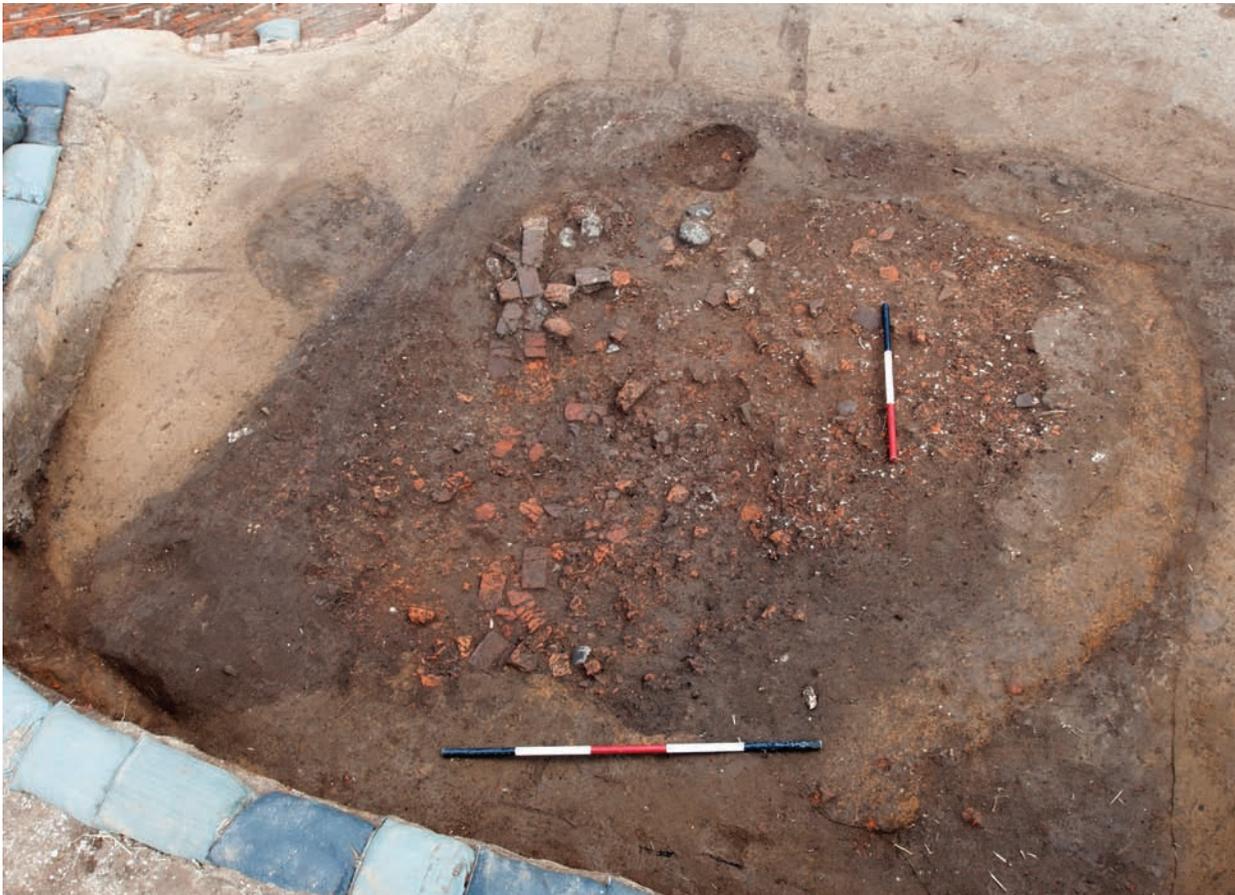
Figure 56. Possible Drummond house, Structure 180 (brick walkway (JR2718B) facing north)

The top layer, JR2718A, consisted of slumped-in sandy brown loam plowzone. The layer below the plowzone, JR2718B, contained heavy brick, brickbat, and cobble concentrations. These concentrations were densest through the middle of the feature and about a dozen bricks were aligned on a N/S axis. These may be remnants of a brick walkway related to Structure 180 to the south, a 3<sup>rd</sup> quarter of the 17<sup>th</sup>-century building. The brick paving in turn sealed a layer of compact orange clay, JR2718C, averaging about 6" in depth.
