# 2007–2010 Interim Report

on the Preservation Virginia Excavations at Jamestown, Virginia

March 2012

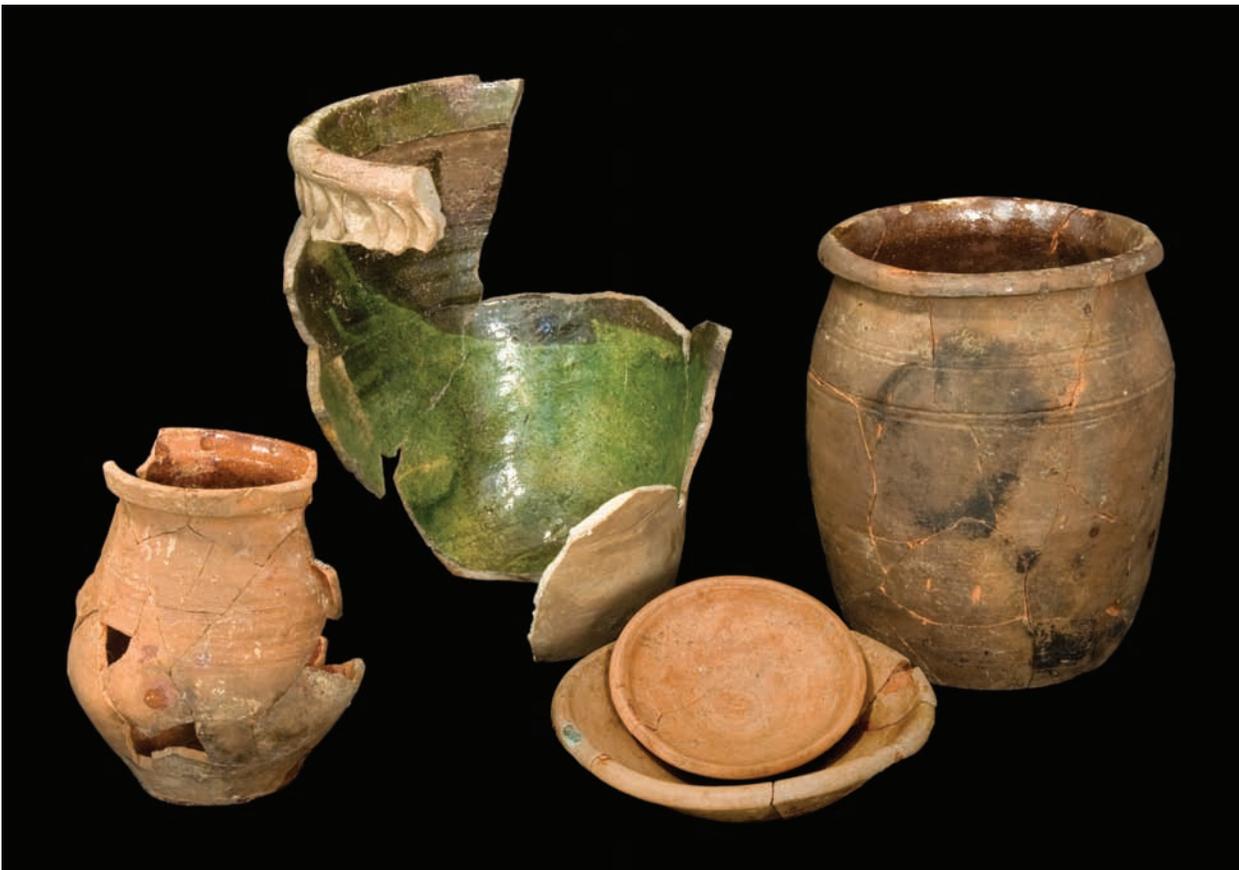
Figure 63. Group of London earthenwares; far right storage jar measurements: height 230 mm, diameter 185 mm

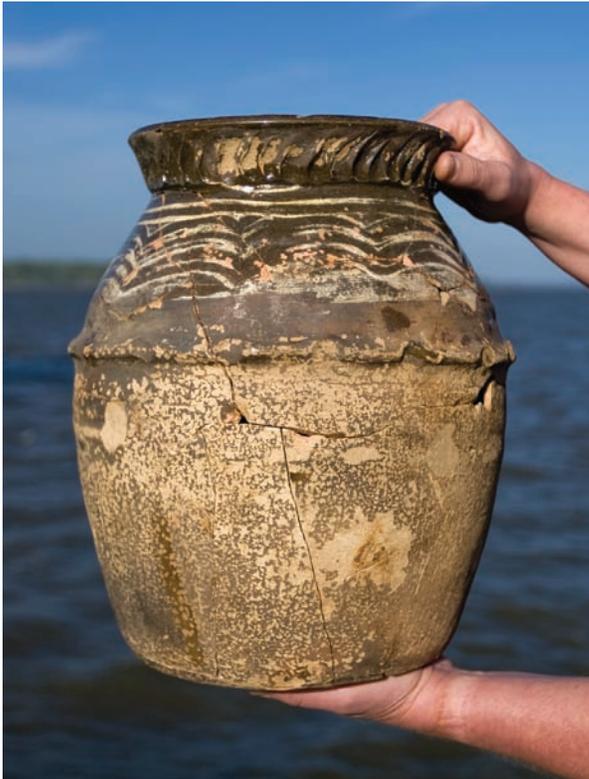
Figure 64. Somerset storage jar (height 375 mm, rim diameter 230 mm)

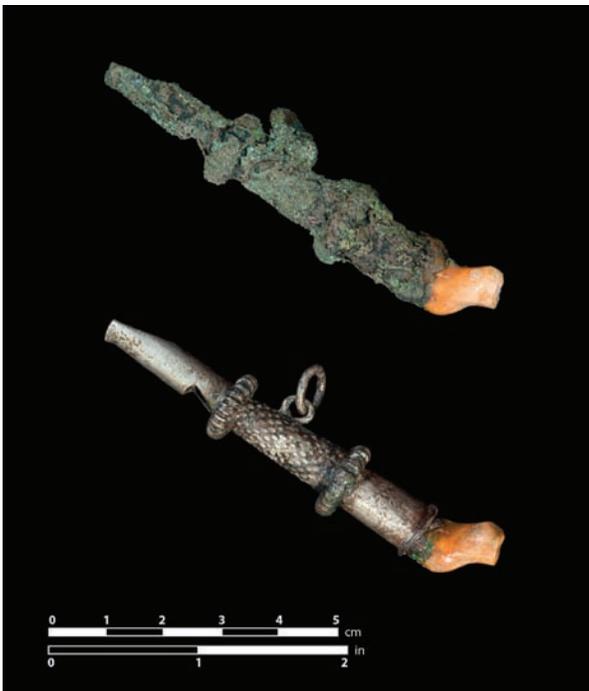
Figure 65. Child’s silver teething whistle with coral, before and after conservation (length 75 mm)

Also of note from layer N was a child's silver teething stick.<sup>34</sup> Incorporating a whistle and janglers, the teething section was composed of red coral, a substance thought from Roman times to contain magical protective properties.

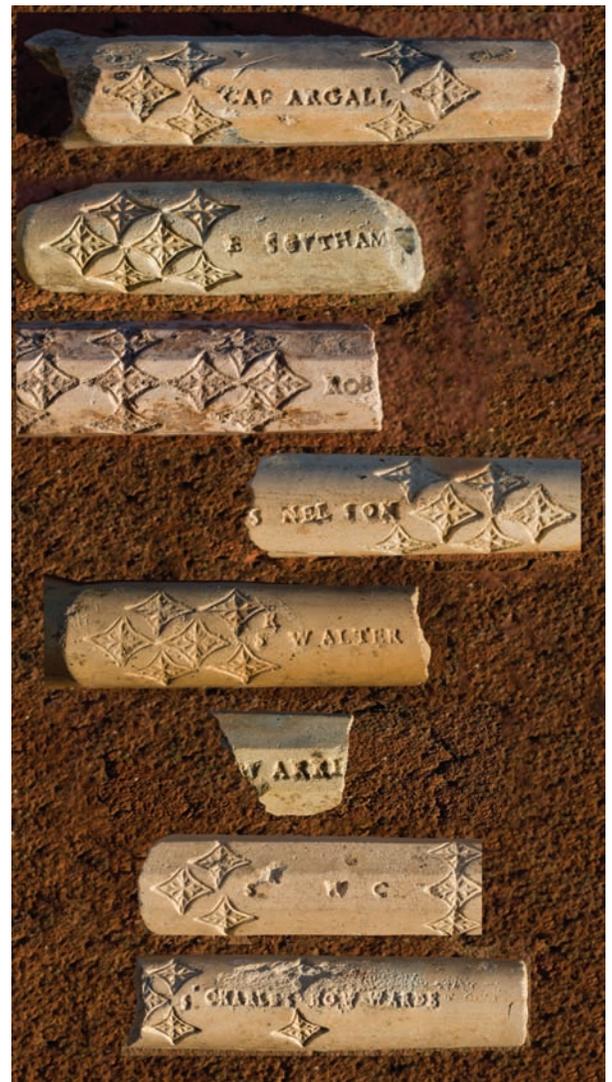
Figure 66. Personalized tobacco pipes impressed with the names of prominent Englishmen

Hundreds of fragments of Robert Cotton tobacco pipes ca. 1608 were found throughout the feature, including eight pipestem fragments with the full or partial names of prominent Englishmen stamped into them with printer's type. The named pipes include "CAP

ARGALL” or Captain Samuel Argall; “E SOUTHAM . . .” or Earl of Southampton; “. . . S NELSON” likely Captain Francis Nelson; “SR WALTER . . .” likely Sir Walter Raleigh; “SR CHARLES HOWWARDE” or Sir Charles Howard; “. . . WARRE” likely Lord De La Warr; “SR W C” likely indicating Sir Walter Cope; and

“ROB . . .” suggested to signify Robert Cecil, although unlikely as there is no honorific. These stem fragments are believed to have been from pipes that were broken during the production process, thereby never reaching their intended recipients. Many more individualized pipes probably survived the firing process and made their way to Virginia Company investors and other well-connected Englishmen.

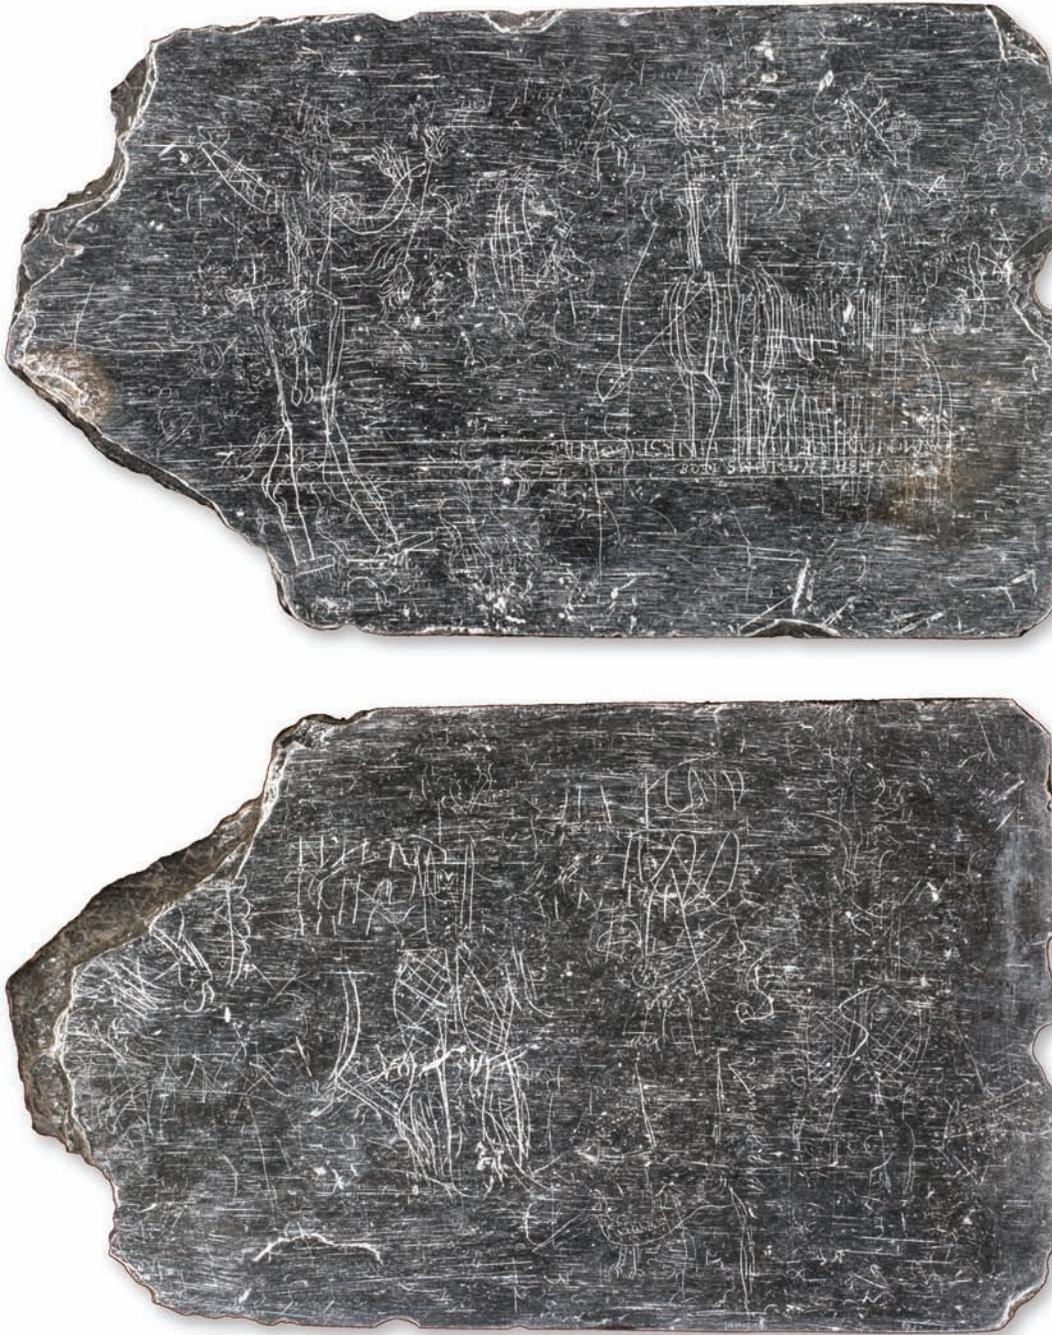
Figure 67. Both sides of slate writing tablet; inscriptions enhanced with chalk dust

Another unusual find came in the form of a slate writing tablet measuring 127 mm by 209 mm. Both sides of the tablet contained numerous faint inscriptions of animals, humans, and plants, along with both freehand and ruled text. The tablet underwent numerous tests to interpret the images. NASA conducted a micro-CT scan, the Smithsonian Institution used Reflectance Transformation Imaging, and the FBI utilized several methods of high-resolution imagery. A light dusting of chalk over the surface of the tablet was found to be the most useful method for viewing

the inscriptions.

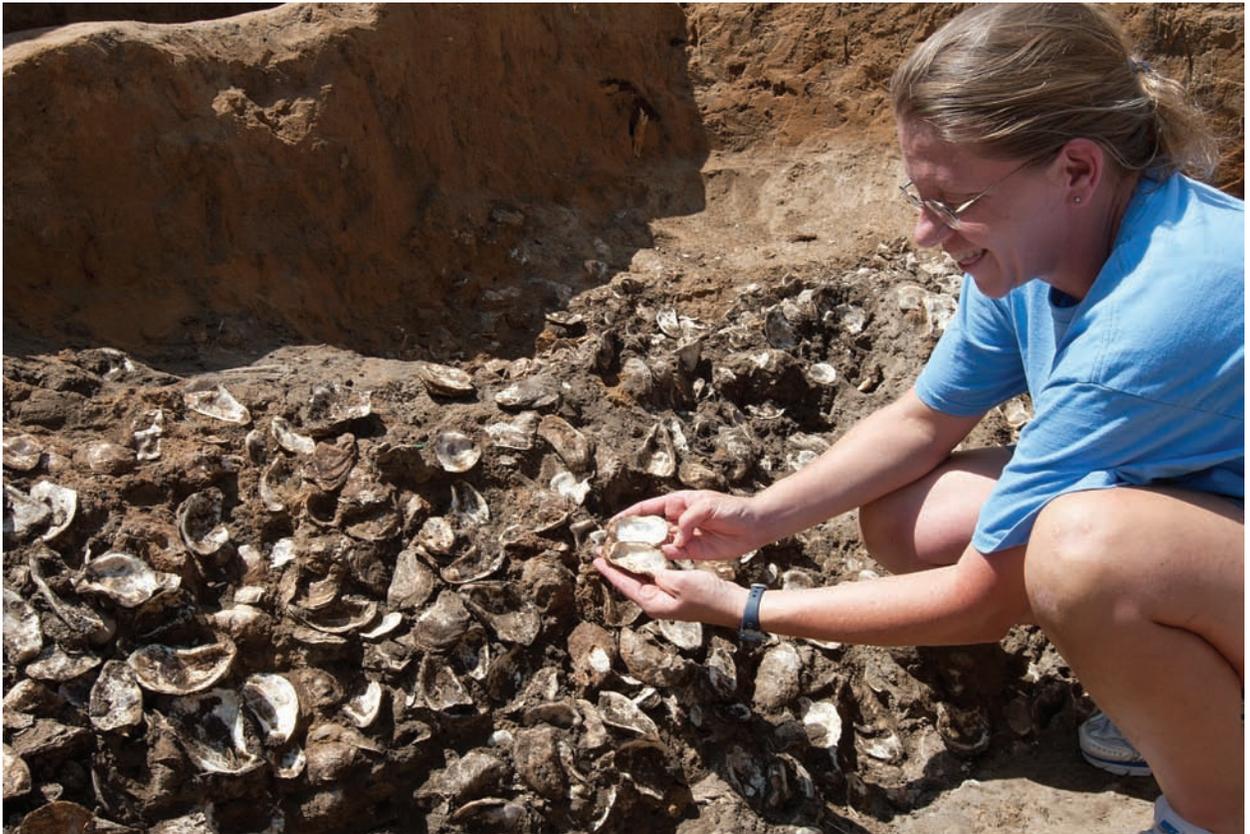
Figure 68. Oyster shell layer JR2718W

A massive layer containing oyster shell concentrations (JR2718W) was sealed by JR2718N. This layer was located along the southern and western sides of the pit, which suggested the layer was dumped into

the feature from the southwest corner. Layer JR2718W slumped deeply into the feature, stopping a few inches from the top of the cask. It was clear this layer was the first major layer deposited in the feature once the cellar/well was abandoned. Tens of thousands of oyster shells

were recovered from this layer. Interspersed among the shells were thousands of artifacts with large amounts of marine fauna including sturgeon, dolphin, blue crab, shark, and numerous other fish and shellfish species.

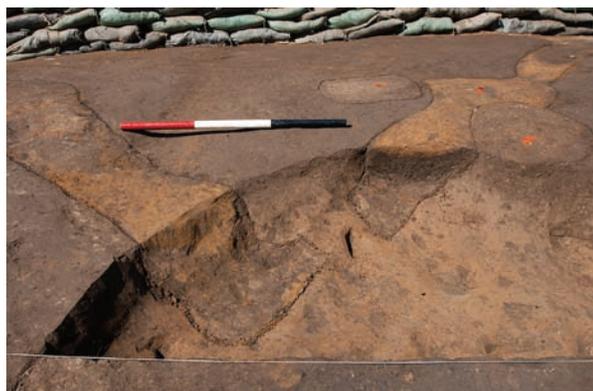
Figure 72. Structure 187 foundation trenches JR2709 (right) & JR2881 (left) with half excavated Pit 20 in the foreground (facing west)

Excavations in 2008, north of the possible storehouse (Structure 179) site, revealed two seemingly related foundation trenches, JR2709 and JR2881, which appear to be wall segments for a fort-period building (Structure 187). The trenches were predominately clay-filled and punctuated with some isolated loam-filled depressions, suggesting that a cobble foundation was possibly constructed and removed within the trenches. JR2709 was oriented NW/SE and measured approximately 8' long by 10" wide and 9" deep. The other trench (JR2881) was NE/SW and about 9' long by 9" wide and 9" deep. The trench segments were perpendicular to each other, but a later pit (Pit 20, JR2710) almost certainly severed any original direct joining of the two segments. Tests into each trench confirmed they both have a flat bottom and contain similar fill deposits. This indicates they are related and likely composed the east corner of a 10'-wide structure.

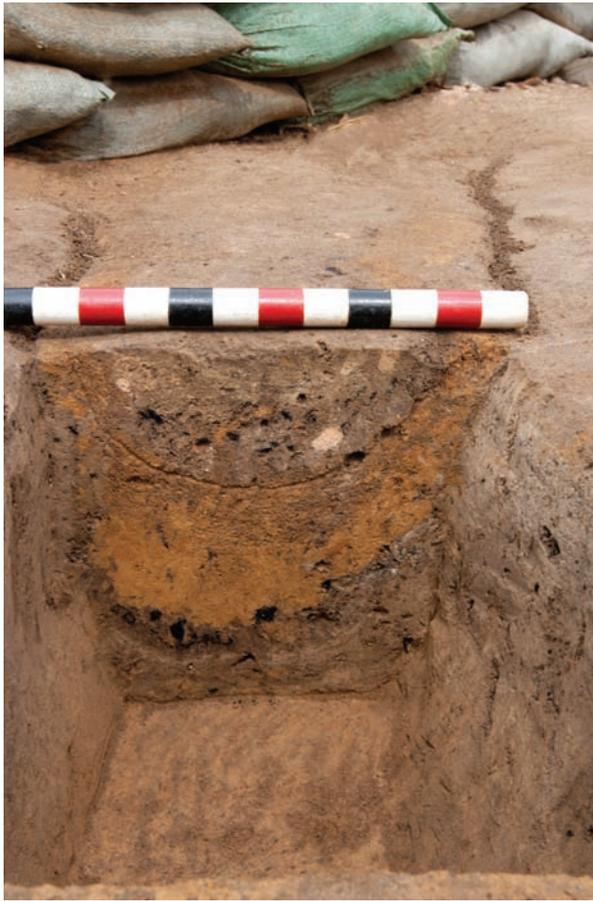
Figure 73. Profile in test JR2877 into trench JR2709; layers JR2877A–D visible (facing northwest)

In 2010 three tests were excavated into Structure 187 in order to establish construction techniques, the date of construction, and possibly the length of time it existed. A 1' by 9" test (JR2877) into a portion of JR2709 identified four layers of fill. The top layer was a brown/tan loam with charcoal flakes (JR2877A), which may have been soil that filled a removed cobble foundation cavity. Another layer, JR2877B, consisted of orange sand with very few inclusions. This sealed JR2877C, a layer of grey loam with some clay inclusions. It contained a heavy mixture of burned wood,

slag, two copper aglets, lead shot, four fragments of turtle bones, and a piece of coral, probably Caribbean. JR2877D, the bottom layer, was mainly a subsoil wash and was void of artifacts.

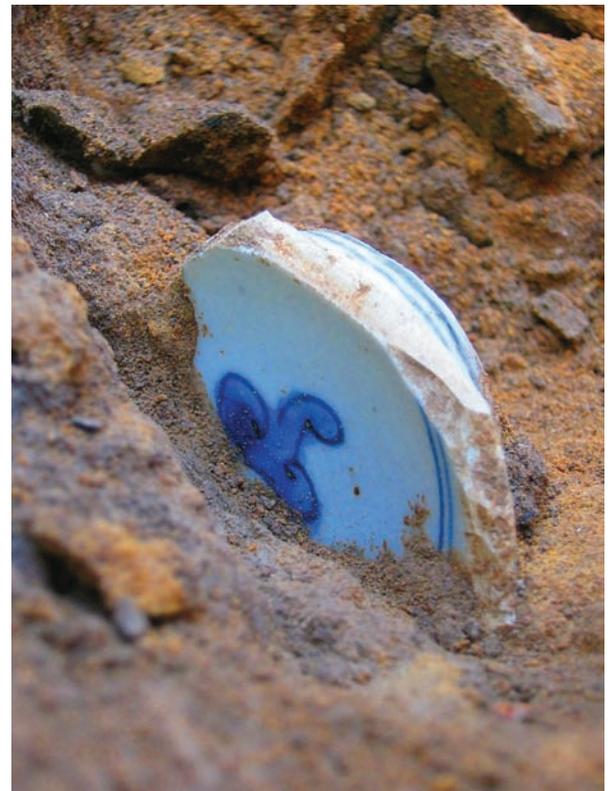
Figure 74. Chinese porcelain bowl fragment in JR2709

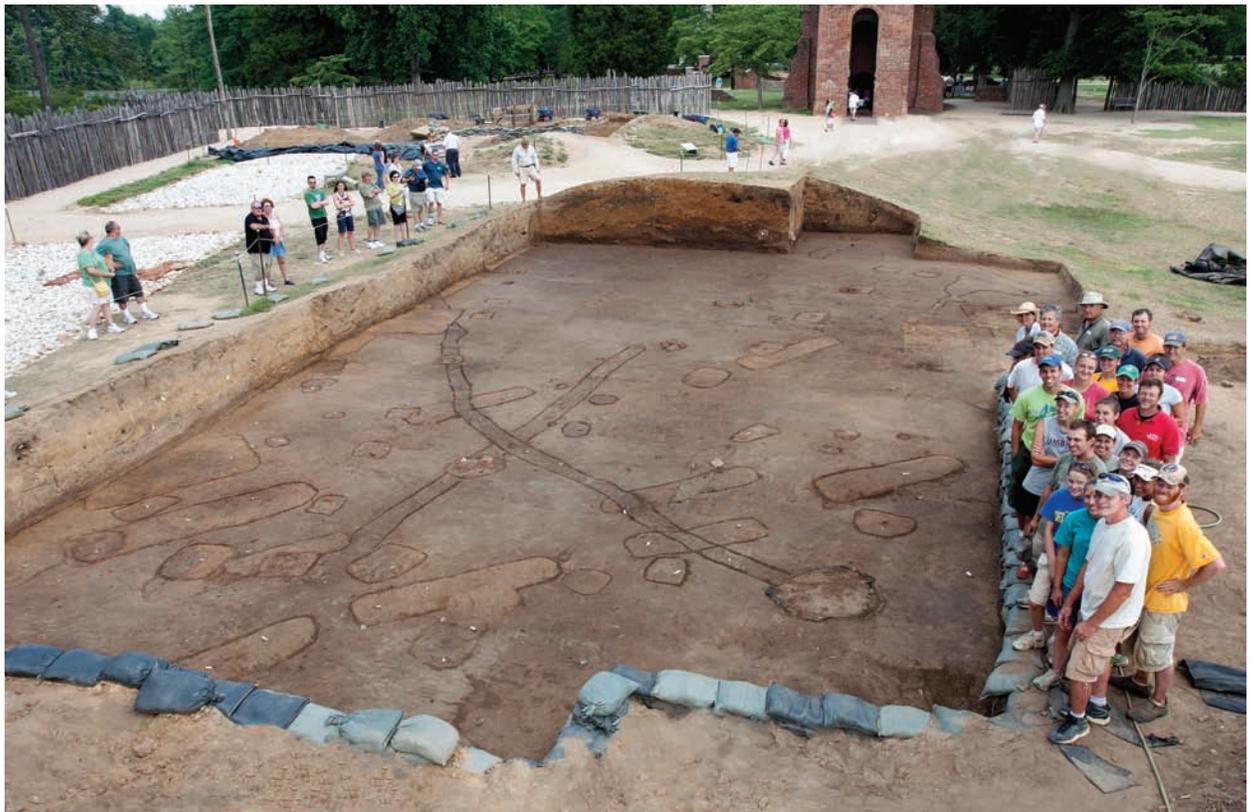
Figure 76. Open-area excavations showing additional 1607 burials

Excavations in the western end of James Fort during the 2007 and 2008 field seasons revealed ten burial shafts to the south of, and associated with,

the already identified early fort-period burial ground (ca. 1607–10). These burials were all oriented on a NW/SE axis, the same axis as the majority of the previously discovered burial shafts.<sup>1</sup> One of the burial shafts, JR2460, was 4'8" wide, much wider than the others. This almost certainly indicates that this burial

contains two individuals, similar to burials JR1362 and JR1368 excavated in 2004.<sup>2</sup> All burial shafts were over 5' in length, which suggests they held adults. The discovery of the additional ten grave shafts brings the total number of individuals buried in the area to thirty-three. A square-shaped posthole, JR2466, was found at the northern end of burial JR2465. This posthole abutted the grave fill and was oriented with the grave shaft, suggesting that it may have supported a burial marker. None of these ten burials disturbed any other features, which may indicate that the burials were the earliest English features in this part of the fort. This was also the case with the twenty burials found from 2003 through 2005.

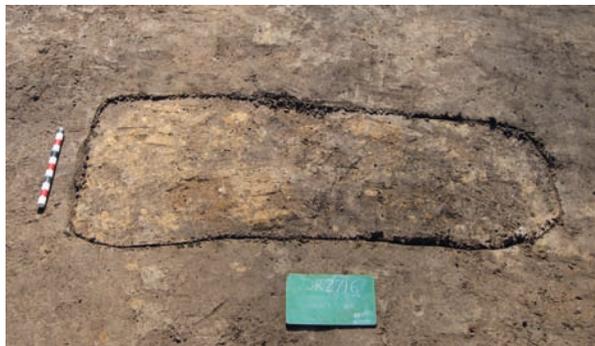
Figure 78. Burial JR2716 (facing east)

A probable burial shaft designated JR2716 and left unexcavated was found near the center of James Fort. The shaft measured 4'5" long by 1'10" wide and was disturbed by one small circular post, JR2717. The grave was located over 130' from the fort's southern palisade, but it was oriented perpendicular to that palisade, suggesting the two were contemporaneous. The grave fill at the surrounding subsoil elevation consisted of orange clay with dark loam inclusions. No historical artifacts were found in the fill at this level, possibly indicating that this feature dates to the earliest years of fort occupation. Located 10' to the ESE of JR2716 was another possible burial, JR2730. This possible grave shaft measured 3'6" by 1'4" and may be the resting place of a child.

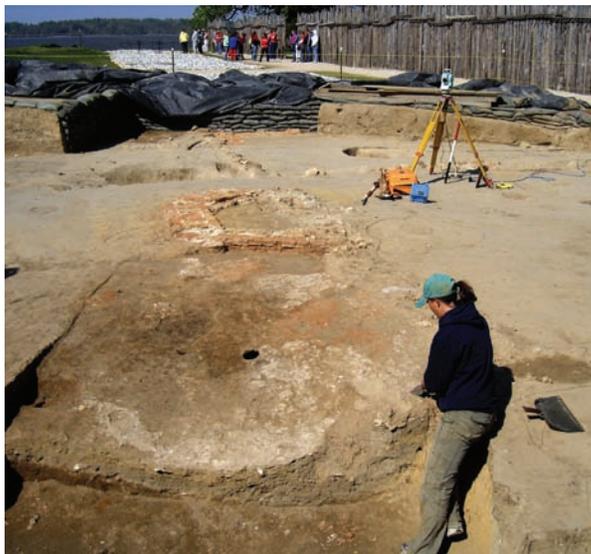
Figure 80. Mortar layer in Pit 16 (facing north)

Pit 16 (JR2336, JR2359) was a mortar mixing pit found in the fill of Structure 183's cellar. The pit was bowl shaped, circular, roughly 6' in diameter, and about 8" deep. There were six layers of fill (JR2359A–F), mostly consisting of sandy loam with brick and mortar inclusions. The bottom of the pit contained two distinct 1"-thick mortar concentrations (JR2359E, JR2359F). In addition to the brick and mortar, layer JR2359F contained a lens of burned clay.

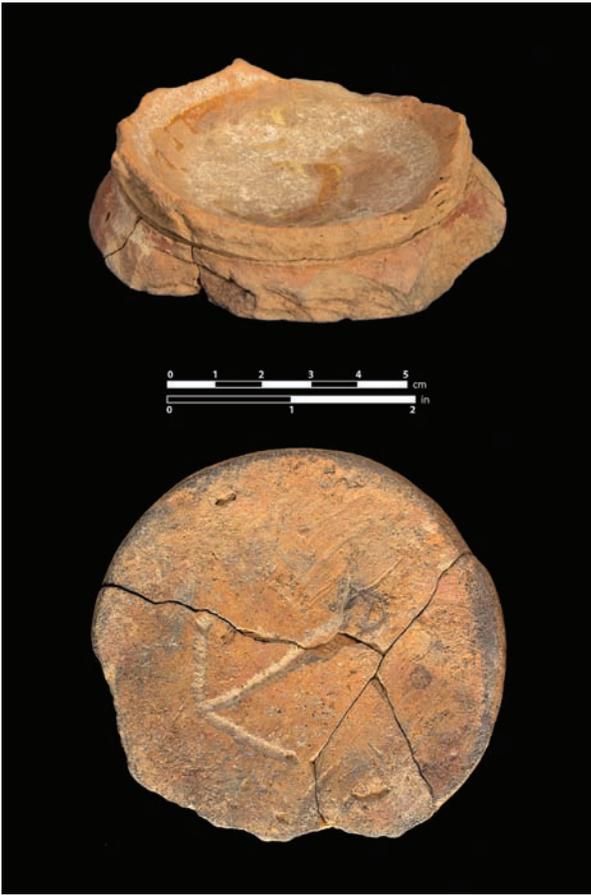
Figure 82. Broad arrow mark on porringer (base diameter 82 mm)

The top soil layer (JR2359A, same as JR2336A) was likely a plowzone colored brown and red from high concentrations of disintegrated brick. An English patent farthing was found in JR2336A. Known as a Lennox round, it is the type of coin issued by the Duke of Lennox between June 1614 and February 1624. JR2359A also yielded several vessels—a jug, bowl, pan, jar, and porringer—made in the south Somerset area of England. The porringer was scratched on the exterior base with a broad arrow, a symbol used since

the 14<sup>th</sup> century to signify property of the English crown. Use of certain marks on stores was restricted by British law, and it is still a misdemeanor crime to use the broad arrow mark on goods without authority.<sup>1</sup> The mark on the Jamestown porringer may indicate it was purchased for use by the Royal Navy; on the other hand, the mark may be a way of personalizing the vessel. A number of vessels associated with eating and drinking found on the 1545 English warship the *Mary Rose* also contained crudely applied marks, some appearing as broad arrows. It has not been determined

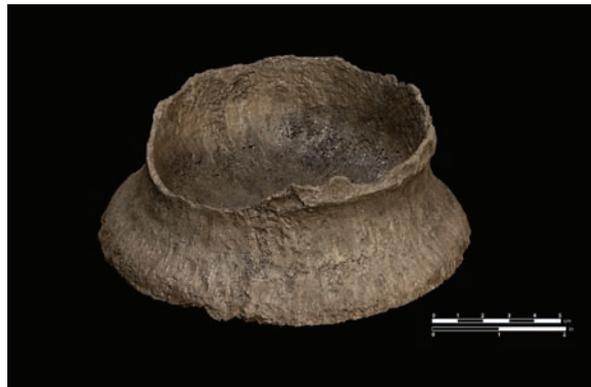
Figure 84. Mortar (diameter 156 mm)

Unusual among the iron objects from the context is the basal section of a mortar, which may have been used for alchemical experiments, or to process comestibles. Although layers JR2359E and JR2359F were primarily composed of white oyster shell mortar, there were several other artifacts, including two ceramic vessels that crossmended with both Pit 6 and Structure 183. One of the vessels is a Somerset pipkin, the other is a Roman oil lamp from the first century A.D. The latter object is discussed in the report for Structure 183.

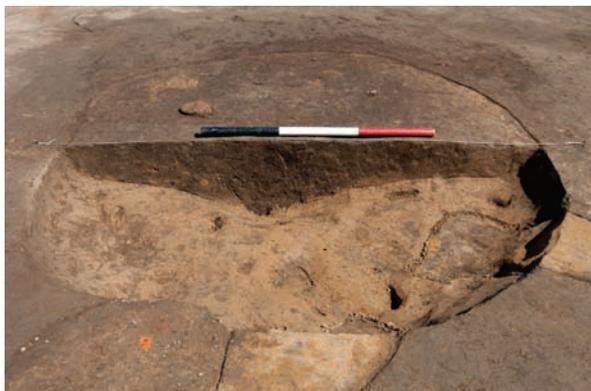
Figure 85. Pit 20 bisected (facing east)

Pit 20, JR2710, is a circular pit near the center of James Fort. The pit measured approximately 6'6" by 6'2" in plan, with an average depth of about 1'. The western half of the pit was excavated in 2010, and the eastern half remained unexcavated. Pit 20 consisted of one fill layer from top to bottom, JR2710A. JR2710A contained a mix of brown loam and clay. Below this layer were subsoil and the remains of two trench features, JR2709 and JR2881, which had been disturbed by Pit 20. These trenches were likely part of a James Fort period (1607–24) building, Structure 187. Pit 20 was also disturbed by two later postholes, JR2714 and JR2715. JR2715 had to be excavated in order to dig the western half of Pit 20. This posthole, which contained a lead cloth seal, dates to the early 17<sup>th</sup> century.

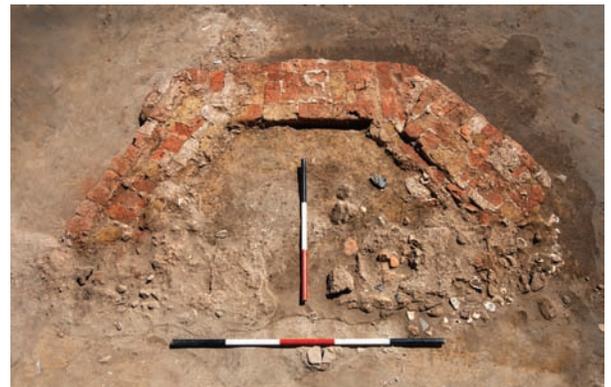
Figure 86. Plan view of brick foundation (JR2295) associated with Structure 176; note oyster shell concentration in Pit 24 (bottom right)

Excavations along the southern foundation of Structure 176 revealed a small, fort-period trash midden, JR2302, located to the north of the three-sided brick foundation JR2295.<sup>6</sup> The midden's northern limits were sealed by the plowzone in the 10' by 10' unit JR2234. Structure 176's foundation, JR2294, and a portion of JR2295's western side directly sealed the feature and obscured its southern limits. Prior to excavation, the visible portion of the midden's surface was comprised of a large deposit of oyster shells.

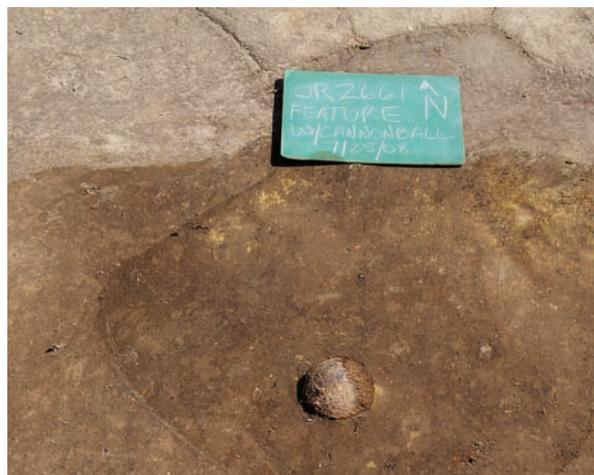
Figure 88. Six-pound shot found in JR2661

In the summer of 2008, a small amorphous-shaped feature, Pit 25 (JR2661), was found near the center of James Fort. A six-pound iron shot of demiculverin size was found at the surface of the feature. The feature was sealed by plowzone and disturbed by posthole JR2663. The southern half of the feature was excavated as JR2661A and consisted of a light brown sandy loam with an average depth of about 6". The purpose of the feature is unknown.

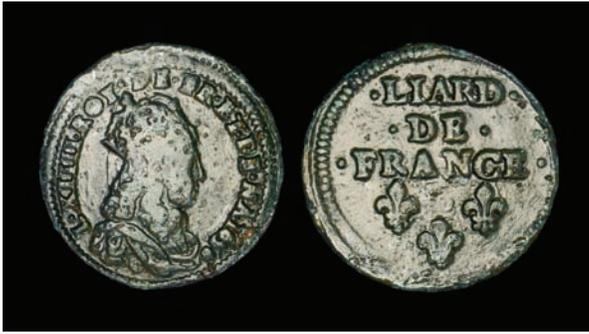
Figure 92. Copper French liard dated 1656, from disturbed builder's trench, Structure 180

Again, Green Spring pottery is the most common ceramic in this context, which also includes Jamestown coarseware and Portuguese faience. A firm terminus post quem is provided by a copper French liard of King Louis XIV dated 1656. Worth three deniers, or three English pence, the liard circulated as currency in the Austrian Netherlands but would have been accepted as small change in the colony.

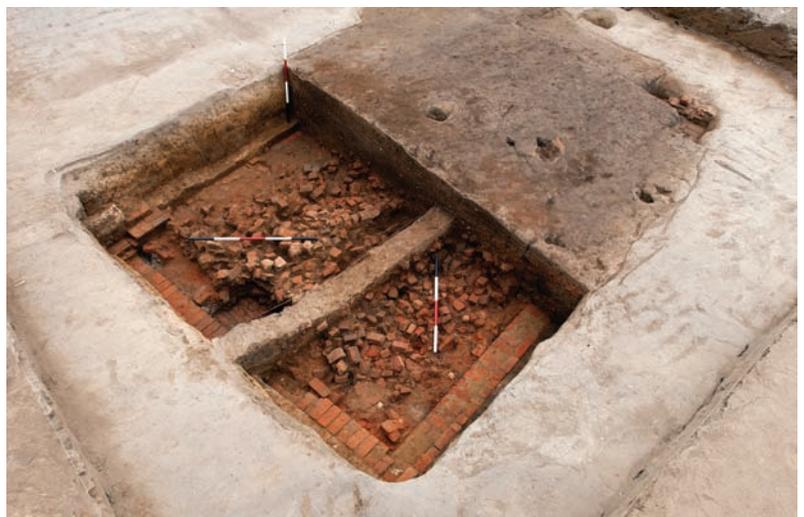
Figure 93. Brick rubble, JR2060D; likely broken bricks discarded during a salvage operation (facing southeast)

A layer of heavy brick rubble, JR2060D, was found beneath the collapsed builder's trench fill, which extended across the entire cellar. This layer was made up

of discarded broken bricks rejected by those salvaging complete bricks from the cellar's foundations. The sheer volume of brick, 4,900 kg, as well as the relative absence of complete bricks in JR2060D, supports that scenario. Heavy whitewashed plaster, brick flooring tile fragments, and some ceramic roofing tiles were also found in this rubble. JR2060E was treated as a

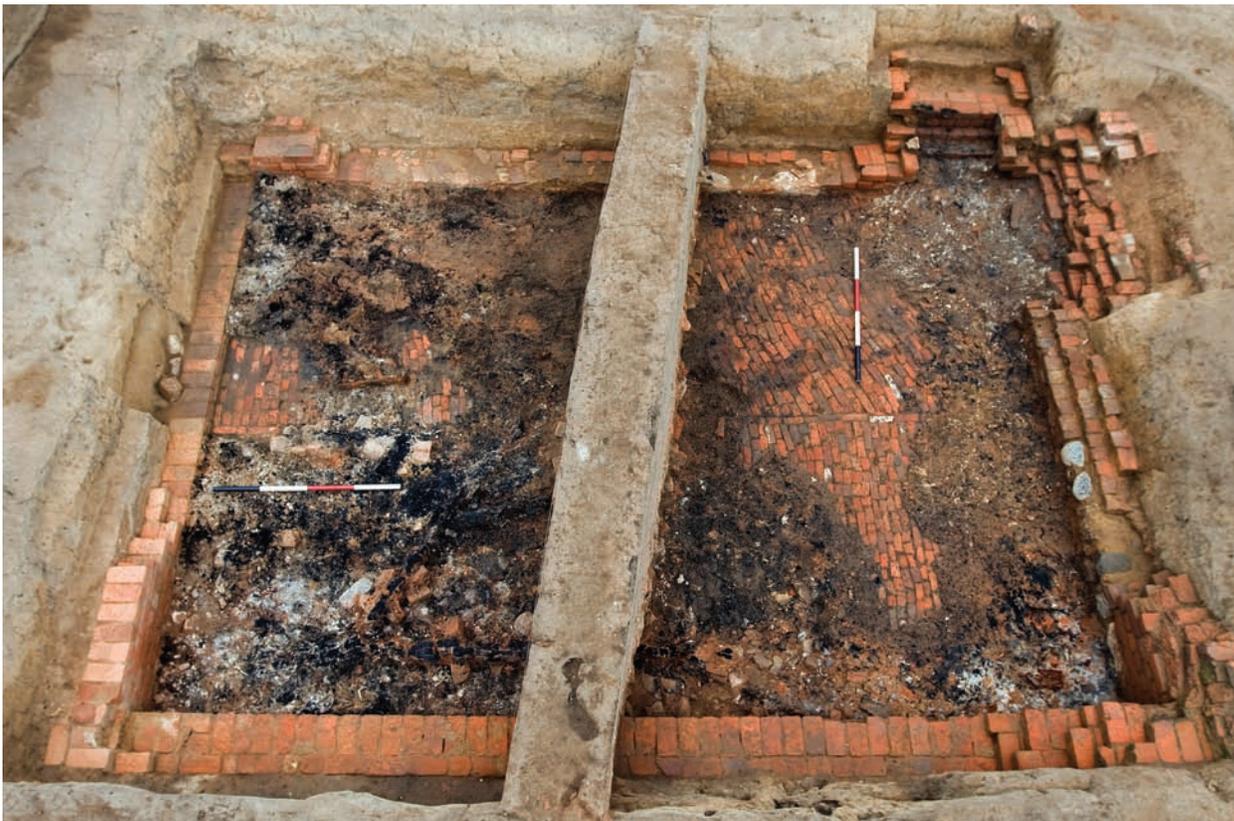
Figure 96. Burned layer, JR2060F, covering cellar floor (facing east)

The final layer that covered the brick floor of the cellar was a dense burned layer, JR2060F, which confirmed that the superstructure over the cellar had burned. JR2060F contained the charred remains of timber framing and the structure's contents. The burned timbers from a collapsed framed wall above had fallen into the cellar from the northern end of the

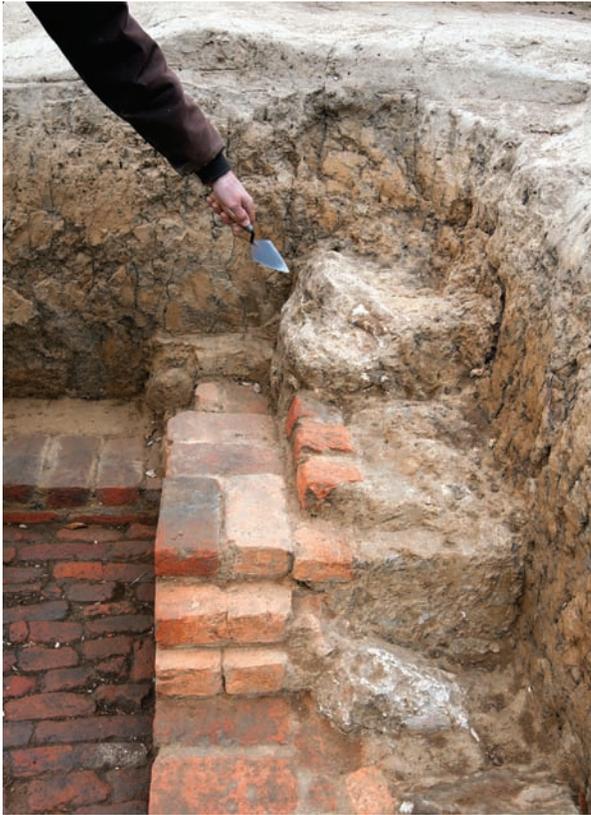
Figure 102. Large limestone cobble found in the builder's trench, northeastern corner of the cellar (facing north)

The builder's trench, JR2060J, was generally 8" to 9" thick as found between the brick foundation and the subsoil walls of the pit. The fill was compact orange clay with some loam. The western, eastern, and northern walls all had builder's trenches, but the southern wall did not as it was built tightly against the subsoil wall. Cobblestones were found throughout the builder's trench fill; these were mostly local quartzite, but also several non-local limestone cobbles and an andesite cobble from the West Indies were found. None of the stones were removed, and their reason for being in the builder's trench is puzzling. In the northeastern corner of the cellar, several sizable limestone cobbles were situated in the builder's trench. These must have

been placed there for the stabilization of the structure's northern wall where it bonded into the grade-level foundation of the rest of the building (now plowed away) beyond the cellar.

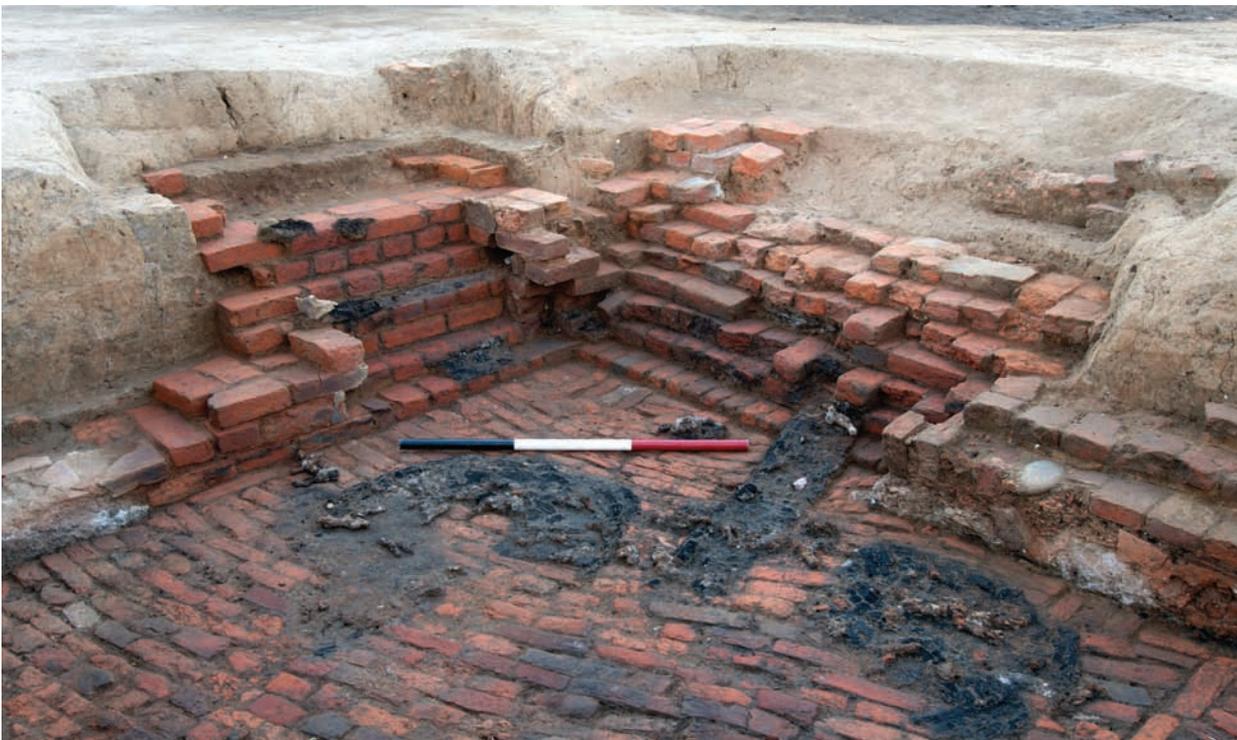
There were two sets of cellar steps, both located at the southeastern corner of the cellar. The wider set of steps, located along the southern wall, was a 4'-wide

Figure 104. Two sets of cellar steps (facing southeast)

exterior entrance. This width allowed for larger containers, like barrels, to be loaded into the cellar. The stair treads were brick and once had wooden nosings that had burned or rotted away. The second set of steps was located along the eastern wall near the southeastern cellar corner. These 2'-wide steps connected the cellar to the interior of the main structure. They were steep,

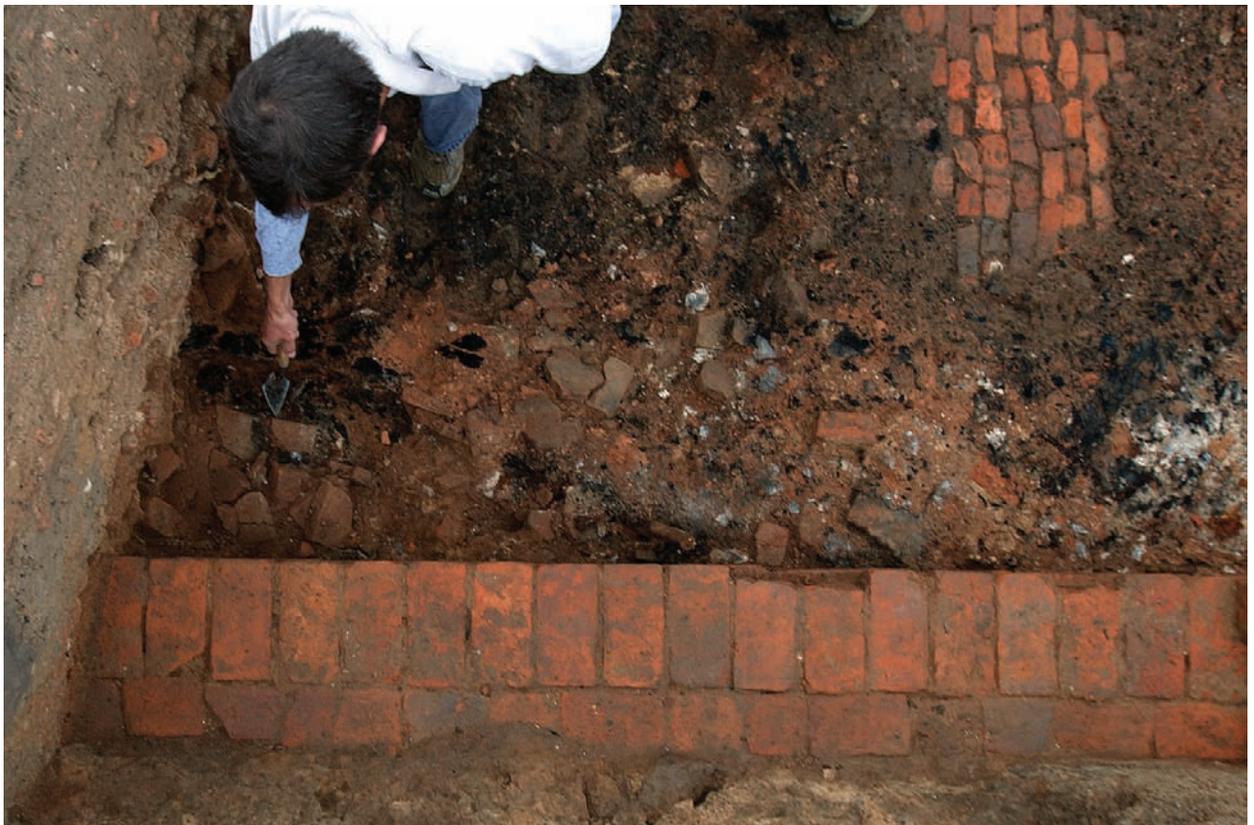
No exterior chimney foundation was found in place at the western end of the building where there had been deeper plowing. However, destruction debris at the center of the western end of the cellar contained large brick paving tiles that may have been from a collapsed hearth. These tiles, which would have fallen through the floor as the building burned, sat atop some of the burned debris, but they were sealed by charcoal and ash. This confirmed they were in the building, or were part of it, prior to the fire. Two complete tiles from JR2060F measured 8½" by 8½", and they were just over 1" thick.

Figure 108. Broken brick paving tiles, possibly from a collapsed hearth, in situ in the charred remnants of Structure 180; apparent evidence of a western exterior chimney

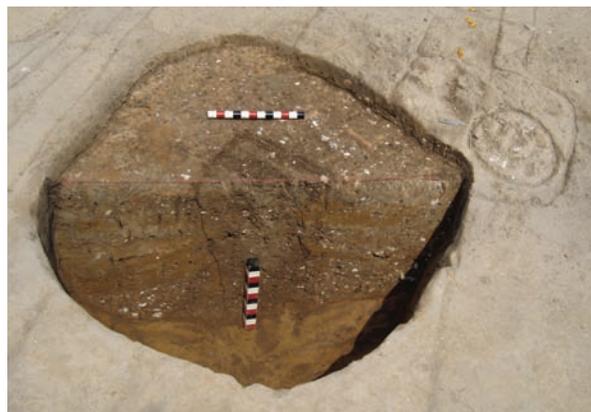
Prior to excavation, an arbitrary 2" layer of soil (JR1695A) was removed to locate the postmold. The mold, JR1695B, was 1'2" square and composed of dark

Figure 110. Northeast corner post JR1695 bisected (facing north)

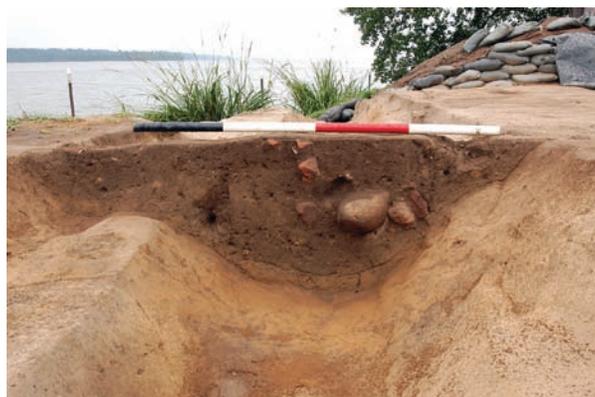
Excavations into Ditch 28 were conducted by placing a series of intermittent 5'-long test sections along the ditch line (JR2407–JR2411). Two fill layers were found throughout these tests. The top (A) layer consisted of brown sandy loam with heavy brick rubble and some cobblestones; the bottom B layer was similar but had few inclusions.<sup>1</sup> The ditch was generally 1'6" deep throughout. The north side of the ditch gently sloped to the bottom, but the south side sloped about

Figure 113. Profile of Ditch 28 (facing west)

halfway down to a 1'-wide shelf before sloping again to the bottom. A small test into what was believed to be the eastern terminus of this ditch, JR2584A, confirmed this and showed that the ditch came to an abrupt end at this point.

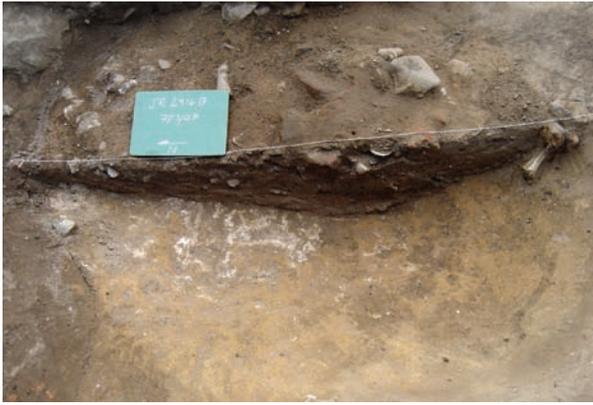
One test section into Ditch 28, JR2410, uncovered a circular pit approximately 4' to 5' in diameter, which may have been a plaster-mixing pit. The pit, JR2416, disturbed Ditch 28 at the southern section of test

Figure 114. Bisected pit JR2416 (facing east)

JR2410, but was disturbed itself by Ditch 29. Some of the pit's fill may have been removed inadvertently as JR2410A prior to its identification. The pit was tested by bisecting it, with the western portion excavated to its bottom level.

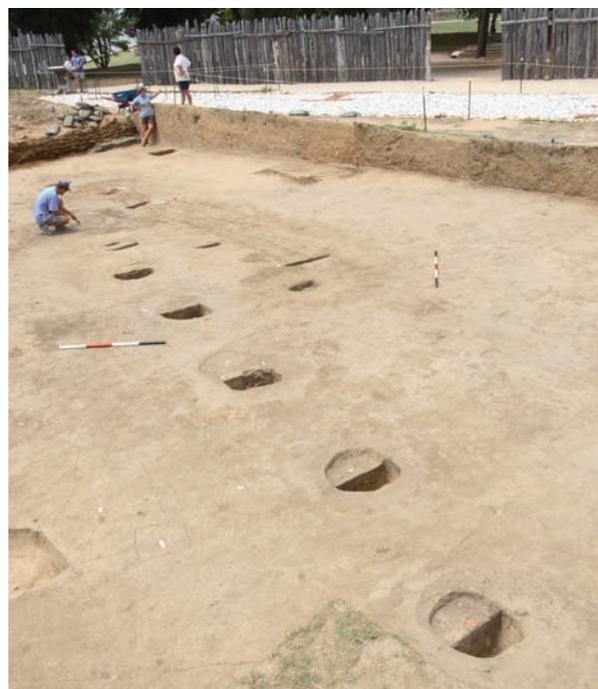
Figure 117. Overall photograph of the fence line, with Fence Line 2 in the foreground (facing northwest)

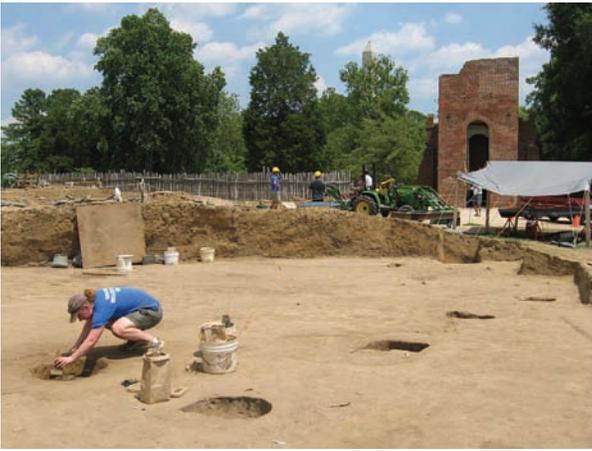
Figure 118. Overall photograph of Fence Line 3 (facing east)

disturbed the slot trench JR2680. The eastern halves of seven postholes were excavated: JR2449, JR2653, JR2654, JR2657, JR2660, JR2685, and JR2701. All but one of the postholes had clearly defined postmolds. The depths of the postholes were almost identical: 1' to 1'3" deep. Diagnostic artifacts from Fence Line 3 suggest a ca. 1630–40 date. These include a fragment of Dutch delftware wall tile, a spattered manganese delftware mug, Jamestown coarseware, and a fragment of a North Devon gravel-tempered pan. JR2660 was the only posthole with no discernable postmold.

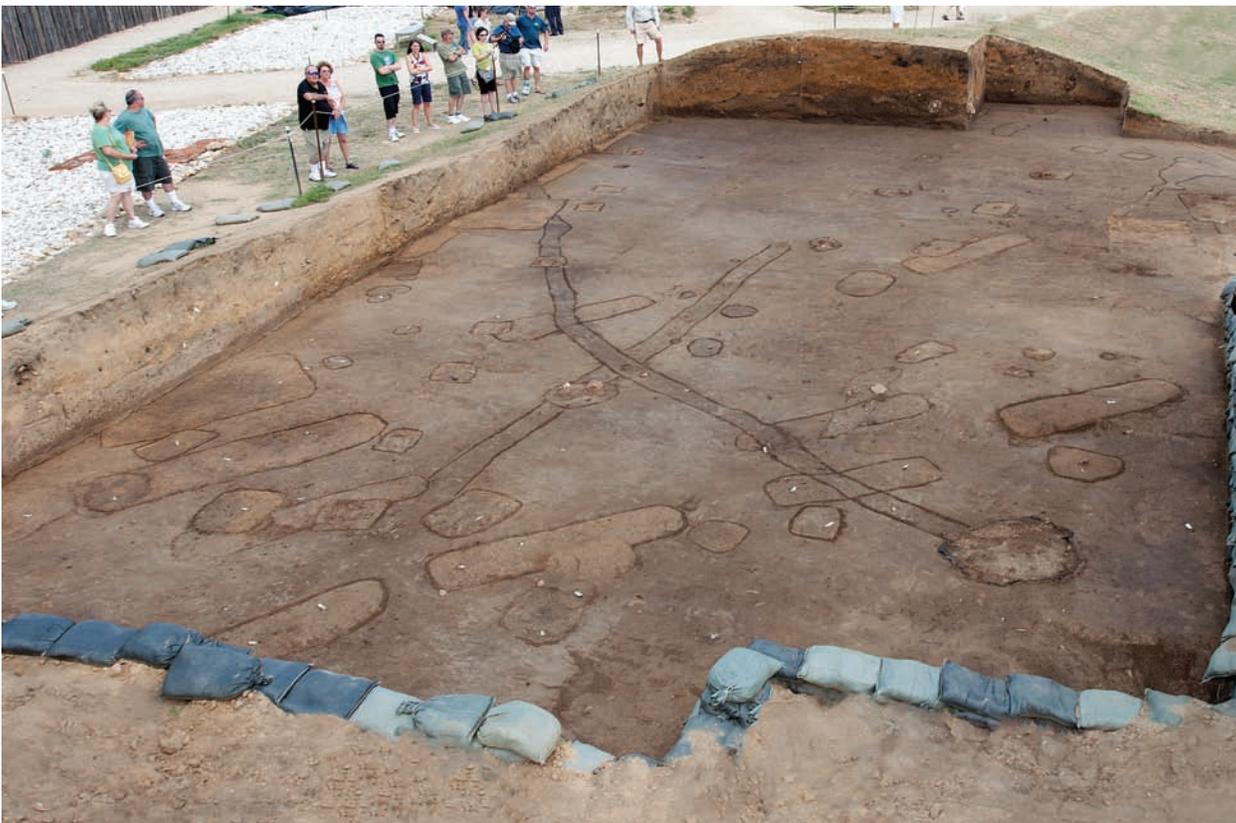
Excavations in the summer of 2008 revealed an additional portion of a narrow, late 17<sup>th</sup>- to early 18<sup>th</sup>-century trench, JR2058, partially investigated in 2005.<sup>2</sup> This new section of the 1'5"-wide trench line, JR2457, ran southwest from the previously identified segment of JR2058 and then curved toward the south. JR2457 was located just south of Ditch 24 and disturbed three graves in the southern portion of the 1607 burial ground. The graves disturbed included JR2552, JR2569, and JR2554. The trench also disturbed JR2680 and ran directly across that slot trench's E/W line.

Figure 119. Site plan of curving slot trench JR2457, and slot trench JR2680

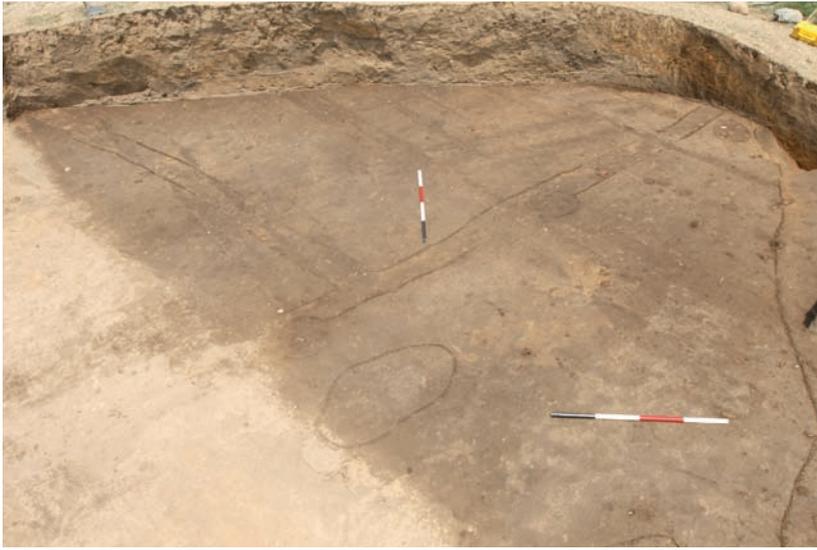
Figure 120. Site plan of slot trench JR2680

Removal of Confederate earthwork fill and plow-zone to the north of the posts in Fence Line 2 and south of Structure 173 revealed a 1'-wide slot trench (JR2680). The largest section of the trench was oriented E/W and measured 95', with an adjoining 18' segment branching off to the north. In order to verify that the trench continued through an area where it was clearly not as visible, two 2' by 5" sections of subsoil and possible trench fill were excavated to a depth of 5" in areas where the trench was projected to extend. These small tests confirmed the existence of the trench. Two more 3' by 1' tests (JR2691, JR2695) were dug directly into the slot trench in order to determine the physical characteristics of the trench. JR2691 was the test into the segment of the trench running E/W, and JR2695 tested the northern extension.

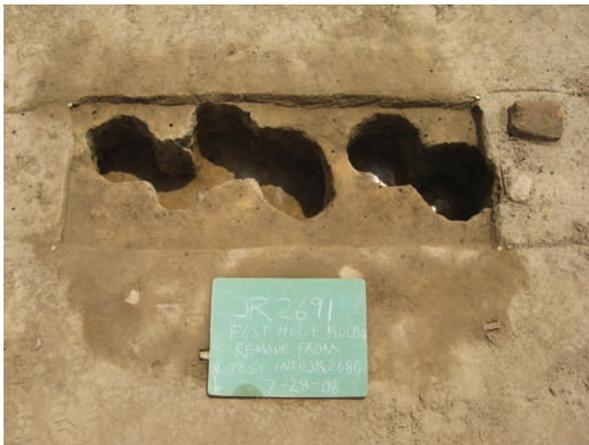
Both tests (JR2691, JR2695) determined that the trench once held upright, circular or oval timbers, ranging approximately 4" to 6" in diameter,

Figure 121. Section of slot trench JR2691

which had rotted away in place. The postmold fill consisted of a greyish-brown, sandy loam with some light inclusions of brick bits. Artifacts in the fill were consistent with a ca. 1630–40 fill date and included a Jamestown coarseware mug, a Portuguese tin-glazed dish, and a Virginia clay tobacco pipe bowl with the characteristic markings of the “Bookbinder school” of pipemaking.<sup>3</sup> Trench fill around the posts contained a mix of brown loam and orange, redeposited subsoil clay. The trench was similar in shape to those of the fort’s palisade trenches with straight sides, 5" to 7" deep, and a flat bottom.
