# 2007–2010 Interim Report

on the Preservation Virginia Excavations at Jamestown, Virginia

March 2012

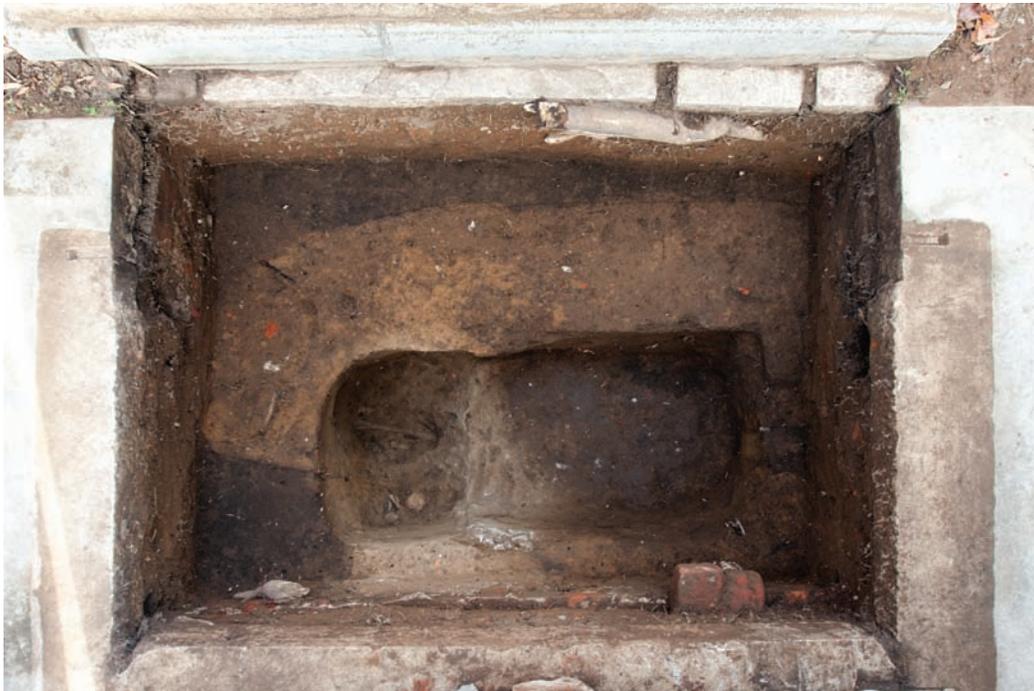
Figure 123. Harrison burial shaft soon after excavations had begun; hole in center is from 1901 excavations

The tombstone was removed with levers, carefully sliding it off the site and onto an adjacent tombstone to the south. Once the stone was removed, a 5’7” by 2’6” rectangular section of the 1901 backfill, JR2741A, was visible. In this fill were several brass tacks not removed by the 1901 excavations, along with disarticulated human remains. After removing 2’ of backfill, the outline of a burial shaft, JR2743, was found along with a section of native cultural horizon.<sup>2</sup> Part of the northern end of a second burial shaft was visible on the southern side of the excavated area. At this level the 1901 excavation shaft became smaller and it clearly disturbed the northern half of JR2743. The excavation was expanded 2’ to the north in order to expose the complete burial shaft.

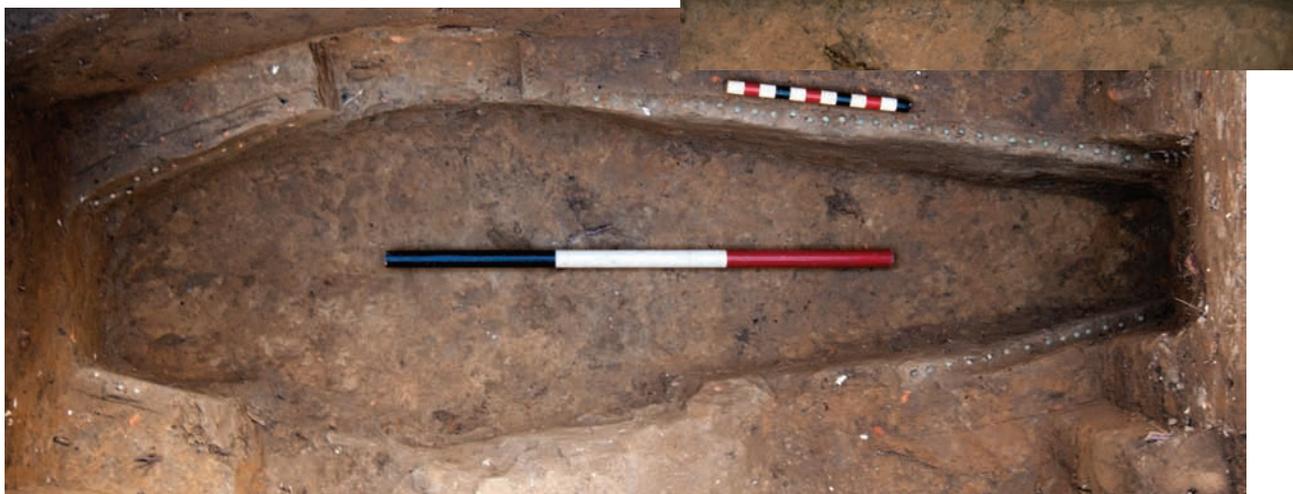
Figure 124. Copper-alloy tacks lining the perimeter of the coffin lid stain

The coffin, JR2743B, was elaborately embossed with brass tacks at 1” intervals along the edges of the coffin lid. Tacks were also found on their sides pointing towards the remains indicating that the sides of the coffin were also decorated. These tacks must have secured leather or some type of fabric wrapping on the coffin. The coffin was hexagonal and held together

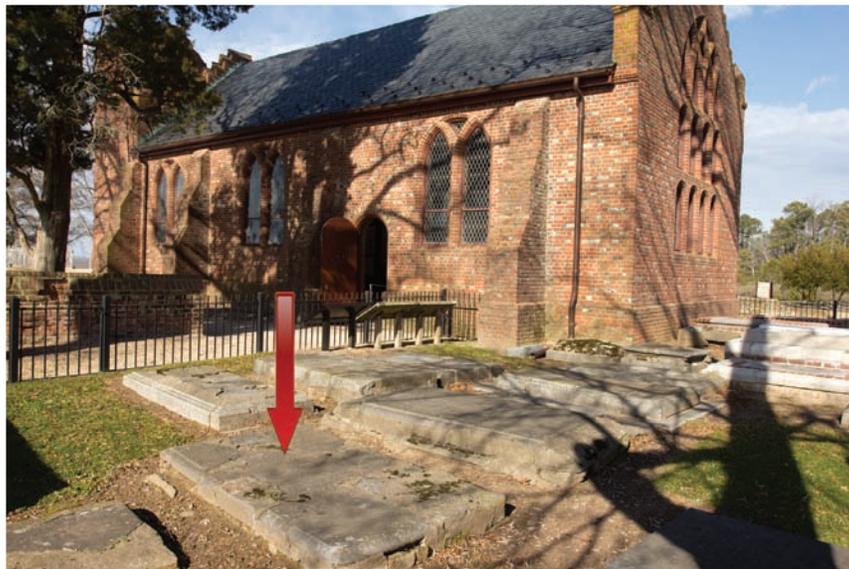
Figure 126. Remains of misplaced Phillip Ludwell II's tombstone

Ludwell's partially reconstructed tombstone is now located 10' to the south of his actual burial. It likely was laid at that location in 1901 when those excavating the burial ground found the pieces and reconstructed it. The churchyard was in absolute shambles in 1901, and it appears from the following description by Mary

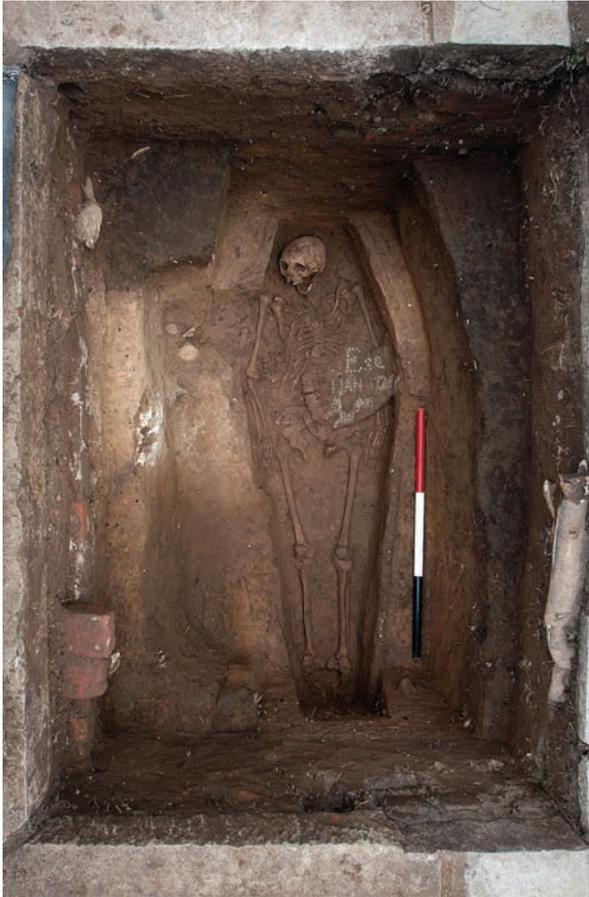
Figure 127. Ludwell's skeletal remains with in situ copper tacks

Analytically, the skeletal remains found in the coffin, JR2743C, have the attributes one would expect: a European male, who could very well have been 54 years old at the time of death.<sup>8</sup> The extended skeleton was well preserved, with the individual's head in the western end of the grave shaft. Two brass straight pins were found on and around the skull. One was found on the mandible and the other on top of the cranium. A copper stain, from what likely had been a third copper pin, was found on the right clavicle, but this bone was dislodged in 1901 and no pin was recovered. These pins may have been part of a face cloth or a chin cloth to hold the individual's jaw shut in preparation for burial. The individual's fourth finger, or pinky finger, appears to have been lost in life with both the right middle and distal phalanx missing. However, many of the fingers were missing the distal phalanx from decomposition. In order to uncover the feet, it was necessary to dig a small tunnel into the eastern end of the excavation shaft. Subsoil was under the skeletal remains. The bones were removed for analysis by the Department of Anthropology, National Museum of Natural History, Smithsonian Institution.

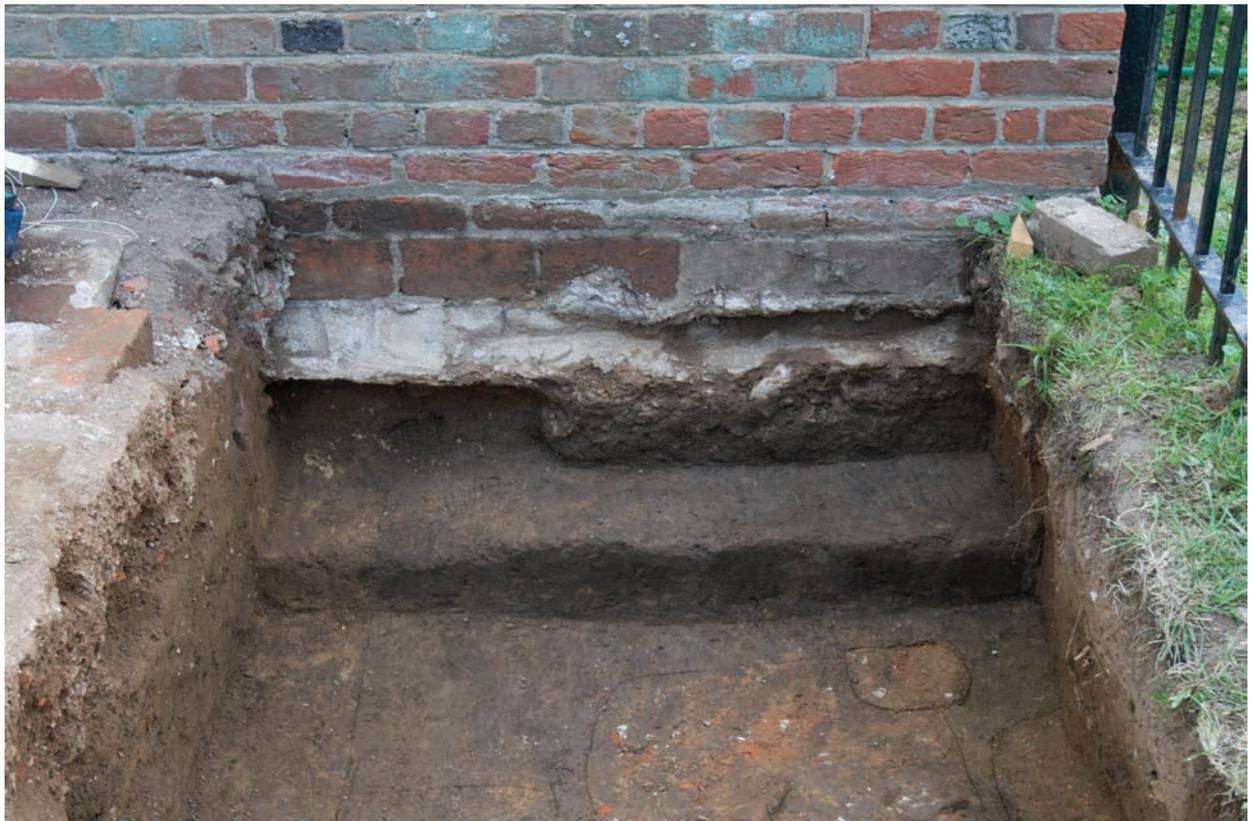
Figure 131. View of the Memorial Church foundations (facing west)

Excavations in the far western end of the unit exposed the 1907 Memorial Church foundation one foot below grade. The base was composed of an oversized footer of brick and portland cement. Fill composed of topsoil mixed with construction rubble (JR2609C) was found beneath this footing. The intact Virginia Indian midden (JR2609D) that had been encountered in tests around the churchyard and delineated cemetery was found below.

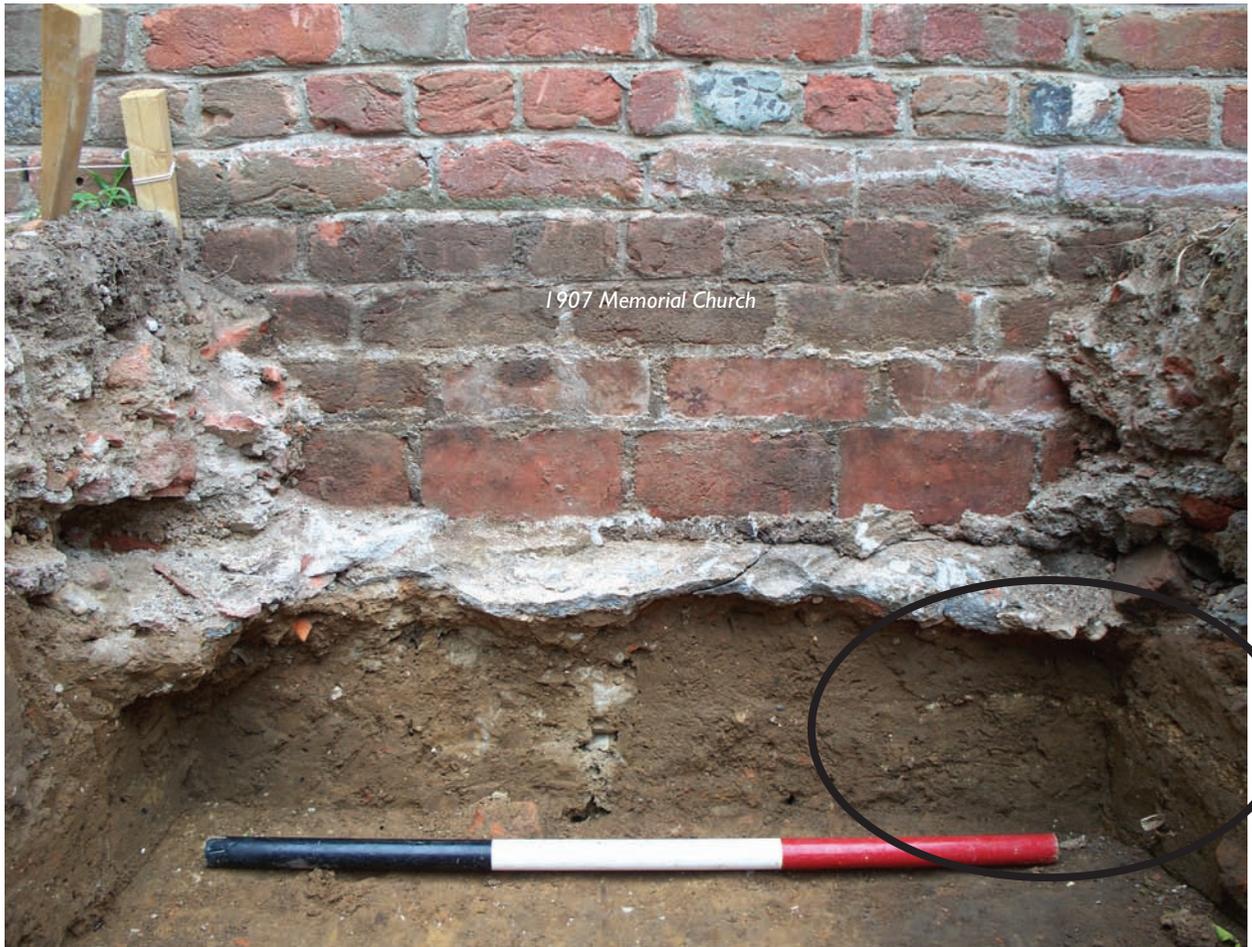
Figure 134. View of Memorial Church foundations and sand mortar band, as indicated by black oval (facing west)

This unit also extended to the foundations of the 1907 Memorial Church. The foundation was made of portland cement and only four courses of brick were found below the ground surface. One notable difference between this section of foundation and the

section exposed by test JR2609 was that the fill below the reconstructed wall consisted of a stratified band of rubble, sand mortar, and floor tile fragments. This suggests a post-1901–06 date (construction of the Memorial Church), or, if intact, the possibility of a layer dating to one of the iterations of the historic churches.

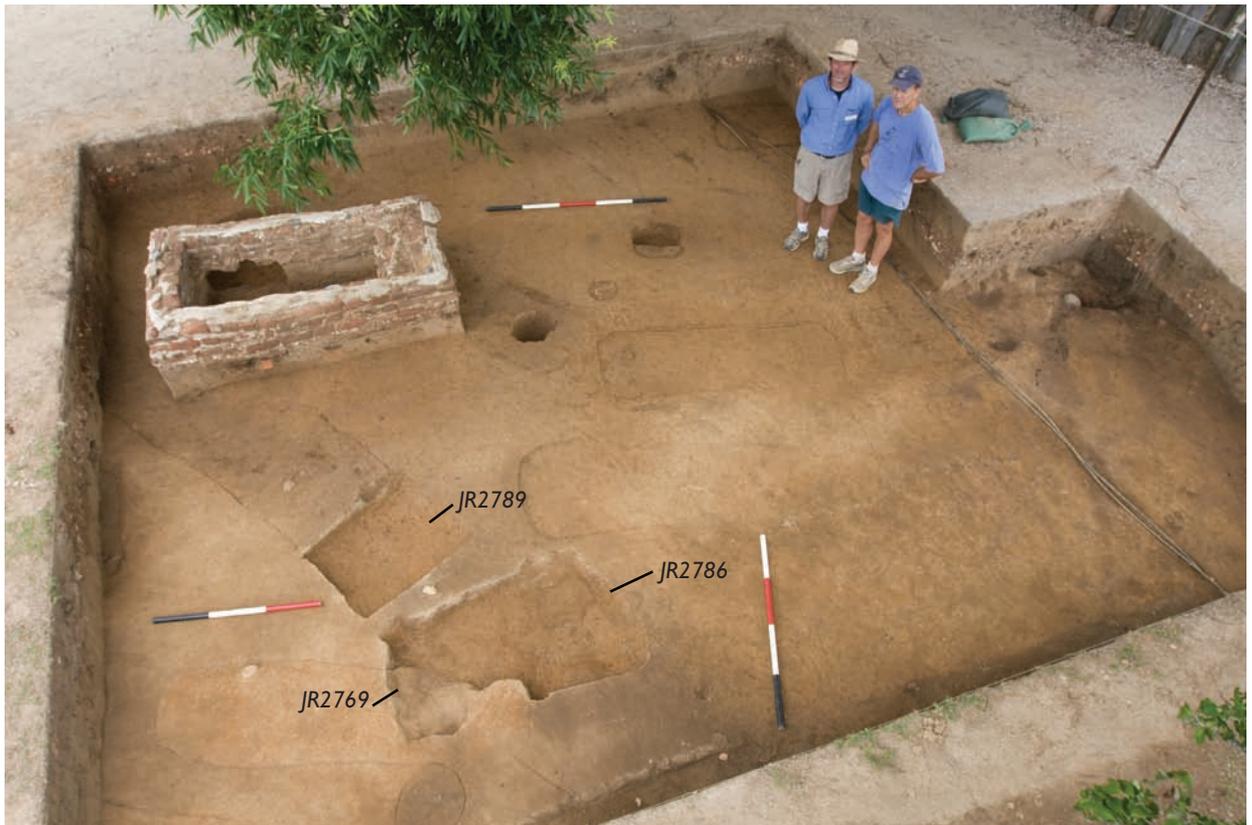
Figure 136. Overview of south churchyard excavation area (facing north)
