DESCRIPTION AND ANALYSIS OF STRUCTURE 144

Report to
APVA JAMESTOWN REDISCOVERY

Cary Carson, Willie Graham, Carl Lounsbury, and Martha McCartney
Colonial Williamsburg Foundation Research Division
20 August 2002

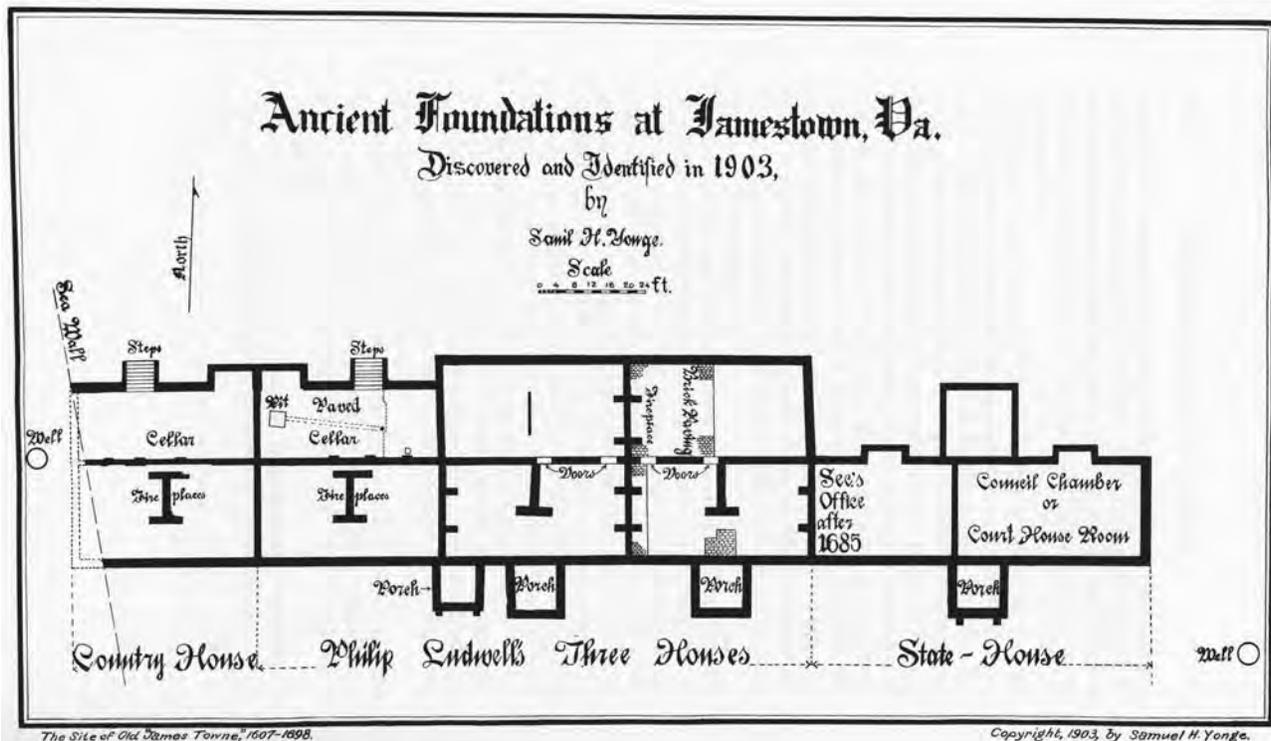
Archaeological plan of the Ludwell Statehouse Group as uncovered and interpreted by Colonel Samuel Yonge in 1903. Published in Yonge, "The Site of Old 'James Towne,' 1607-1698," Virginia Magazine of History and Biography, July 1904.

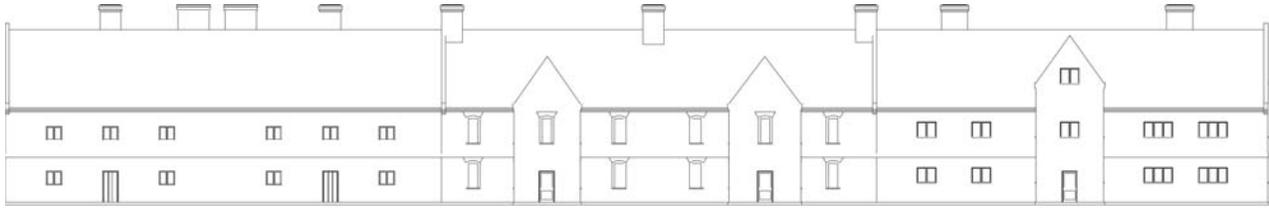
Reconstructed south elevation of Structure 144 as it might have appeared before final destruction in 1698. It is likely that House 2 remained in ruins after Houses 3 and 4 were rebuilt about 1694. Drawing by William Graham, Jr.

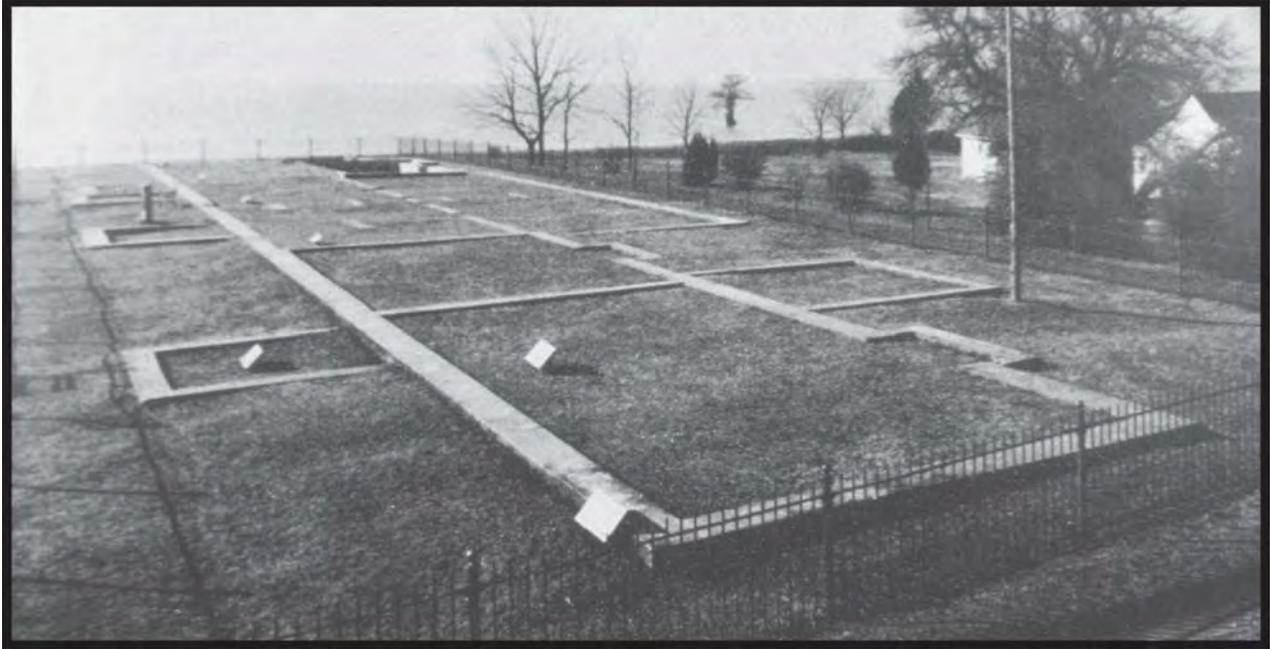
Foundations of the Ludwell Statehouse Group outlined with a concrete cap. Photograph, plate 11 in John Cotter, Archaeological Excavations at Jamestown, Virginia, (1958).

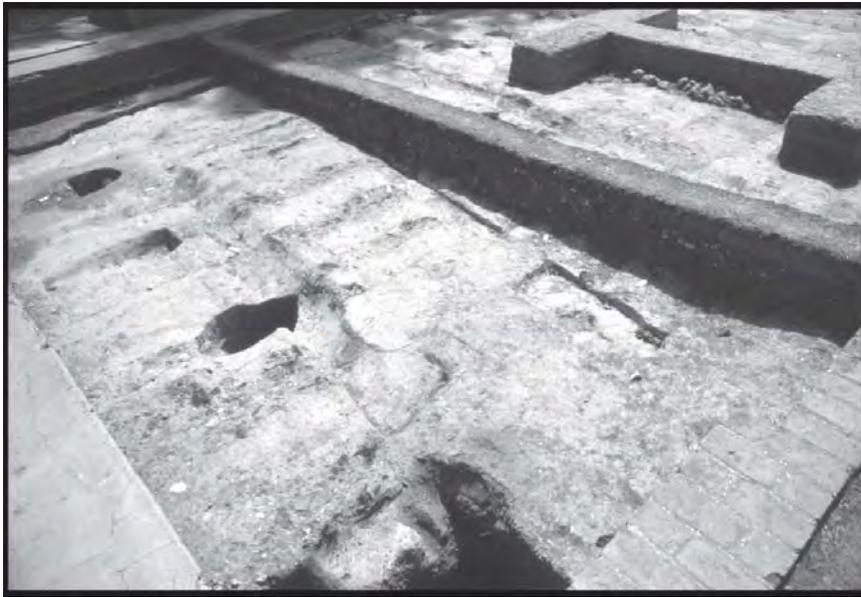
Foundations of House 2, looking southwest. Note the remains of floor joists in the foreground with two excavated holes cutting through them. Photograph by Willie Graham, 2001.

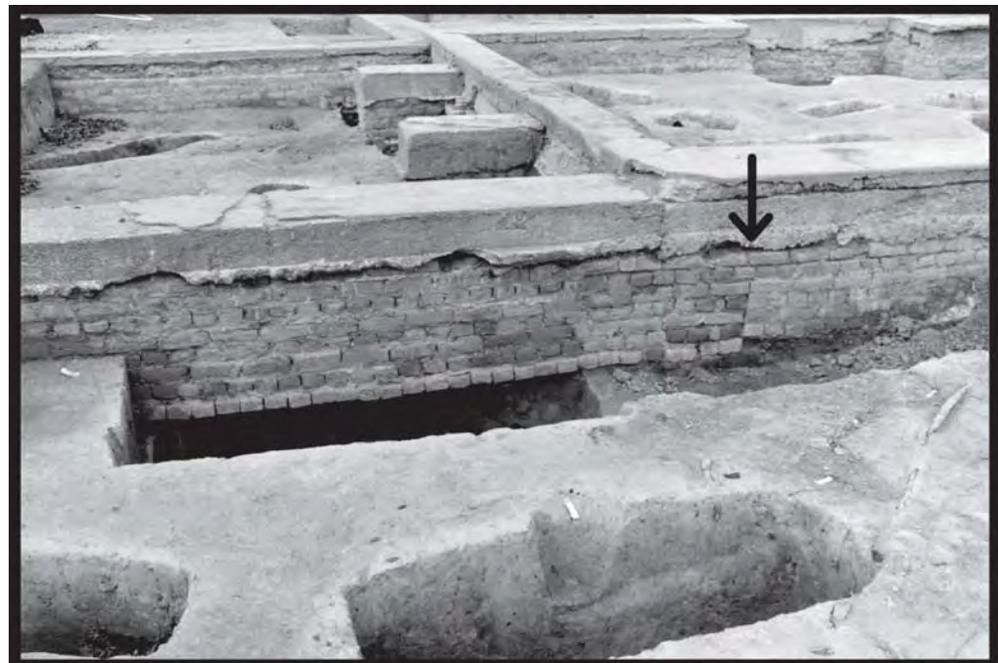
View looking north at foundations of House 5 to the right where it abuts that of House 4. Graves in foreground predate the building, including one beneath foundations of House 4. Lower row of bricks for that wall is slightly stepped, unlike the treatment for House 5. Photograph by Carl Lounsbury, 2001.

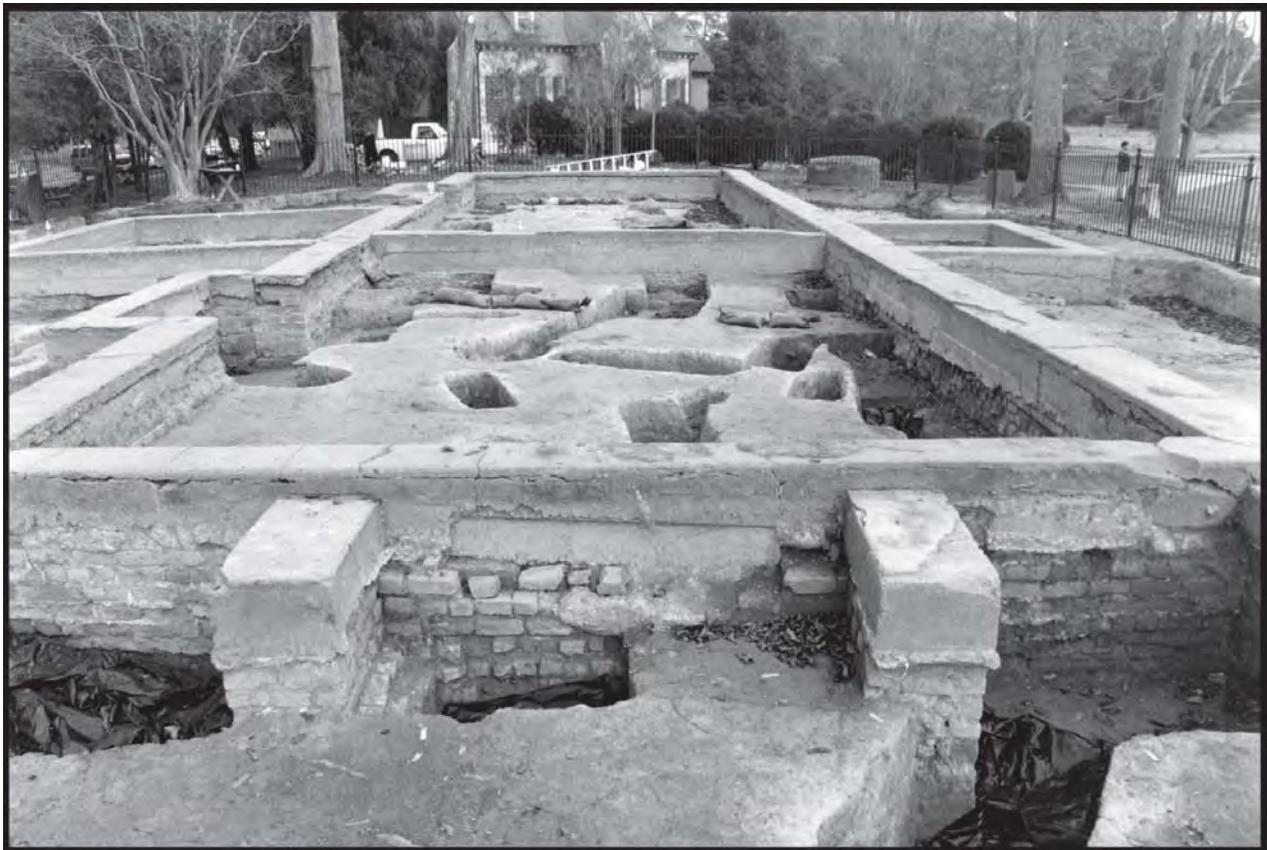
The same pattern of internal changes occurred in House 4. Archaeological investigation of the *View of east chimney of House 4, with House 5 in background. This chimney was added at a later date; its cheeks do not bond into the gable wall of House 4 and its mortar matches other later alterations.* Photograph by Carl Lounsbury, 2001.

chimney base on the east wall of House 4 reveals that it was not bonded into that end wall, confirming that it was a later addition. Any evidence for a similar pair of scaffold holes outside the east wall of House 4, which would be situated inside the western room of House 5, did not materialize in the recent

excavations, which suggests that the construction of the east chimney of House 4 may have had to take into consideration the presence of House 5 at the time in a way that was unnecessary for House 2. This east gable-end chimney that abuts House 5 had a hearth made of gauged-and-rubbed bricks. With the exception of some bricks found within the original fort that may have had an industrial application and date to c. 1610, the first rubbed bricks that have been recorded in the Chesapeake are from the tower of St. Luke's (Newport Parish) Church in Isle of Wight County (c. 1682). The first use of gauged brick that has been observed is at the College of William and Mary (c. 1695-97). It could be argued that the hearth was re-laid late in the century. However, if not, then the gauged brickwork indicates a late seventeenth-century date for the alterations to Houses 3 and 4. Although Colonel Yonge indicated that House 4 also had brick paving in the western front room and the west back room of the addition, recent investigations suggest that Yonge misread the evidence and that no such paving existed in these two rooms.

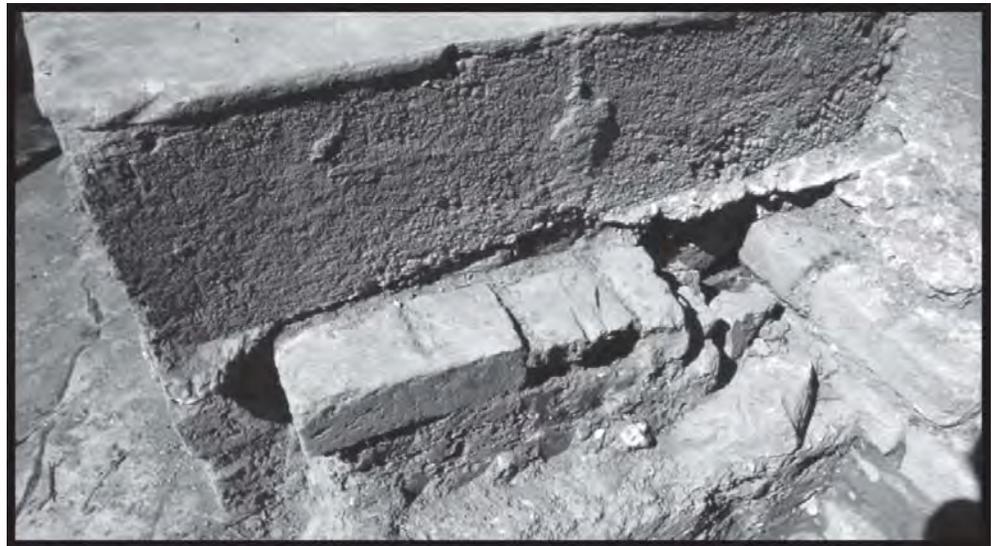
Detail of rubbed hearth brick, east chimney, House 4. Photograph by Willie Graham, 2001.

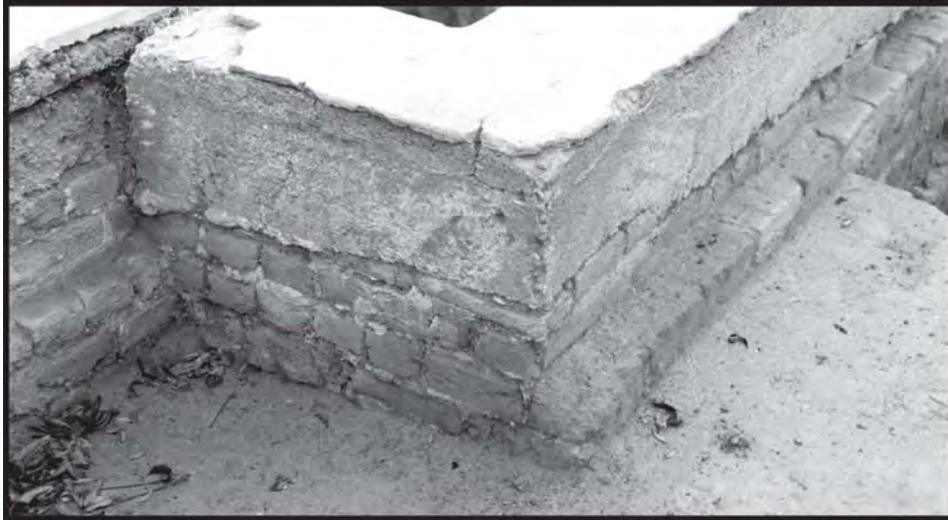
West chimney, House 5. Note the stepped watertable on the north wall and chimney base. At this end of the row, the water table on the main wall would have barely been exposed, while that on the chimney must have been hidden. Photograph by Carl Lounsbury, 2001.

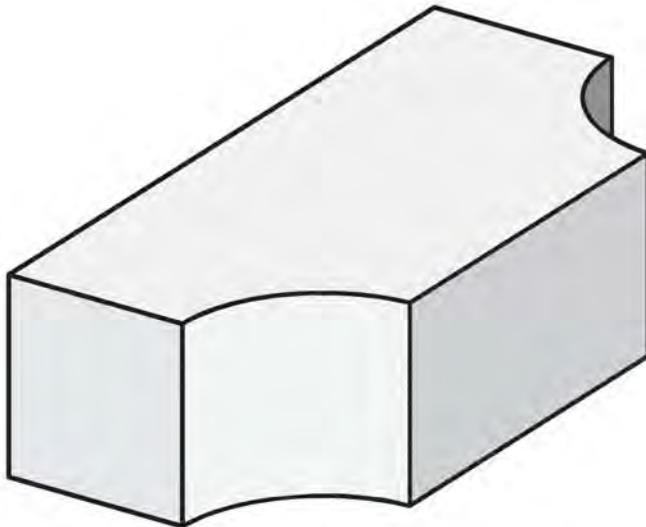
Mullion brick recovered from the site of House 5. This brick measures 8 1/2" by 4 1/8" x 2 1/2". It was originally painted with a red limewash, including the mortar.

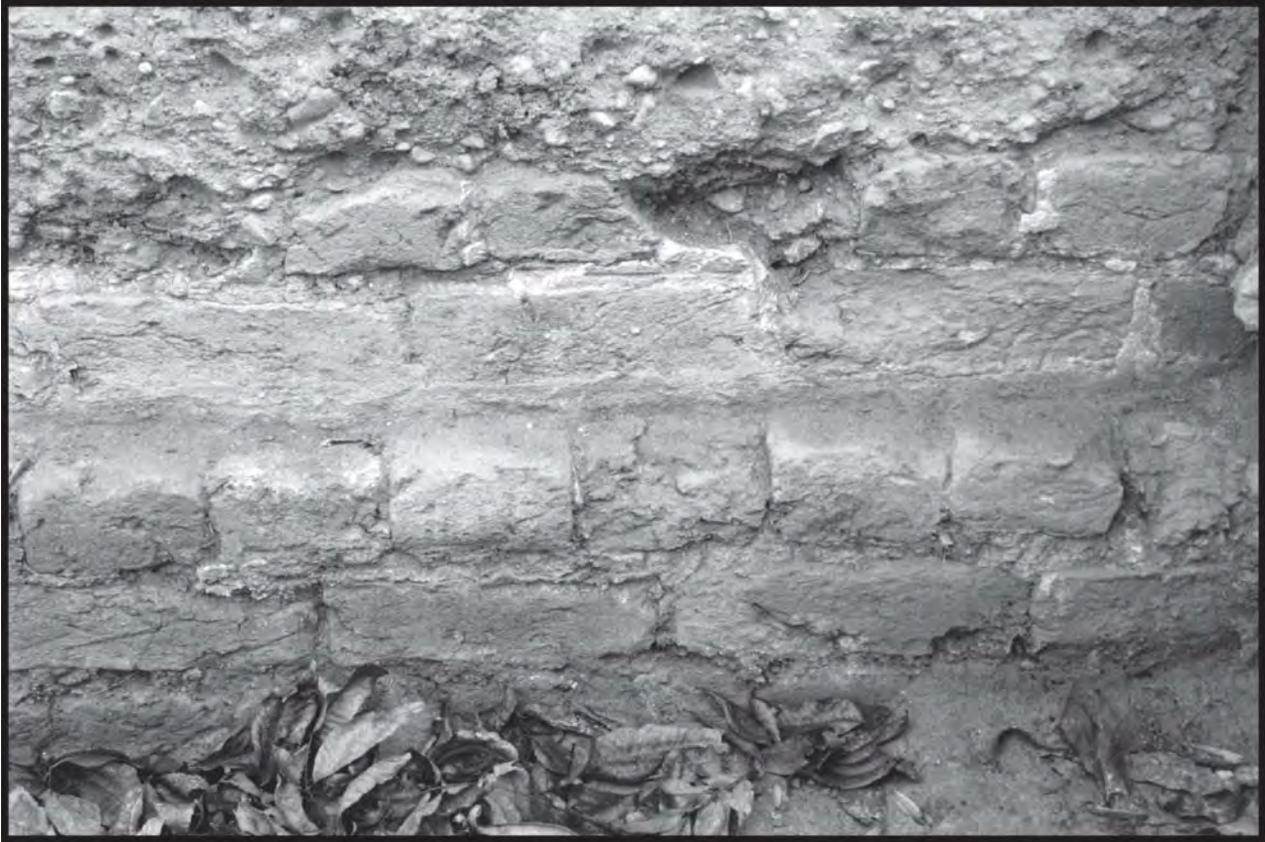
Foundations of House 5, east of west chimney. Note the remains of grapevine joints. Joints were painted with the same red wash as the brickwork, applied before the mortar had dried. Photograph by Carl Lounsbury, 2001.

Above the watertable, the walls were laid in irregular English bond. On the north face of the foundations at this level, there are finished or tooled "grapevine" mortar joints typical of the mason's repertoire in this region from the seventeenth through the late eighteenth century. John Page's house, built in 1662 at Middle Plantation, had struck mortar joints, as did Bacon's Castle (1665) in Surry County. Samples from the finished mortar joints of House 5 analyzed by Susan Buck revealed the mortar and bricks were painted with a reddish finish consisting of pigments in a binder. A door- or window-jamb brick with cavetto-shaped corners found in the 1950s and associated with House 5 was painted red on its exterior face, providing further evidence for the building being painted. Evidence from House 3

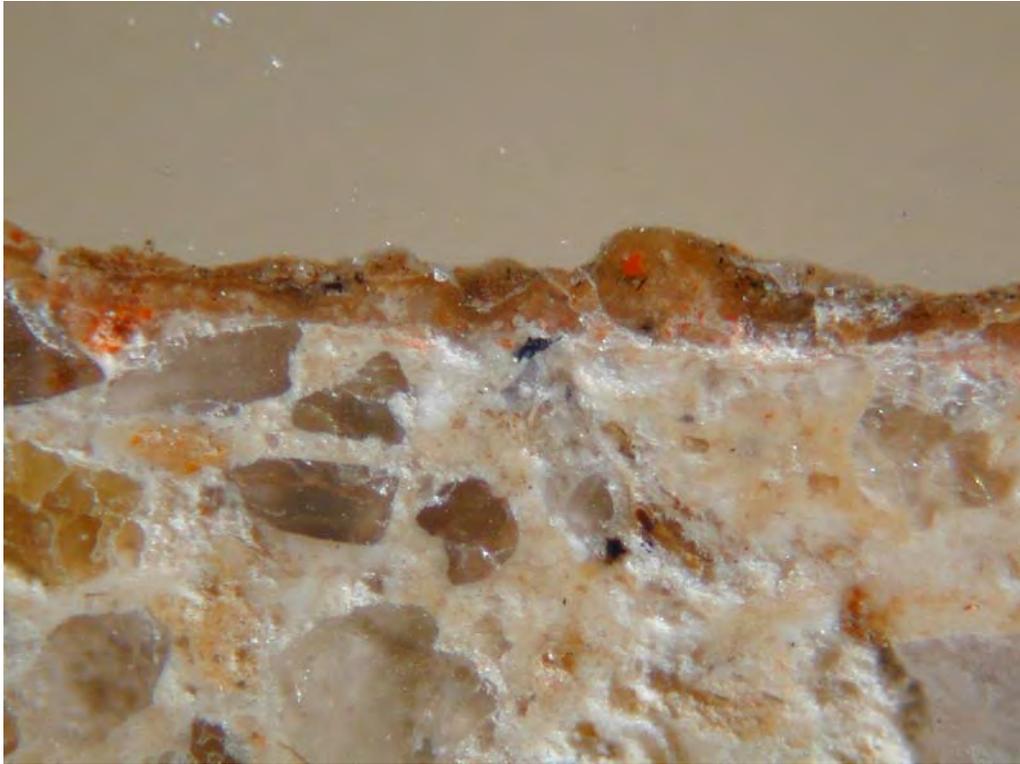
Photomicrograph attached to email “ Jamestown house 5 mortar sample,” Mark Kutney to Carl Lounsbury, 4 April 2002 showing what appear to be a pigmented coating on the mortar.

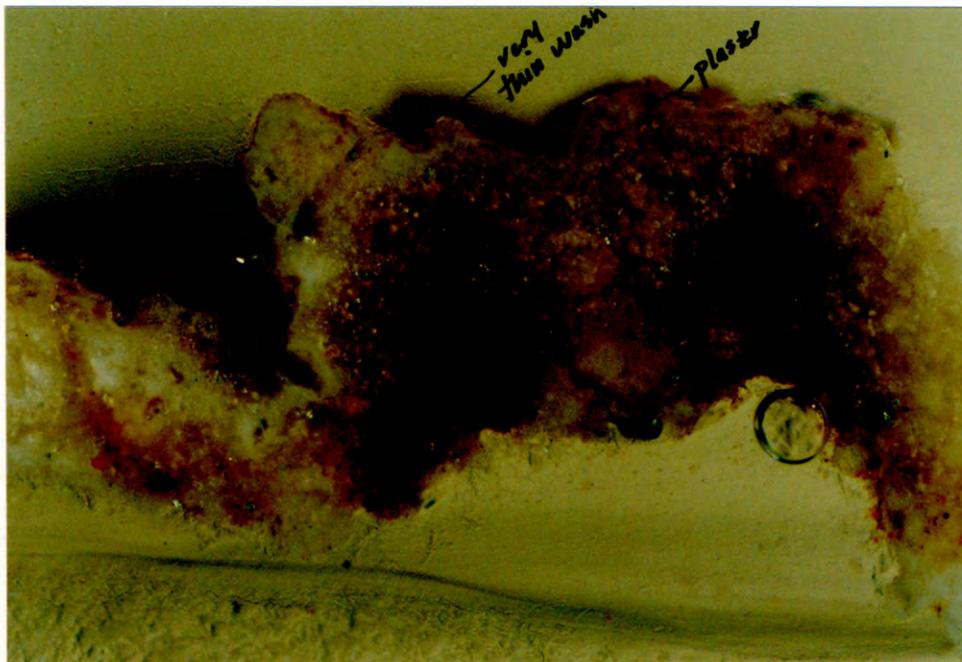
Sample 2. Structure 144, Building 5. Cavetto window jamb brick; pinkish wash, A-1055. In cross-section under reflected visible light there is no readily discernible coating on the brick substrate. However, under reflected ultraviolet light there is a thin light red or pinkish paint layer on the surface of the brick. This coating flowed into the crevices and interstices of the original brick surface and there is no dirt trapped between the coating and the substrate, suggesting the coating was applied before the brick became weathered. The coating is composed of white and red pigments which were identified as calcium carbonate and red ochre using polarized light microscopy. This limewash layer is very similar to the coating identified in sample 4 from building 3. (See page 11.)

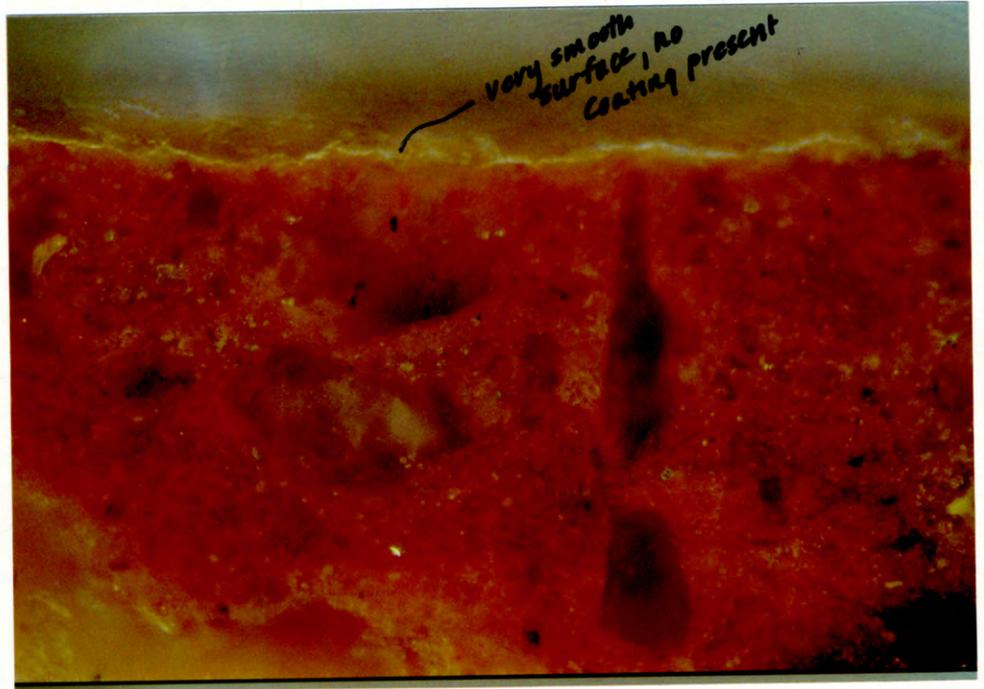
Visible Light 125X

Sample 3. A-15334, J-26509. Building 3. Smooth orange layer along edge of brick.

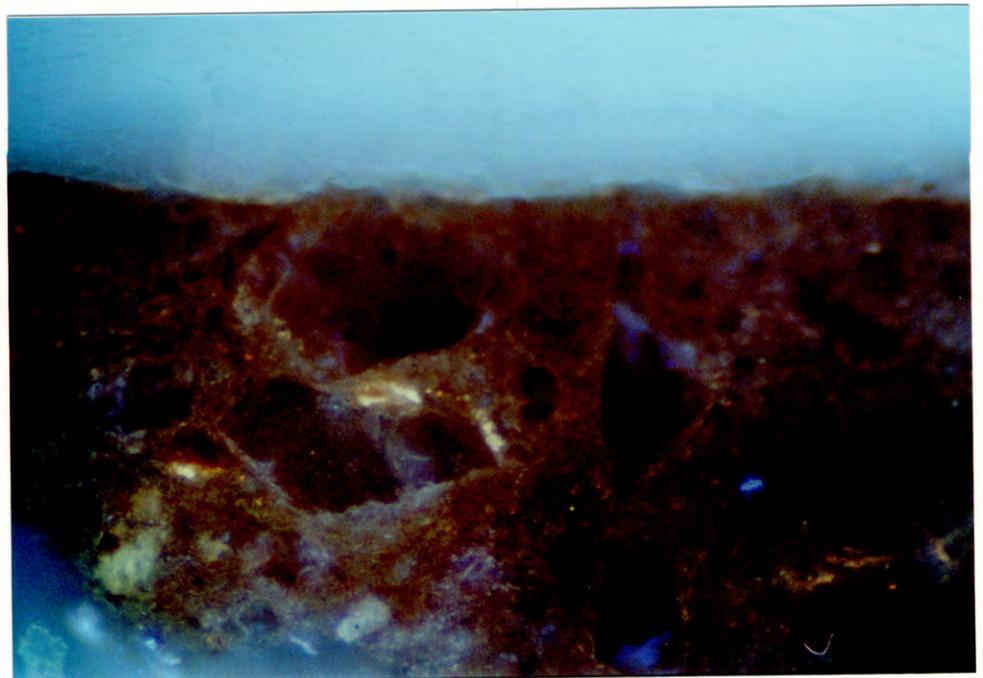
Sample 4. JR5019A plaster. Building 3. Limewash (?) on surface of brick. The layer on top of the brick is somewhat uneven and disrupted, but the cross-section evidence indicates the brick was originally coated with a pigmented limewash. There is no dirt on the surface of the brick that would suggest exposure to weathering before the paint was applied. There are red ochre pigments irregularly dispersed throughout the calcium carbonate-based limewash layer suggesting it was deliberately pigmented, perhaps to produce a pink or light red wash. This coating is very similar to the pigmented limewash coating found in sample 2 from building 3. (See page 6.)

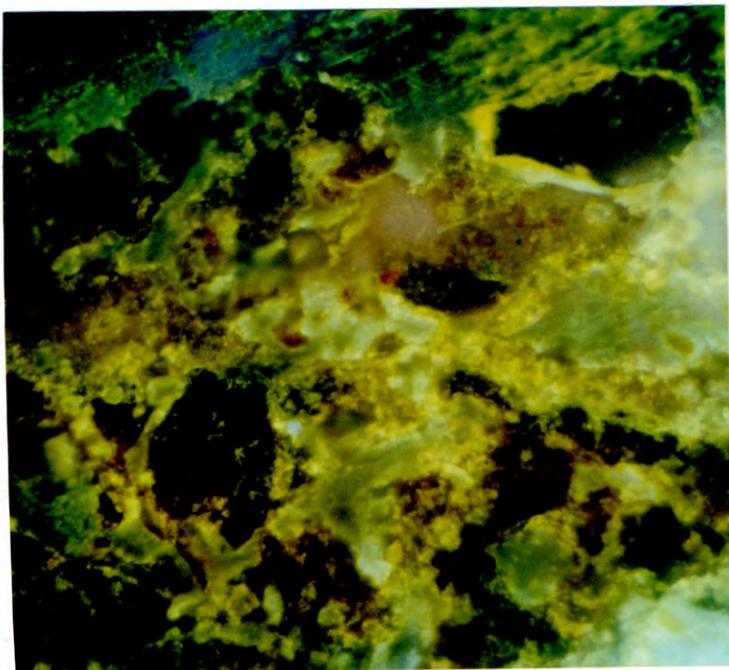
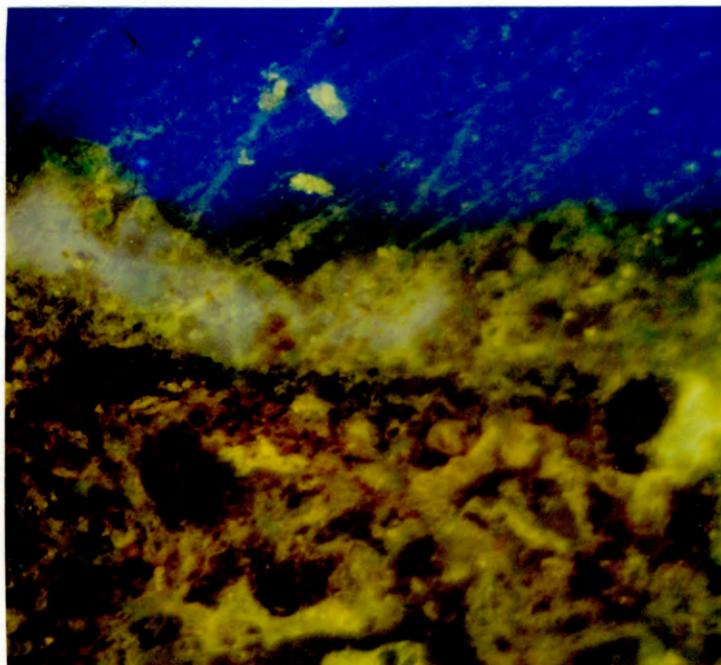
Sample 5. JR5019A plaster. Building 3. Grayish plaster with white drip (limewash?) on surface. It was difficult to determine the nature of this material because of its degraded state, but at 30X magnification it initially appeared to be a gray-pigmented plaster (or perhaps a coarse gray limewash), with at least one layer of unpigmented limewash on top of it.

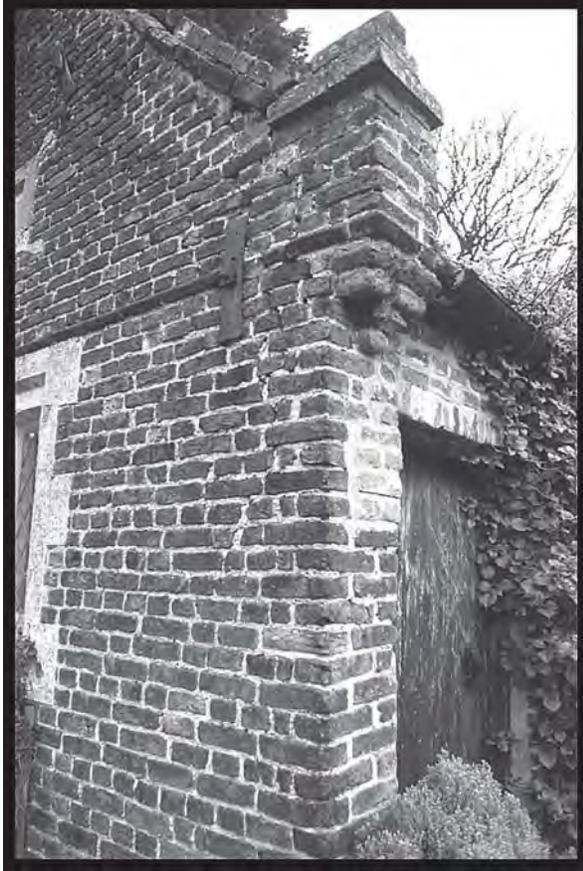
Detail of decorative corbelling supporting a straight parapet on the Little Thurlow Almshouse (1618), Suffolk England. Photograph by Willie Graham, 2001.

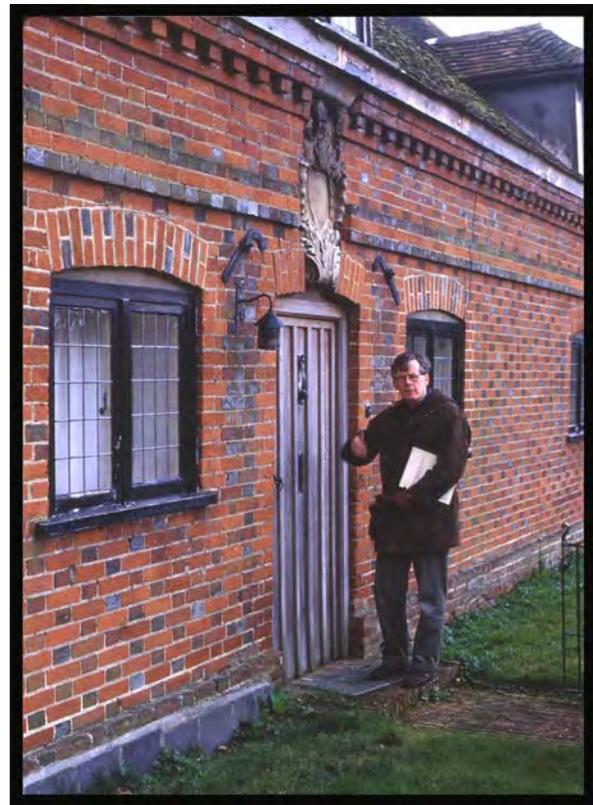
Above: Cottered Almshouse (ca. 1700), Hertfordshire, England. Note the use of all-glazed header Flemish bond and the decorative glazing pattern in the arches, cornice and stringcourse. Photograph by Willie Graham, 1994. Below: reconstructed façade of Arlington (ca. 1676), Northampton County, Virginia. Designed by Cary Carson; model built by Terry Ammons, 1999.

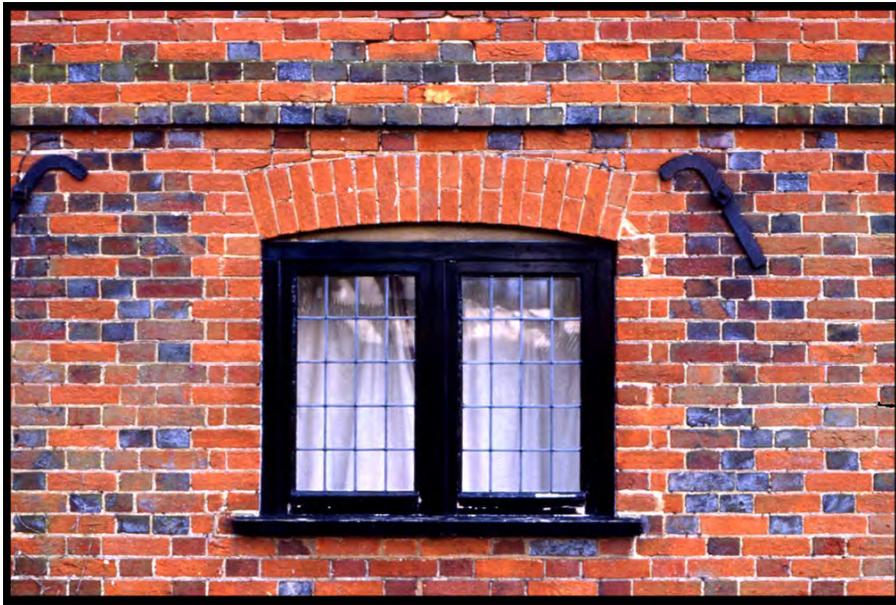
Cottered Almshouse (ca. 1700). By the end of the seventeenth century, masons were skilled in the use of manipulating color in brick walls. Note the lighter, rubbed work around the window and the decorative placement of glazing in the wall and stringcourse. Photograph by Willie Graham, 1994.

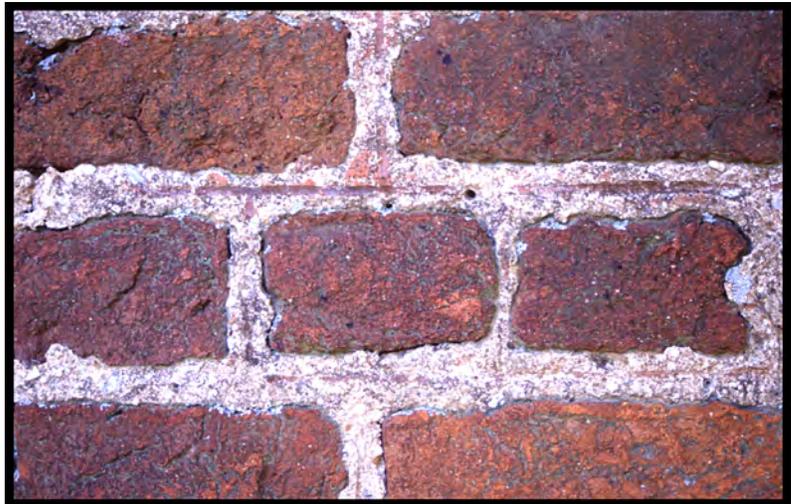
Detail of painted mortar joints and brickwork at Bacon's Castle (1665) in Surry County, Virginia. Paint analysis by Susan Buck revealed that the masonry was given a red wash from the outset, before the mortar had time to cure. Photograph by Willie Graham, 2002.

paint was applied to the entire exterior brickwork before the mortar had fully cured indicating that the building was coated from the outset. The wide mortar joints and variegated bricks were disguised beneath a uniform red finish that gave the surface of the building a superficial regularity that exceeded the best workmanship of the period.⁶ Perhaps the deep red of the brick walls was intended to contrast with the lighter color of the lugged surrounds of the second floor and the rendered work around the front entrance (now destroyed).

After discovering paint evidence at Bacon's Castle, masonry at House 5, Structure 144 was examined where the north exterior wall survives a few courses above the water table. A sample from this area revealed that it had been painted like Bacon's Castle. Red pigments were discovered in the mortar of the finished mortar joint. A surviving cavetto window jamb brick from the building that had been recovered during the 1950s excavation also had evidence of red paint on its surface. In addition, evidence from House 3 indicates that other sections of the row were painted as well.⁷

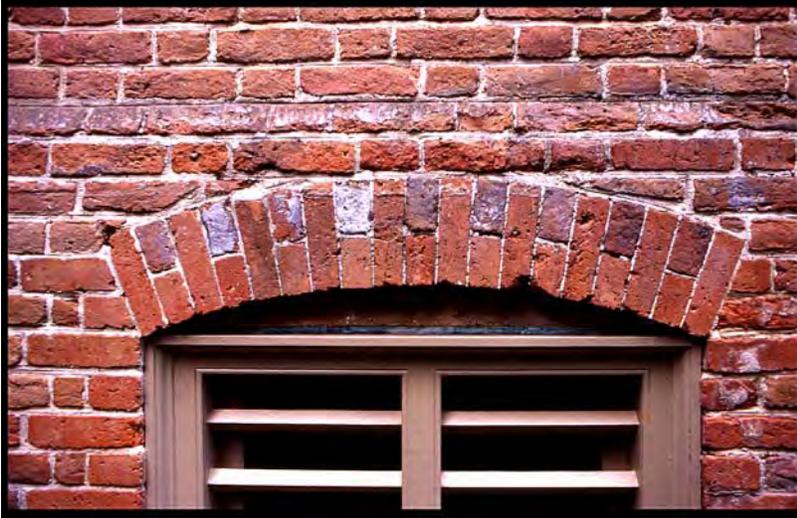
College of William and Mary, Williamsburg, Virginia. The brick walls were laid between 1695 and 1697. Although lightly glazed bricks have been randomly dispersed throughout the walls, headers have been deliberately picked out in the cellar arches. Note that the water table and the course below it have been rubbed. Photograph by Willie Graham, 2001.

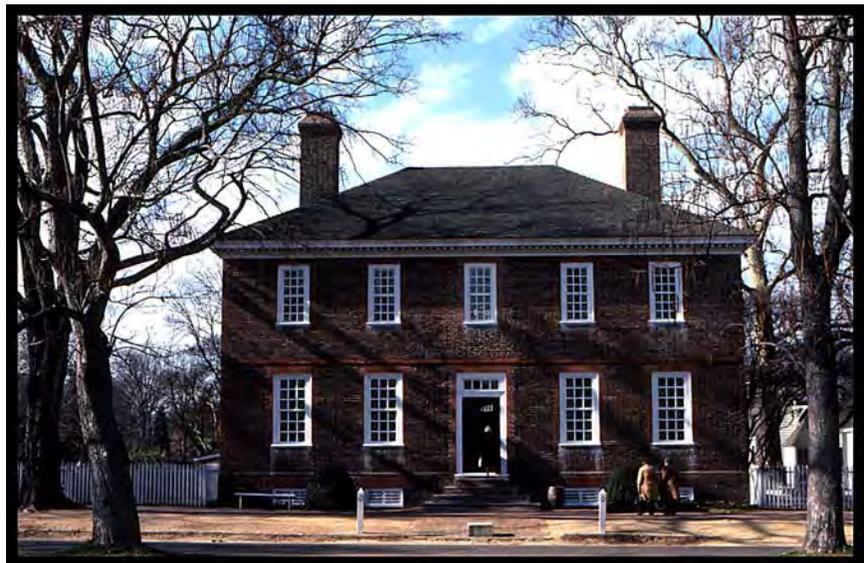
George Wythe House, Williamsburg, Virginia. By the third quarter of the eighteenth century, Virginians began to prefer a more restrained appearance to their brickwork, and glazing was often eliminated from primary façade. Photograph by Willie Graham, 1983.

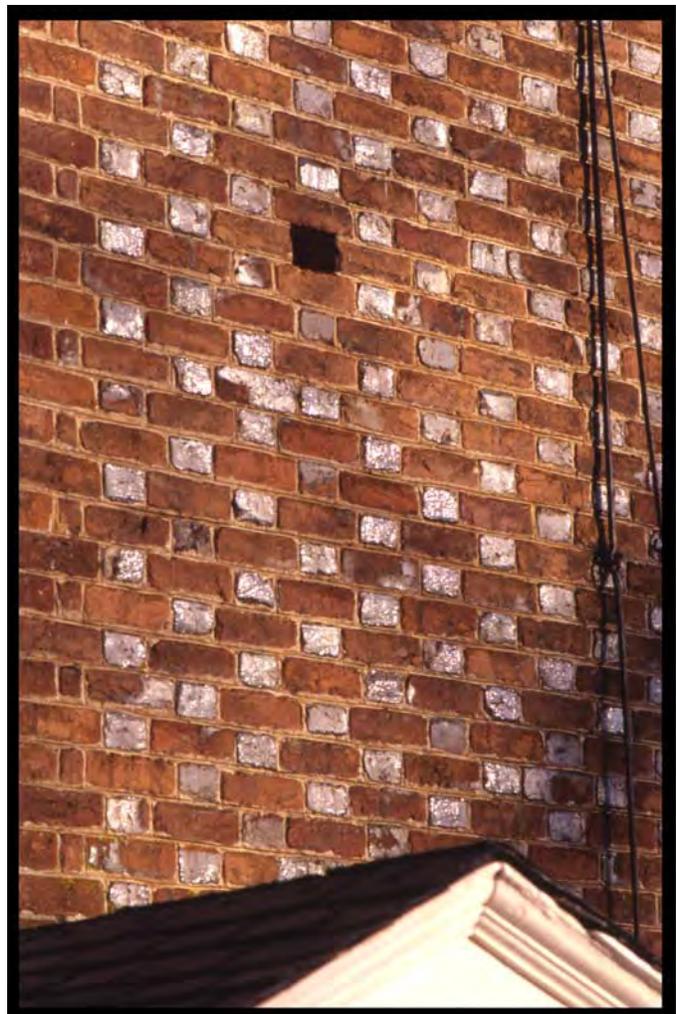
All-glazed header Flemish bond brick gable at Tuckahoe, Goochland County, Virginia, dating to about mid century. Photograph by Willie Graham, 1998.

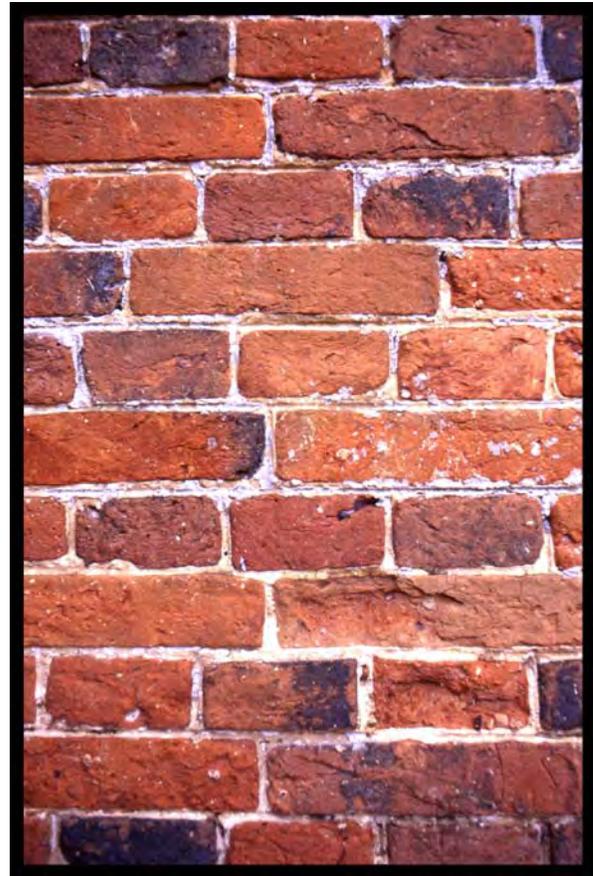
Late seventeenth-century English bond brickwork on the principal elevation of Dun Cow, Swainsthorpe. Note the ruled mortar joints.

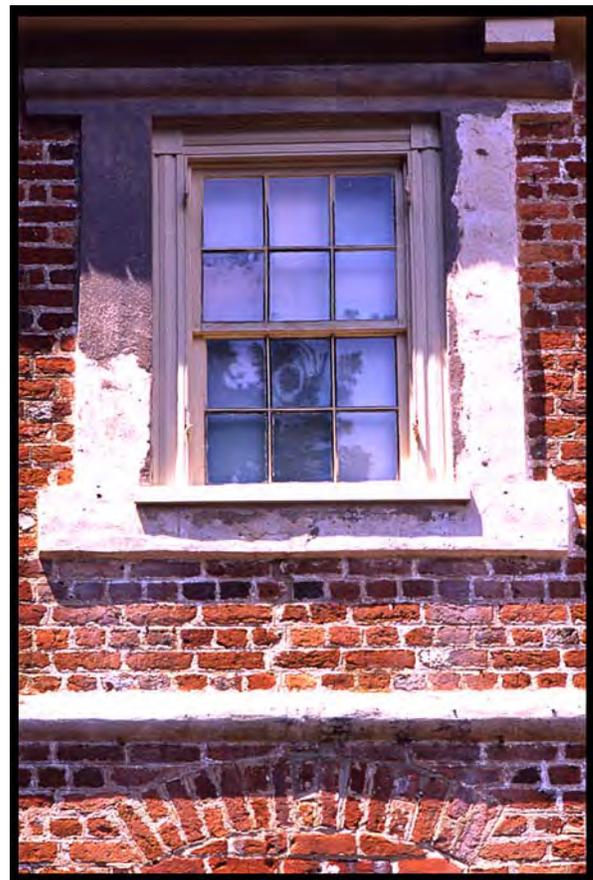
Above: detail, front façade of Ravensmere (1694), Beccles, Suffolk, England. This finely crafted stringcourse has a molded top and bottom course, is made of precisely gauged-and-rubbed brick, and stops short of the corners. Note also the use of carefully chosen orange stretchers and contrasting black, glazed headers arranged in a Flemish bond pattern for the wall. Photograph by Willie Graham, 2001. Below: Molded and stuccoed stringcourse at Bacon's Castle in Virginia. Photograph by Willie Graham, 2001.

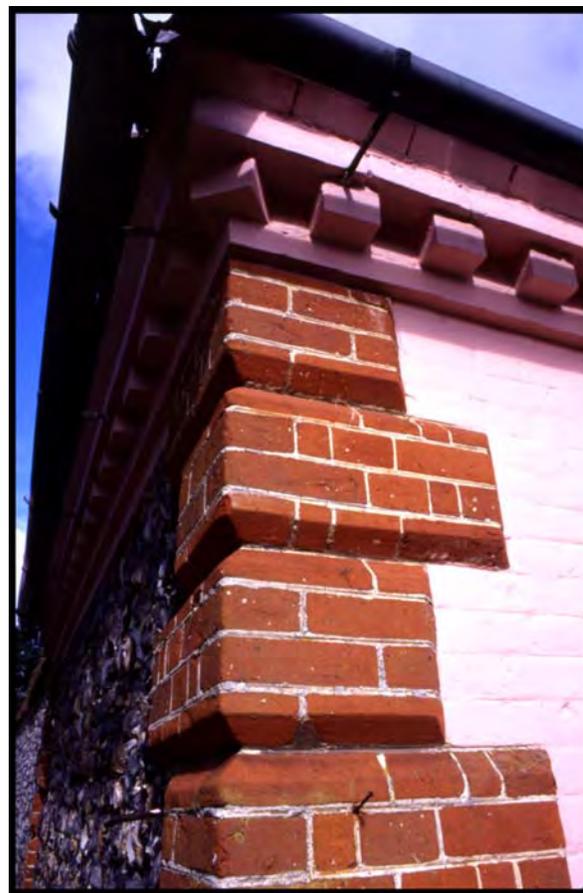
Brick modillion cornice and carved gauged-and-rubbed quoins, Ampton Almshouse (1693), Suffolk, England. Photograph by Willie Graham, 2001.

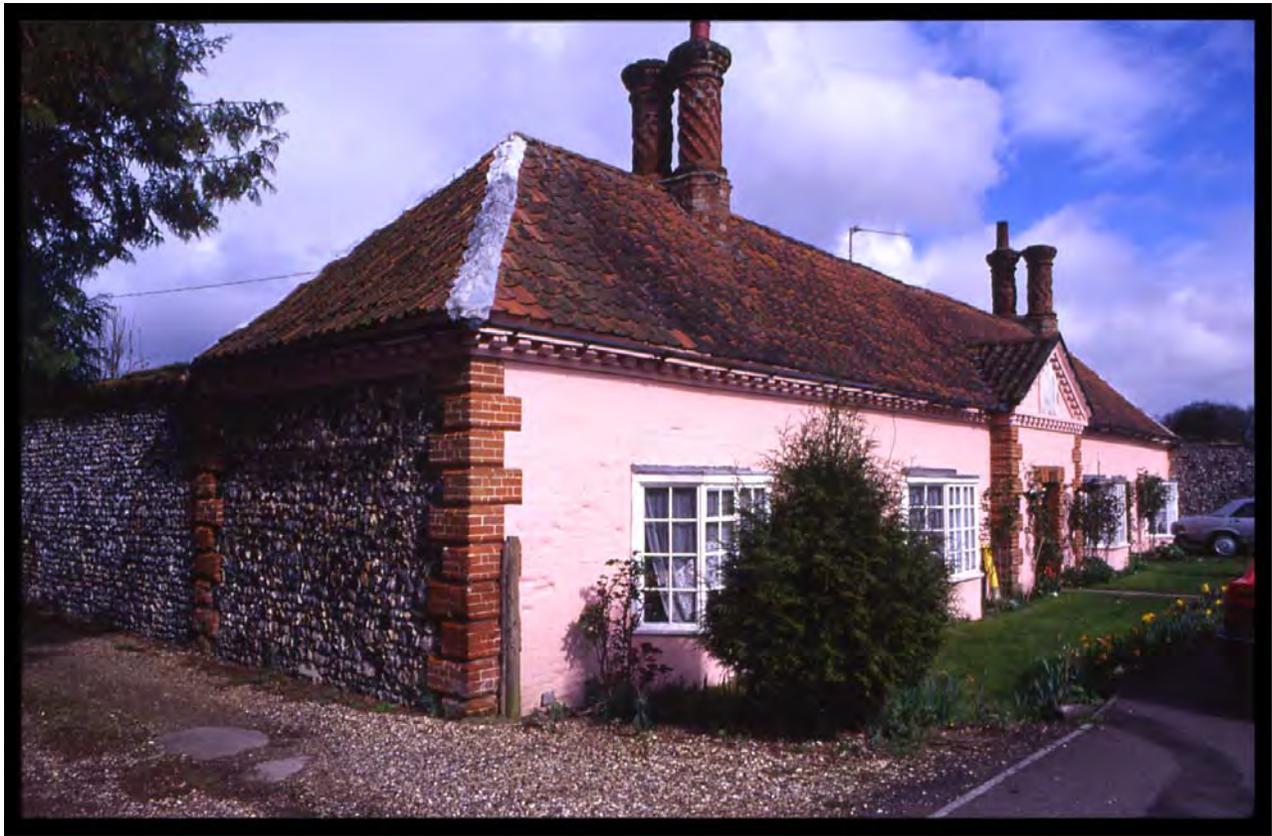
Ampton Almshouse. Carved, rubbed, and gauged bricks were used to create the quoins on this 1694 building. Hipped roofs were become fashionable at this time as shaped gables waned in popularity. Note the flint gable and the twisted chimney stacks, the latter of which were hopelessly out of date by this time. Photograph by Willie Graham, 2001.

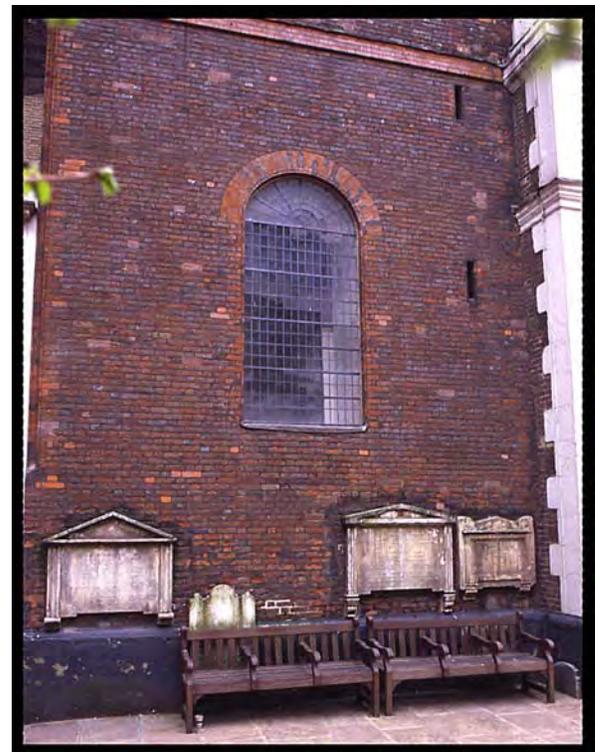
St. Peter upon Cornhill (1677-84), London. Designed by Sir Christopher Wren. Note the use of rubbed work in the stringcourse, surrounding the window, and at the corner. Heavy quoins, as used at places such as the Black Horse Inn, have been eliminated, but Wren has still had the corner sculpted with carved brick. Photograph by Willie Graham, 2001.

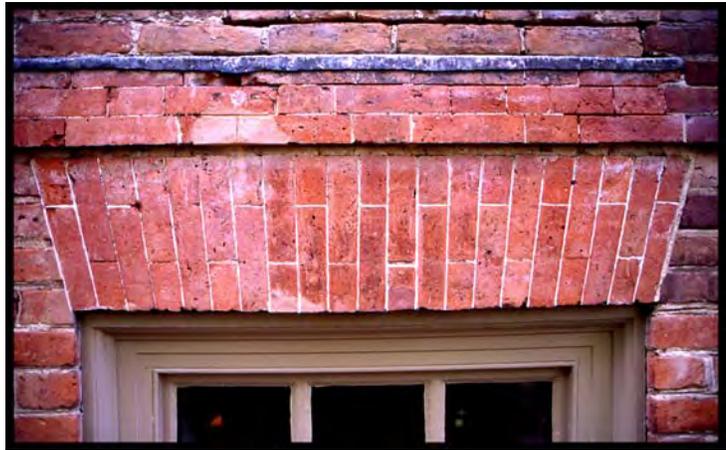
Although wide openings for casements were initially laid out at the College of William and Mary when work began in 1695, workmen were immediately directed to switch the proportions for installation of sash windows. Above cellar level, gauged-and-rubbed jack arches spanned the openings, here seen tucked beneath the stringcourse with its lead capping. Photograph by Willie Graham, 2001.

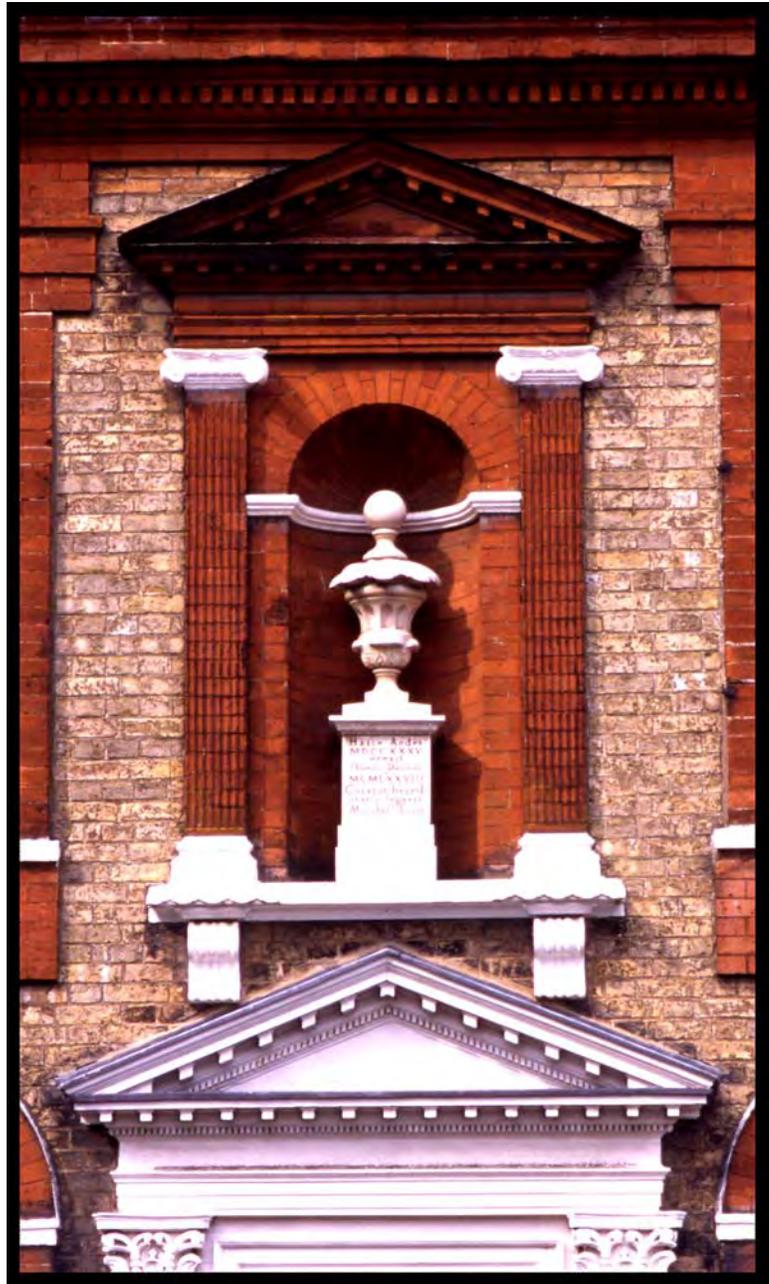
Thomas Sherman House (1735), Dedham, Suffolk, England. Carved gauged-and-rubbed work is used in this eighteenth-century house to contrast with its yellow wall brick. Photograph by Willie Graham, 2001.

earliest known example. The arches are carved bricks, made to appear as voussoirs, and the jambs are laid as quoins. The nature of carved work lent itself to being rubbed in order to regularize its surface and to remove blemishes. By gauging the bricks, joints could be laid more tightly (with 3/32 inch often used as the tolerance). Gauged bricks allowed for a more

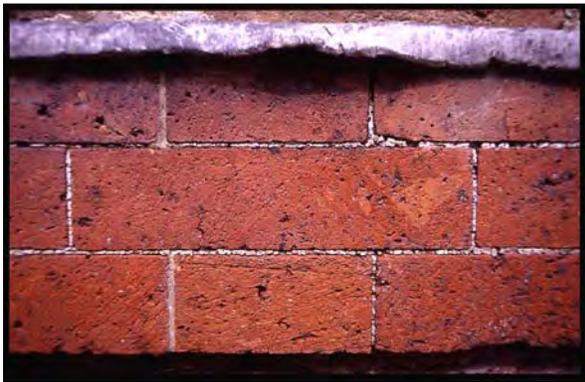
Detail of the stringcourse at the College of William and Mary (1695-1697). Mortar joints average 3/32". The lead capping, which is largely original, was originally painted red. Photograph by Willie Graham, 2001.

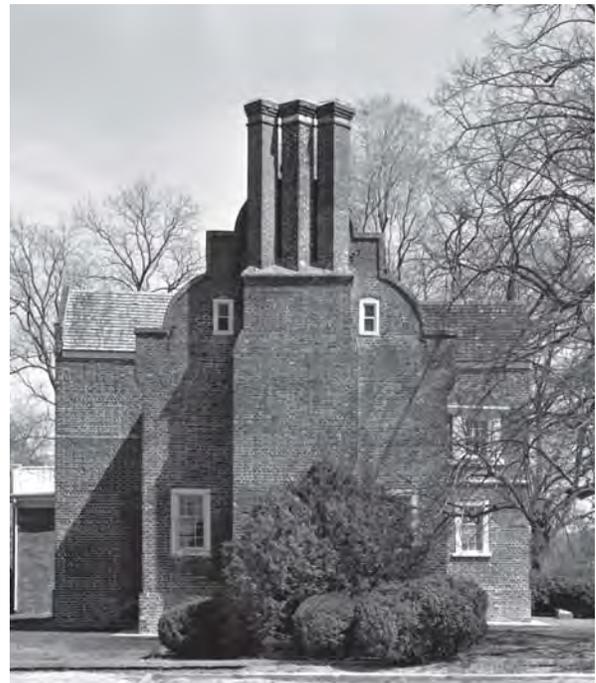
Bacon's Castle (1665), Surry County, Virginia. The curvilinear gables are partially masked by exterior chimneys with their triple, diamond-set stacks. Photograph by Willie Graham, 1991.

Shaped gables migrated to the colonies in the seventeenth century—Bacon's Castle (1665) in Virginia, being perhaps the most familiar early building to survive with them. They appeared in Boston in the Province House of the 1680s as well as in Dutch-influenced colonies such as New York and New Jersey. The Caribbean saw its share of shaped gables such as at St. Nicholas Abbey in Barbados (third quarter seven-
