DESCRIPTION AND ANALYSIS OF STRUCTURE 144

Report to
APVA JAMESTOWN REDISCOVERY

Cary Carson, Willie Graham, Carl Lounsbury, and Martha McCartney
Colonial Williamsburg Foundation Research Division
20 August 2002

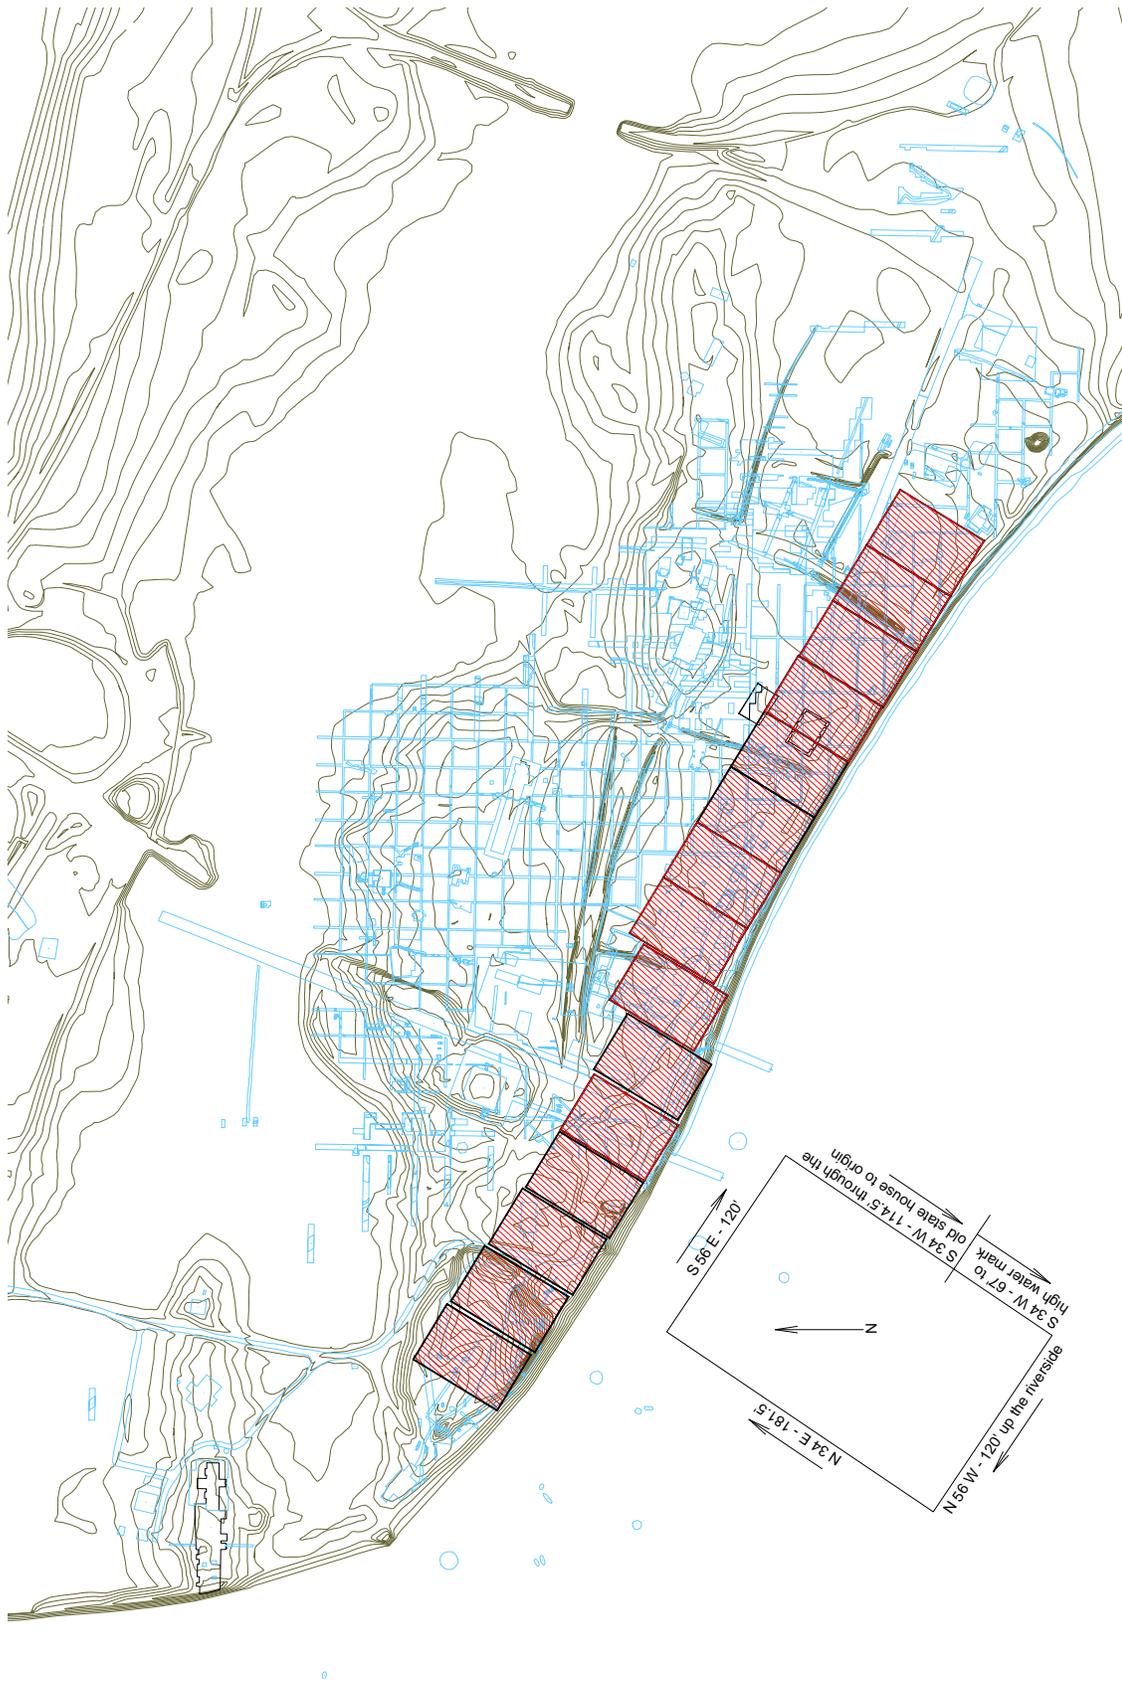
Figure 1. Locations at which the 1667 Ludwell-Stegg patent (if accurately transcribed) could be placed along urban Jamestown's shoreline.

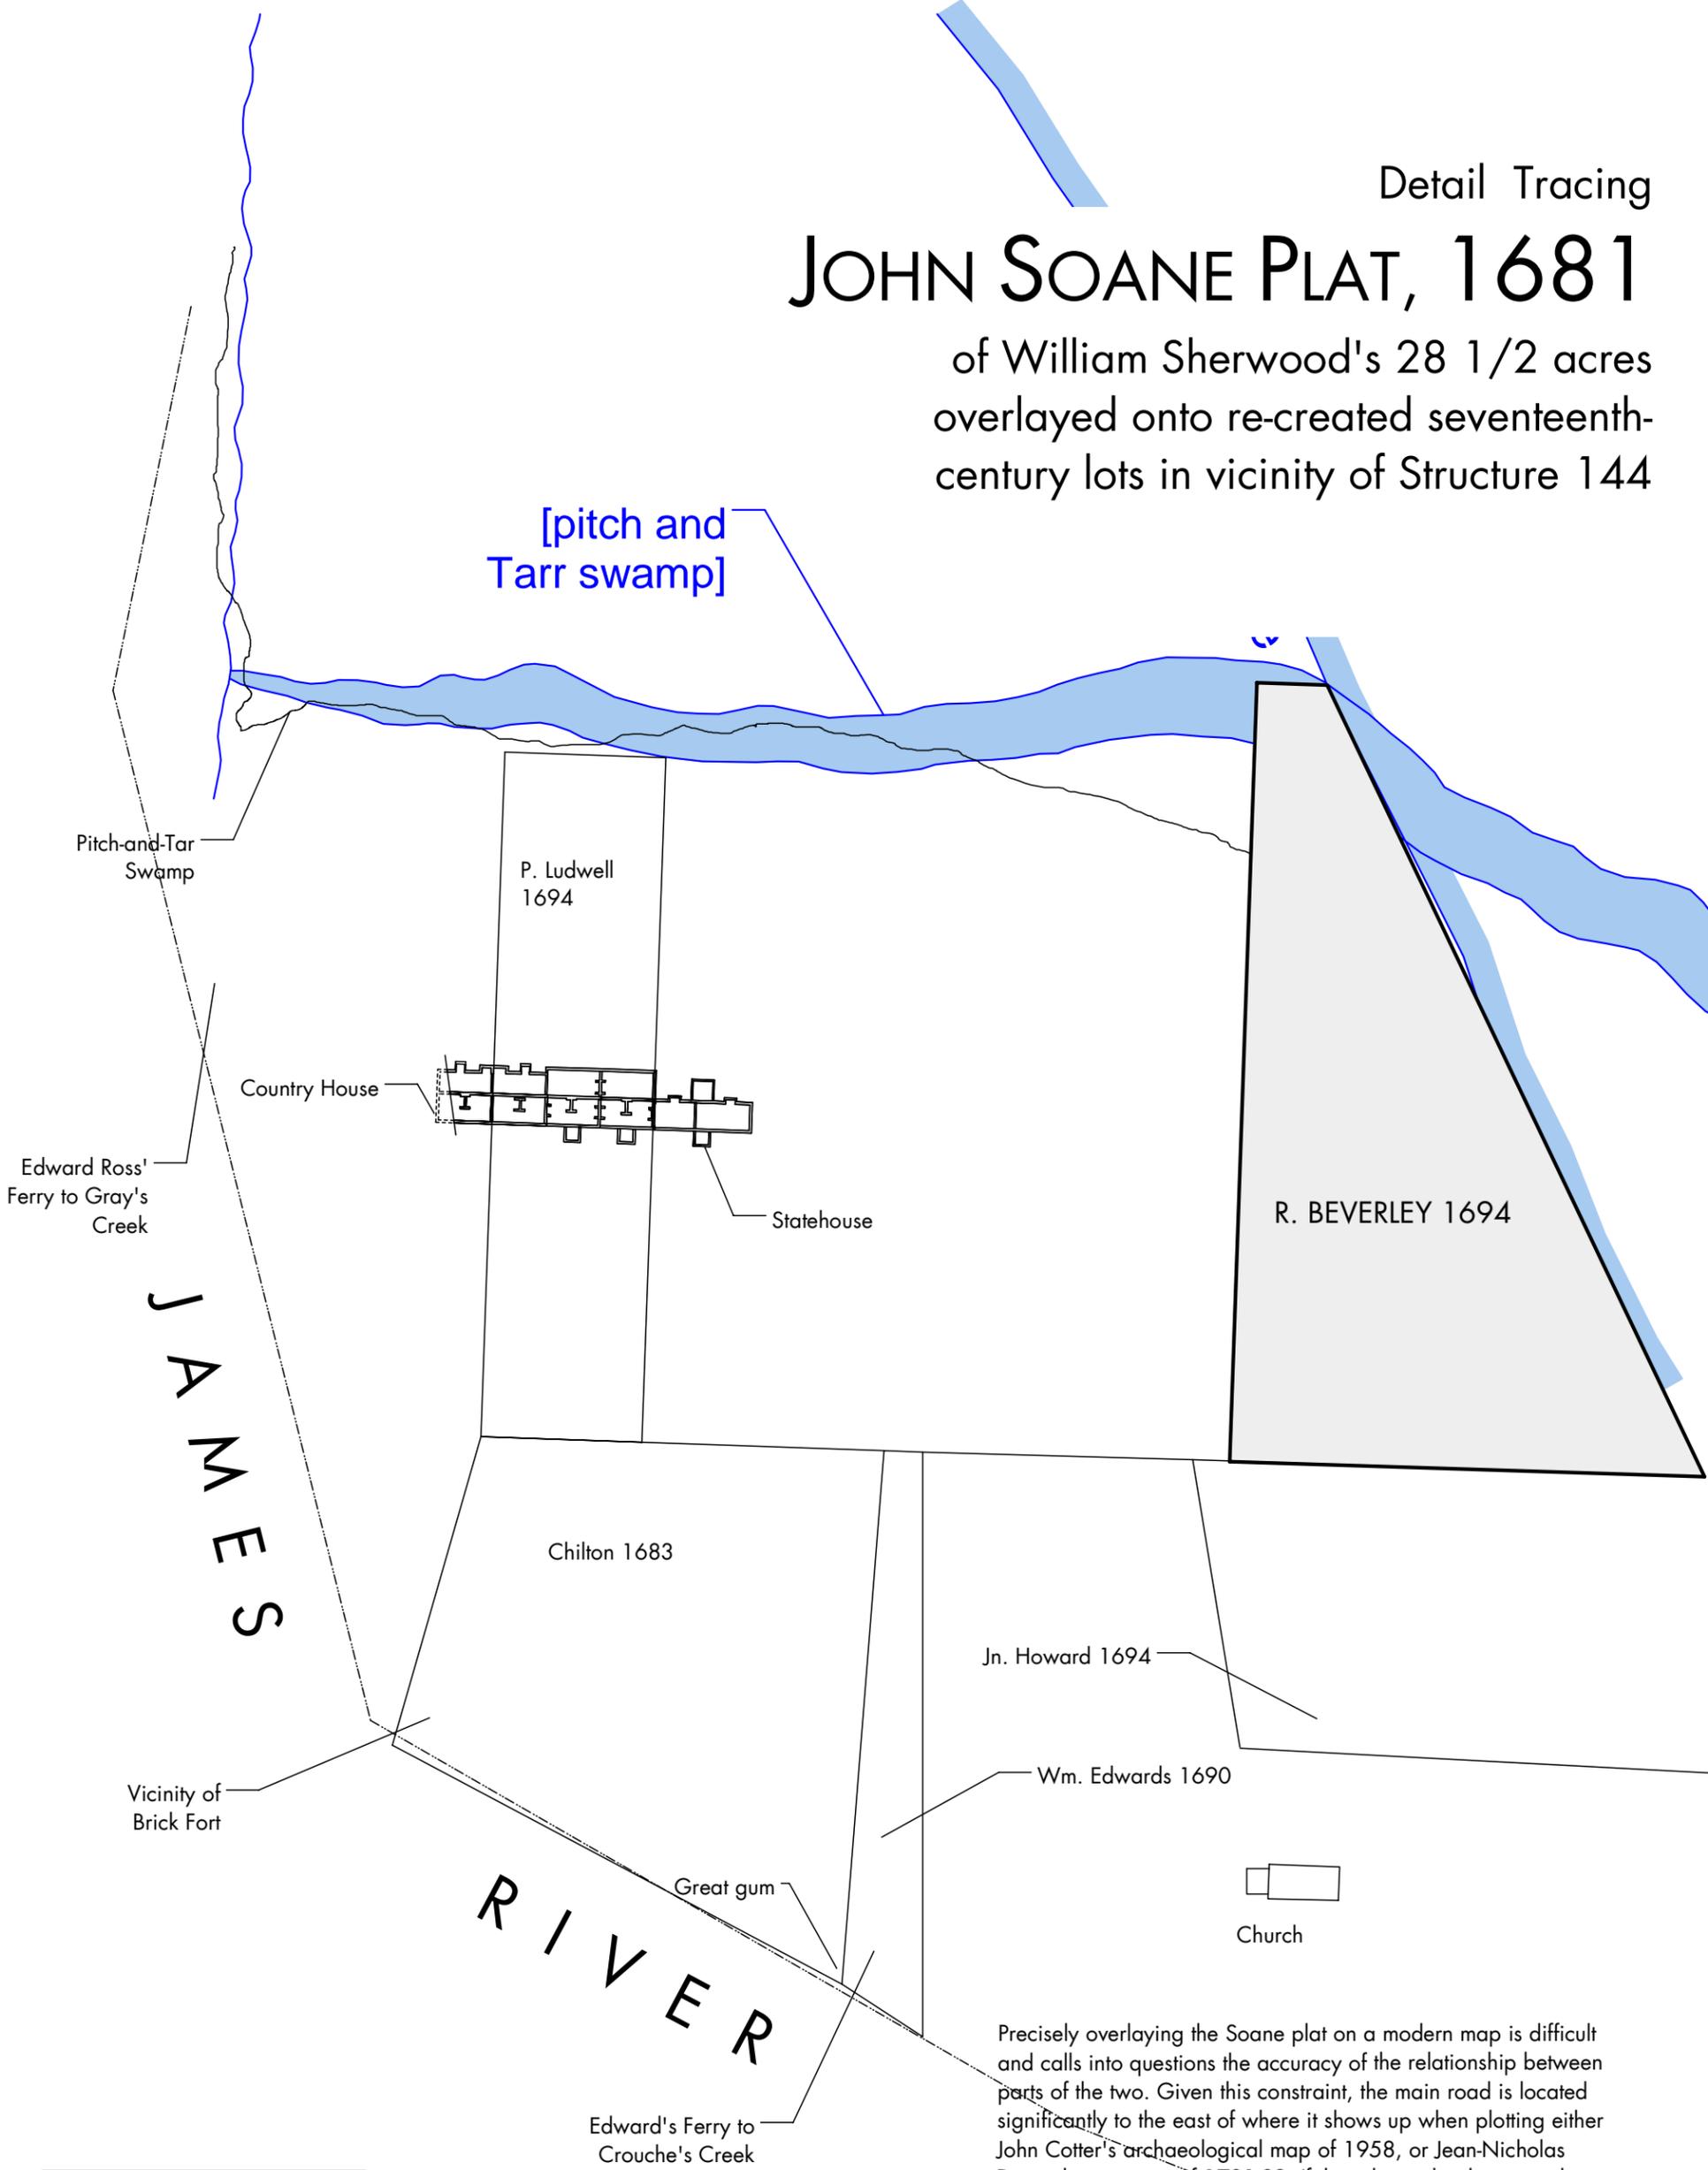
of William Sherwood's 28 1/2 acres overlaid onto re-created seventeenth-century lots in vicinity of Structure 144

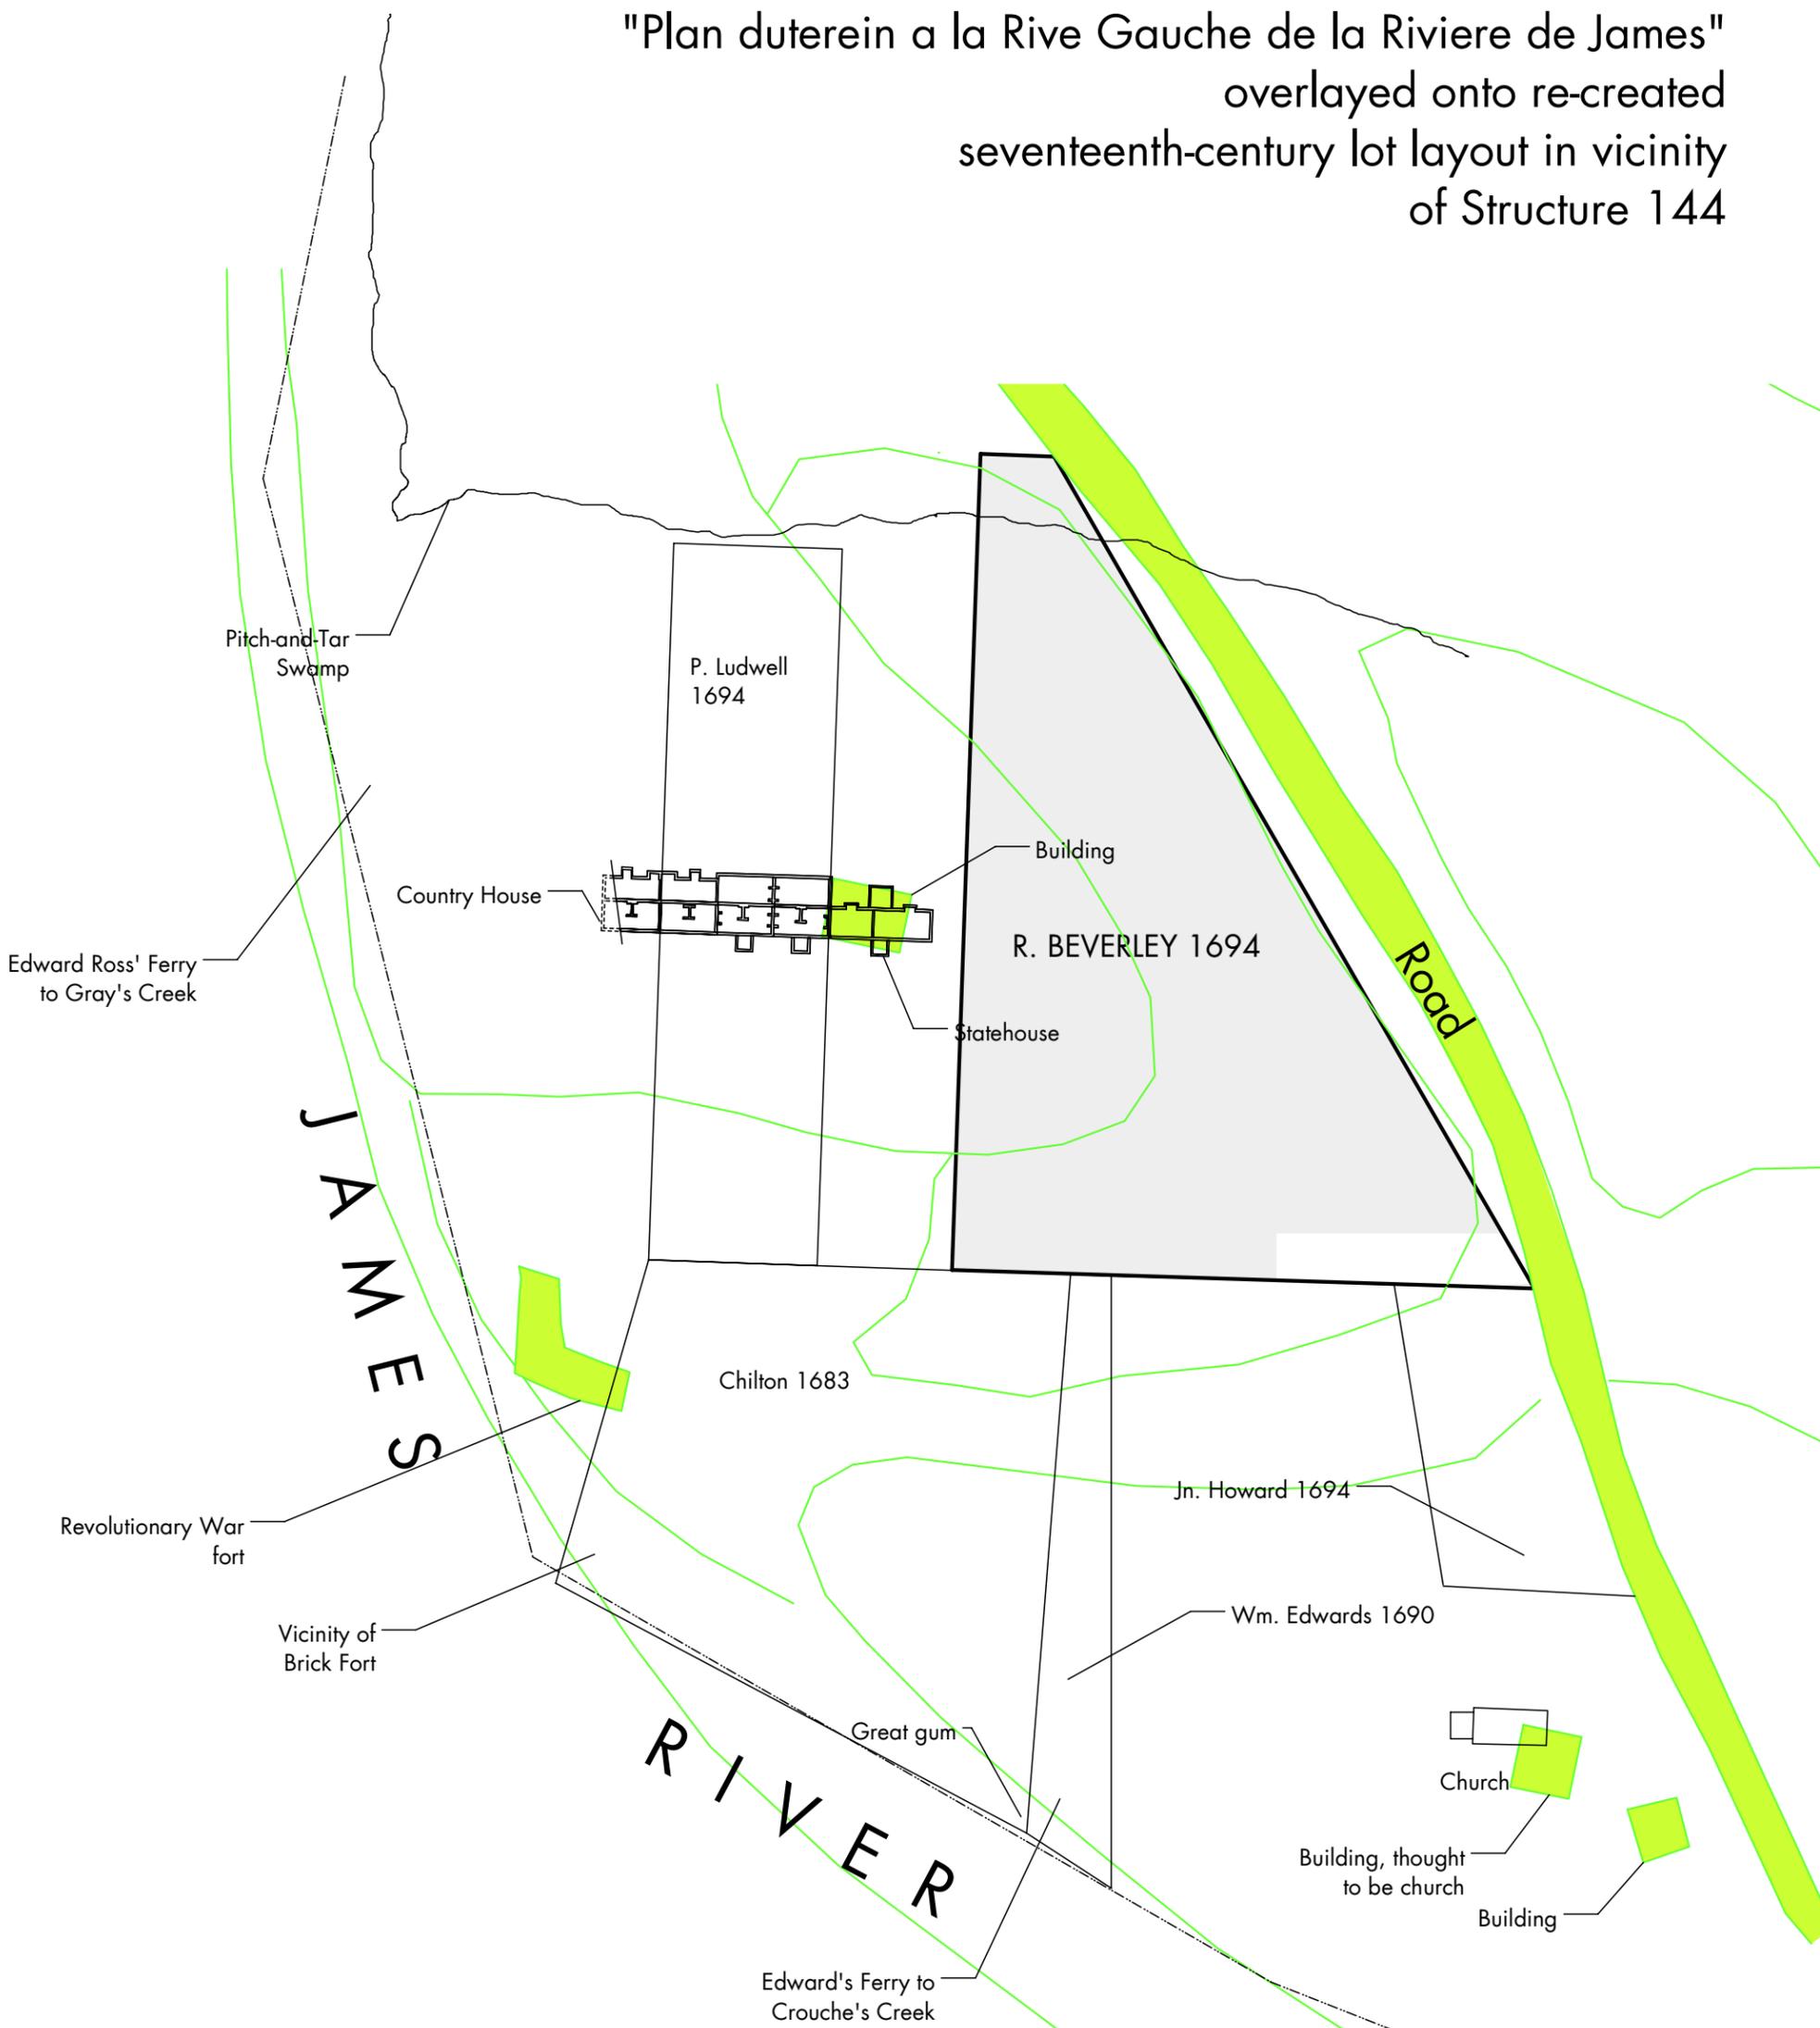
"Plan duterein a la Rive Gauche de la Riviere de James"
 overlaid onto re-created
 seventeenth-century lot layout in vicinity
 of Structure 144

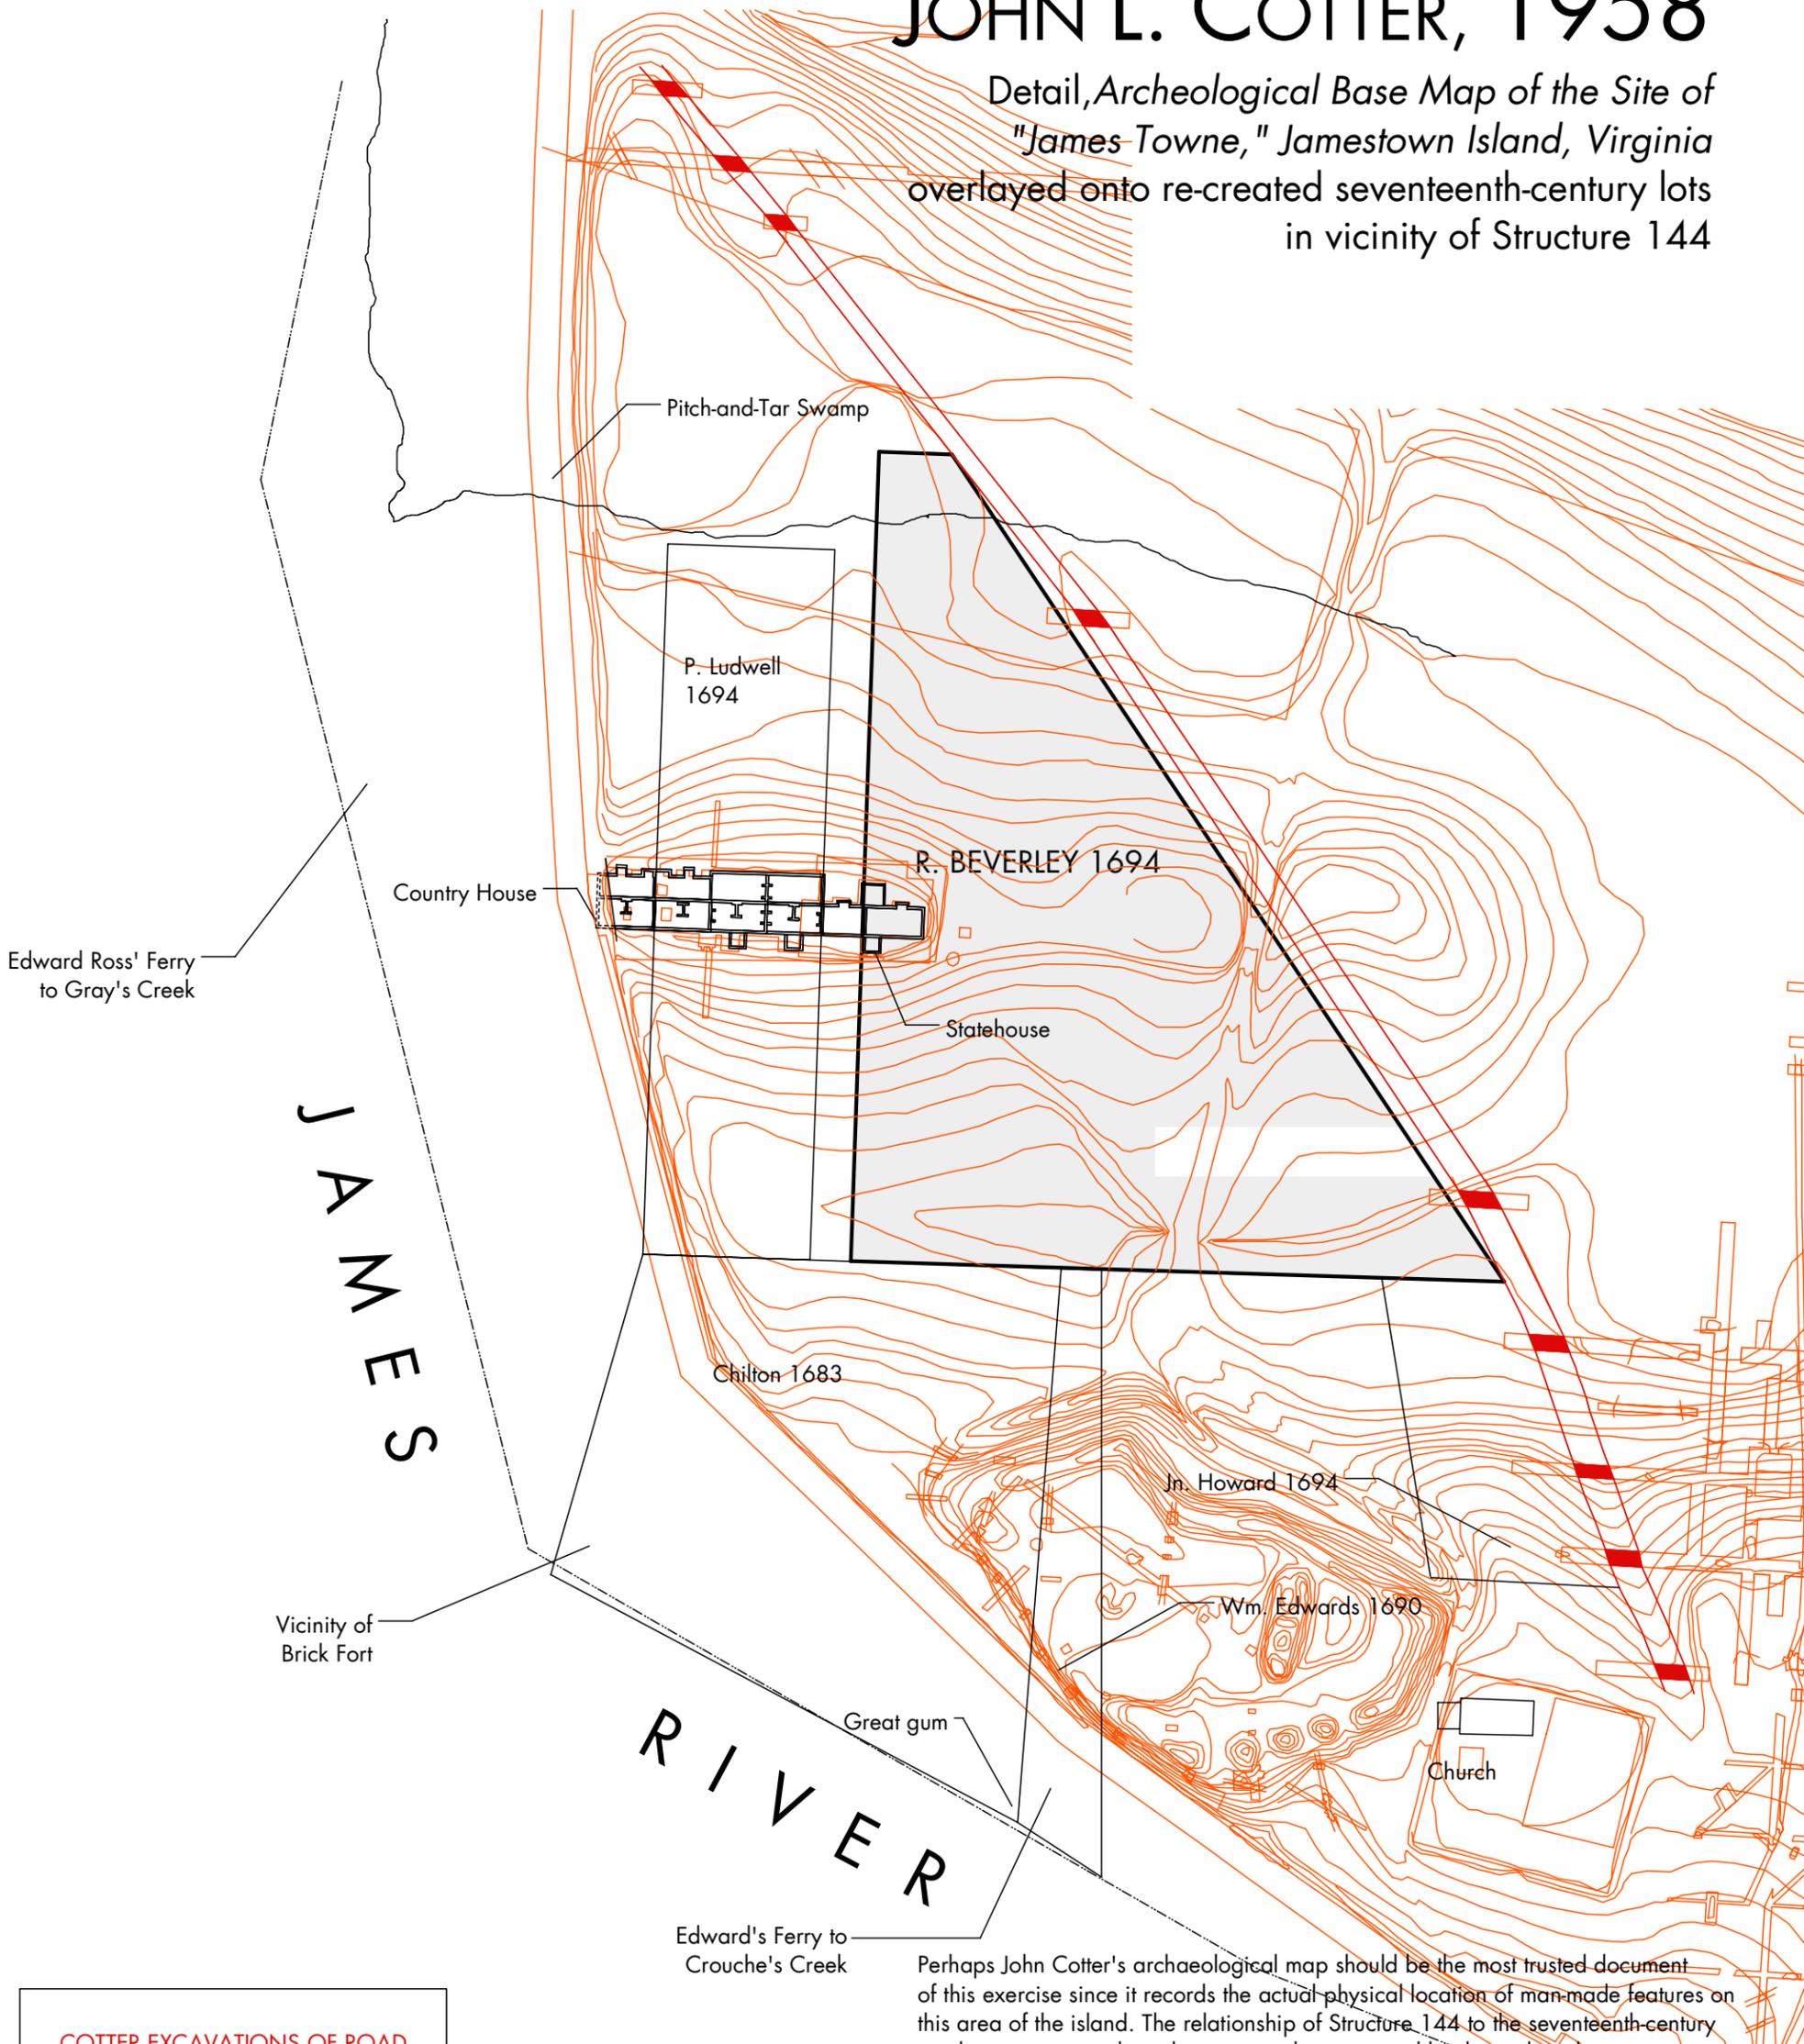
Detail, Archeological Base Map of the Site of "James Towne," Jamestown Island, Virginia overlaid onto re-created seventeenth-century lots in vicinity of Structure 144

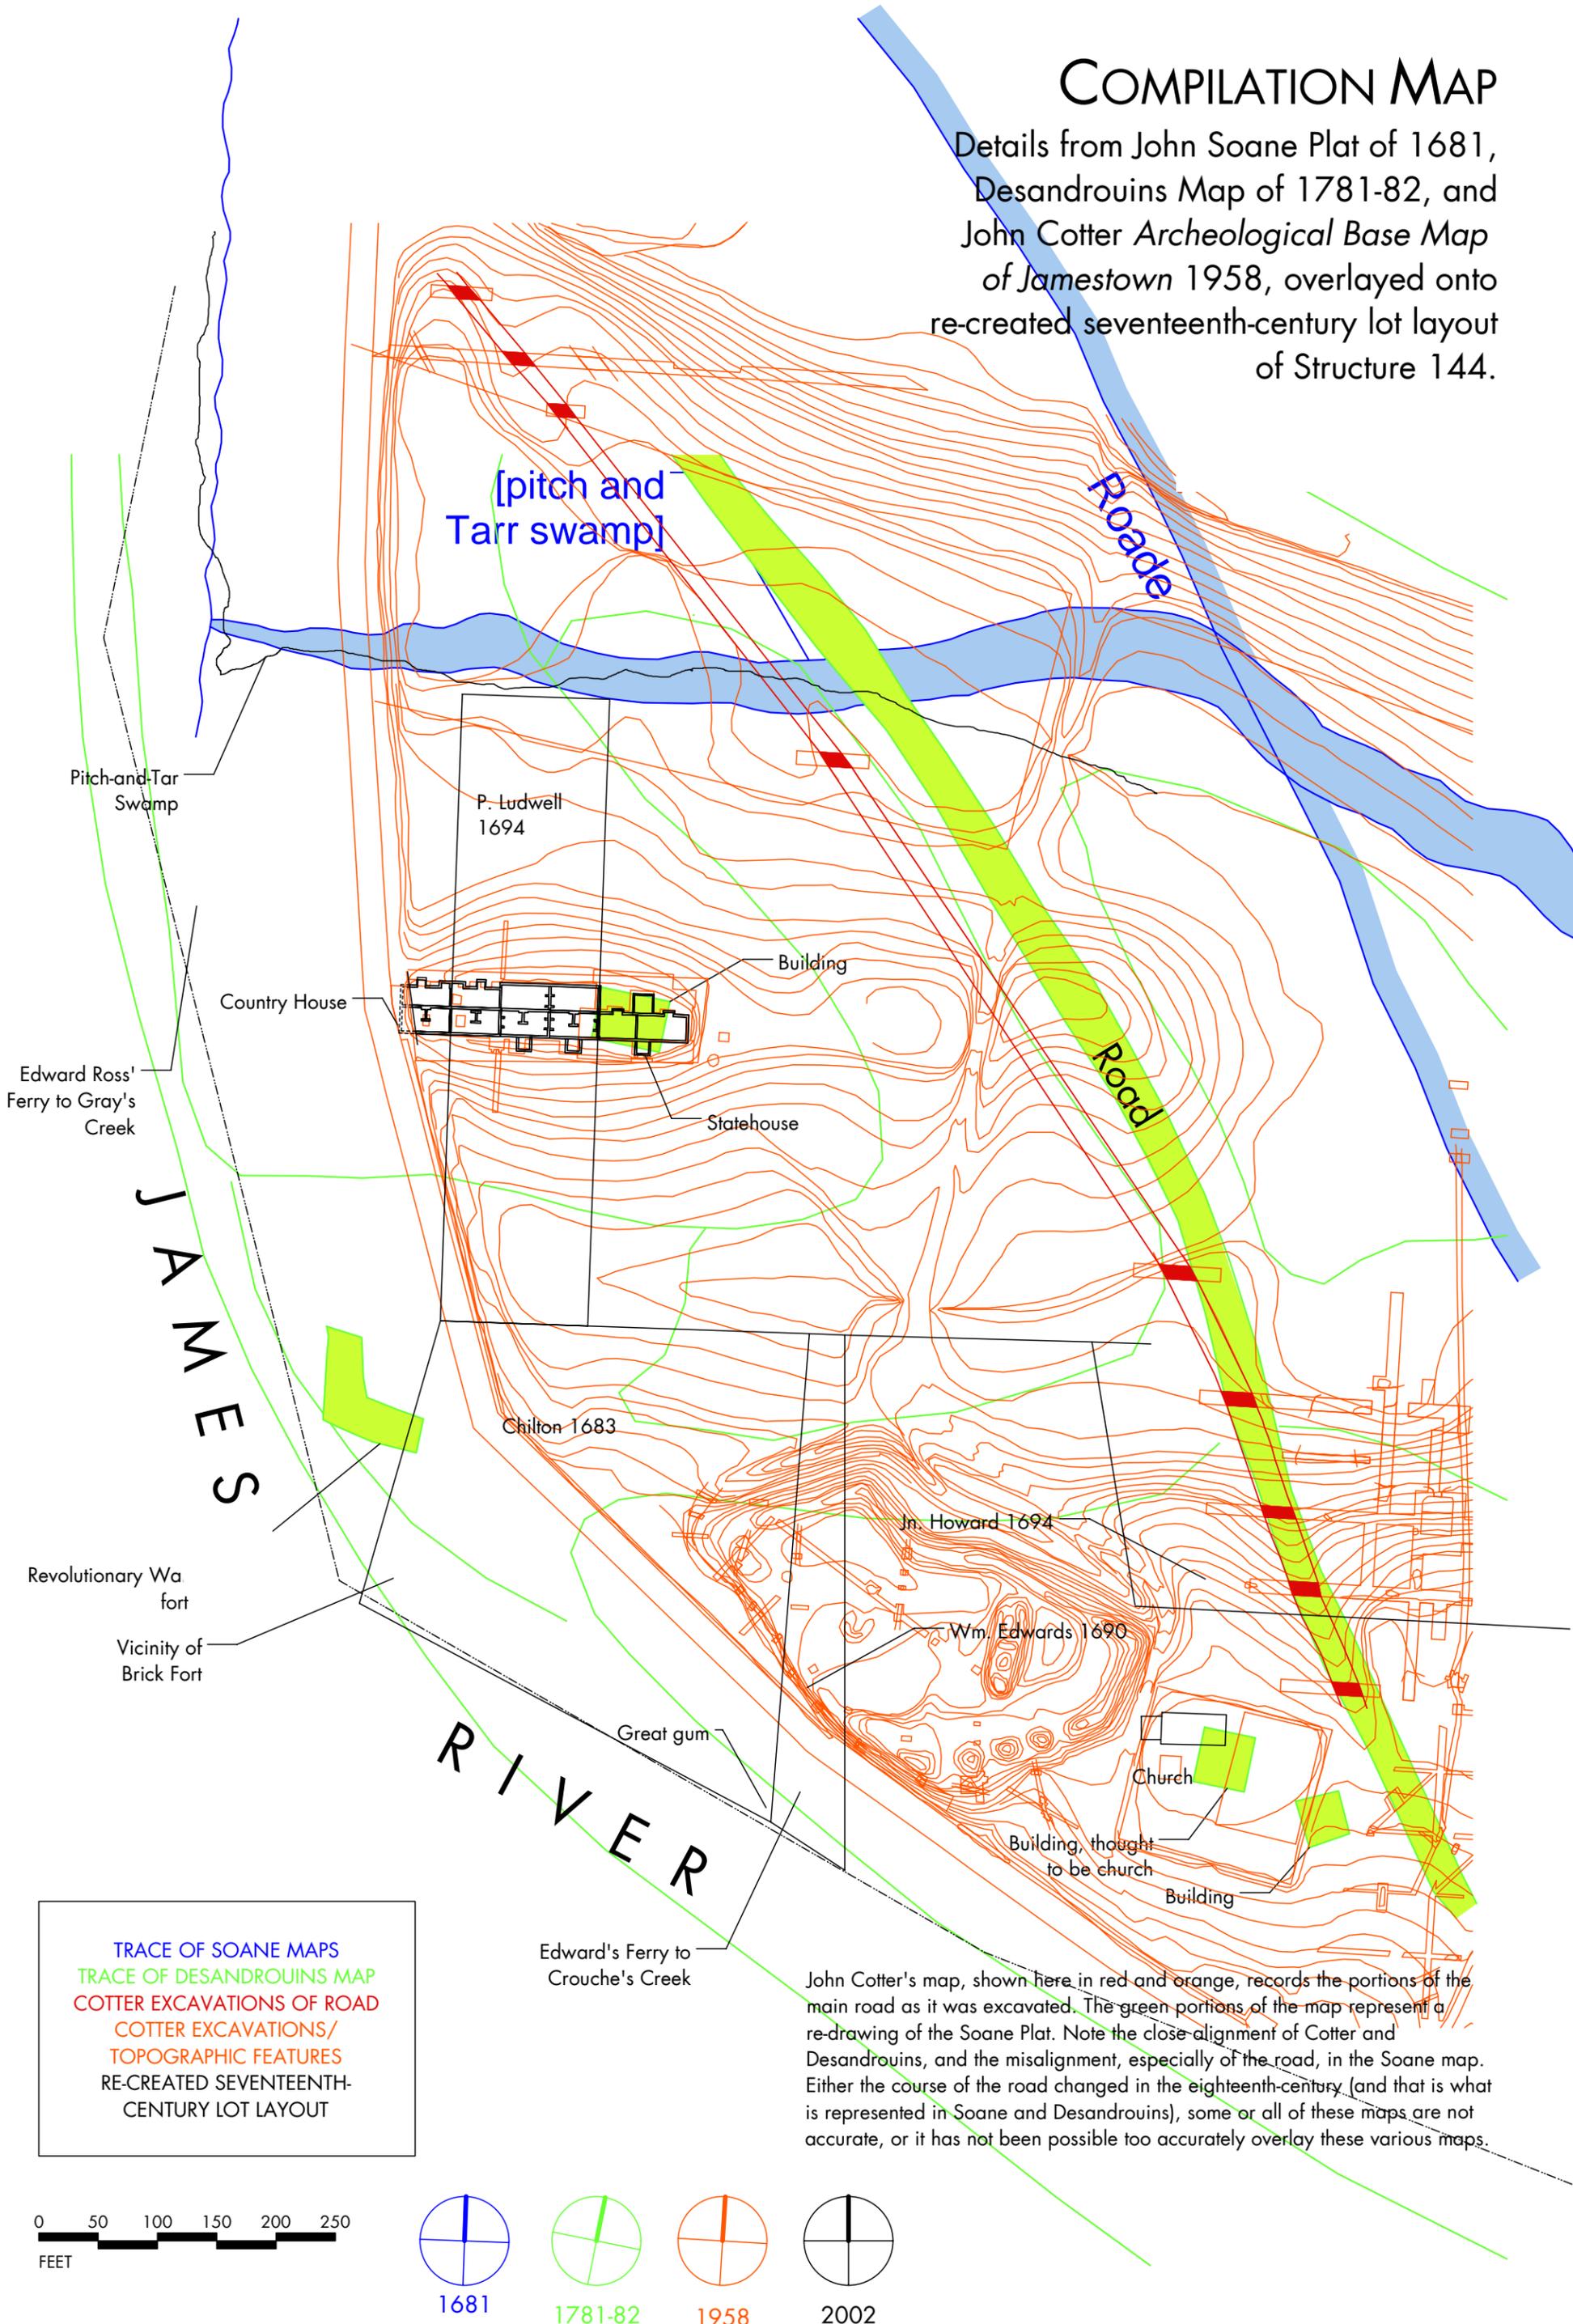
John Cotter's map, shown here in red and orange, records the portions of the main road as it was excavated. The green portions of the map represent a re-drawing of the Soane Plat. Note the close alignment of Cotter and Desandrouins, and the misalignment, especially of the road, in the Soane map. Either the course of the road changed in the eighteenth-century (and that is what is represented in Soane and Desandrouins), some or all of these maps are not accurate, or it has not been possible too accurately overlay these various maps.

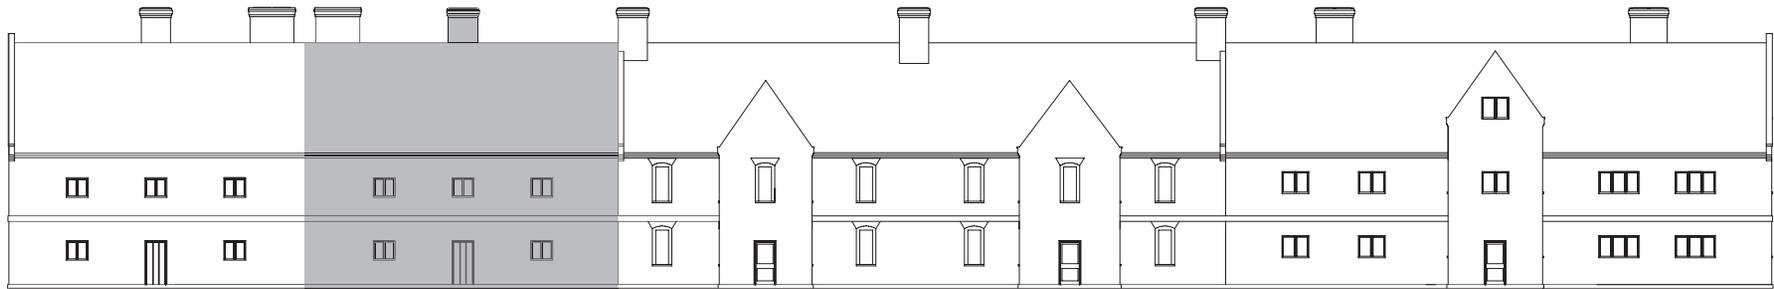
SOUTH ELEVATION

Note: House 2 in ruins.

As it may have appeared prior to 1698

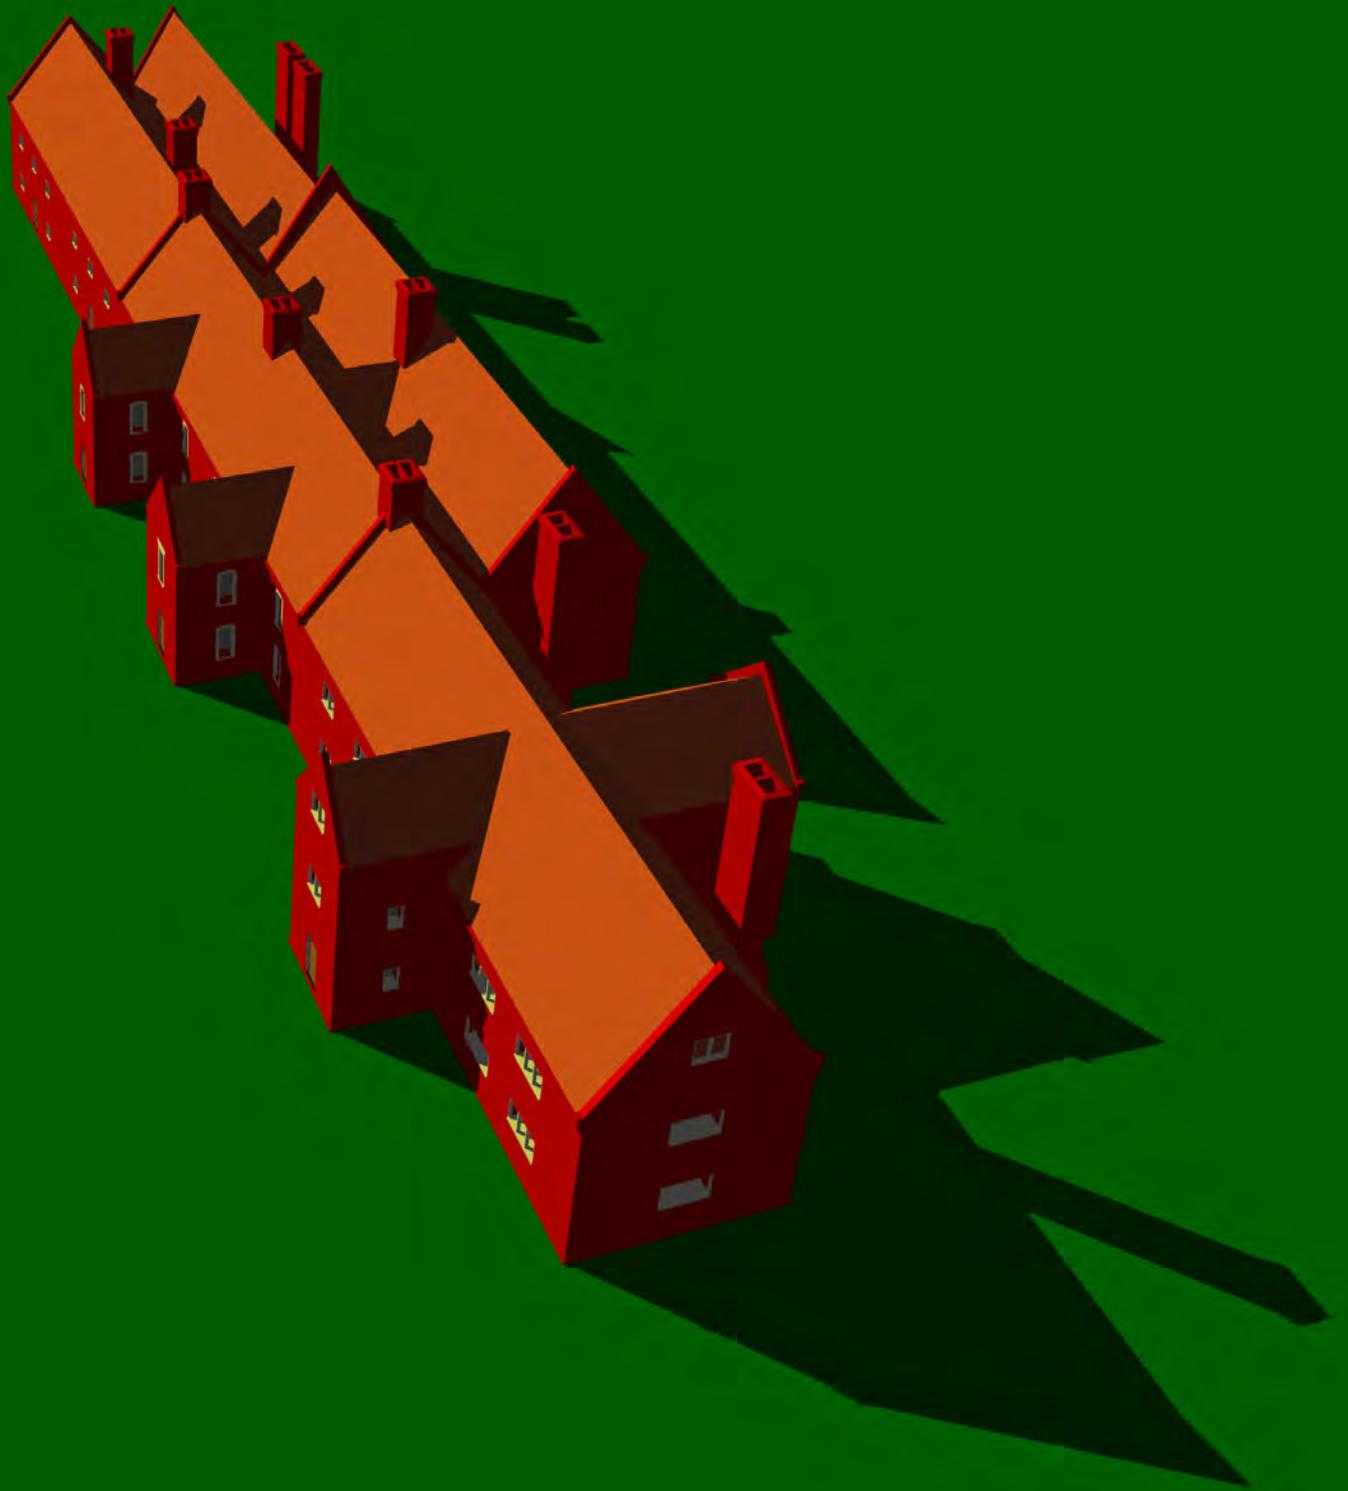
(Previous page)
Reconstructed bird's-eye view of
Structure 144, looking northwest.
Computer rendering by William
Graham, Jr., 2002.
