The Magnetic Map of a Fireplace Base

3 November 2003

prepared for: Eric Deetz
Jamestown Rediscovery
1367 Colonial Parkway
Jamestown, VA 23081

by: Bruce Bevan
Geosight
356 Waddy Drive
Weems, VA 22576

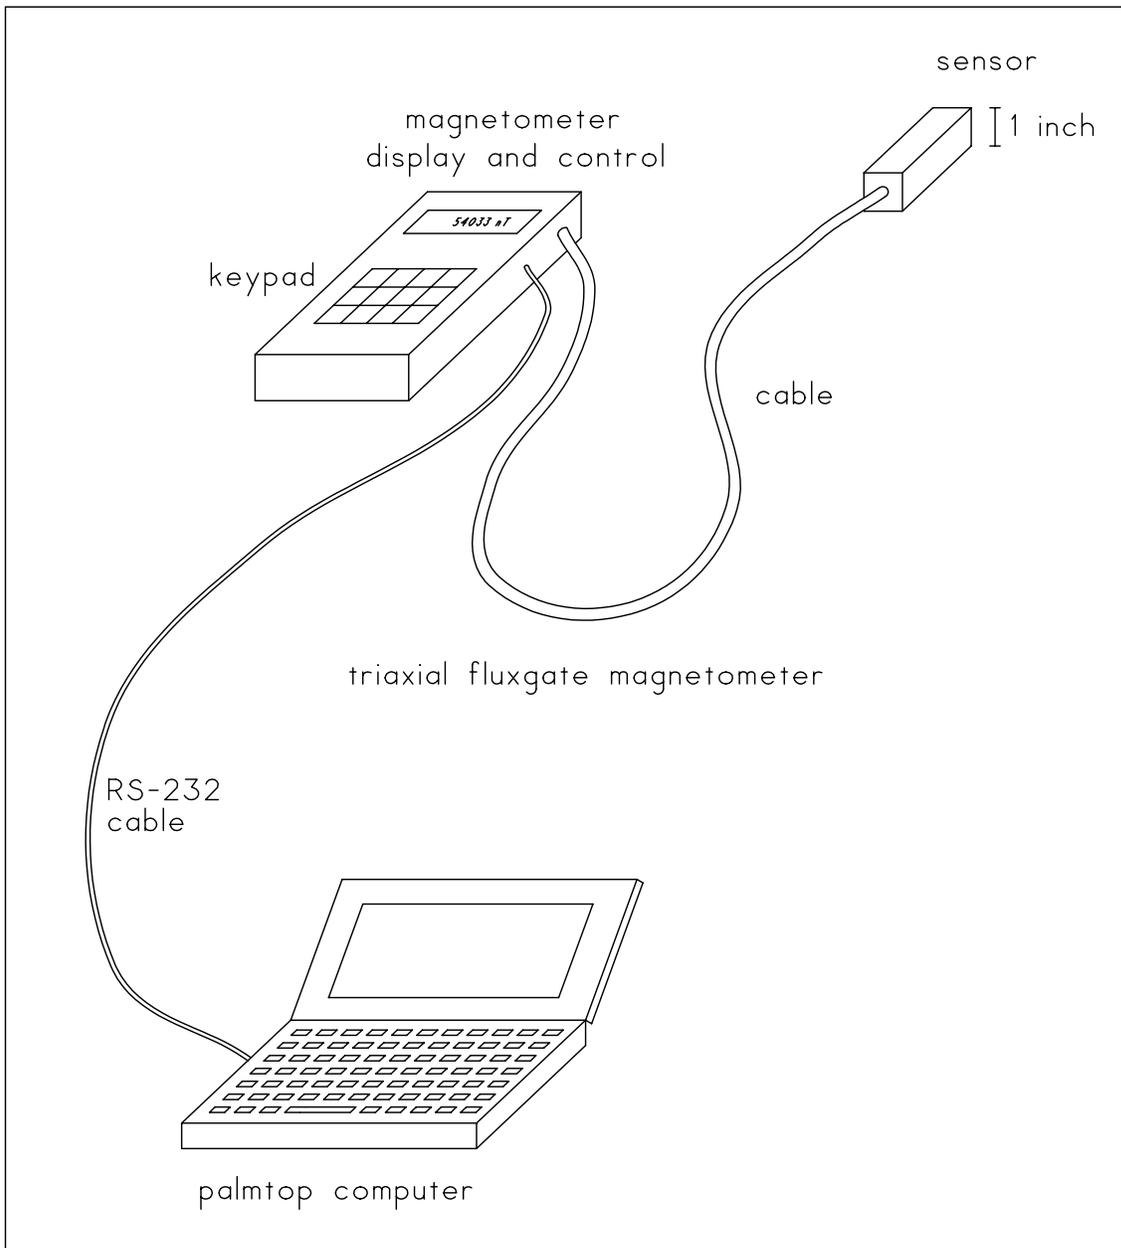
Figure 2: The magnetometer. A small sensor is connected to a control and display console with an electrical cable. While the measurements are shown on the LCD, they can also be sent to a computer with the aid of a serial (RS-232) cable. The magnetic sensor was moved over a square area, and the measurements created a magnetic map of that square.
